Failure to maintain approach distance cited as root cause of Hayden accident

A recent accident at Hayden Substation in northwest Colorado occurred when an electrician failed to maintain the minimum approach distance to energized parts, according to the Accident Investigation Board report.

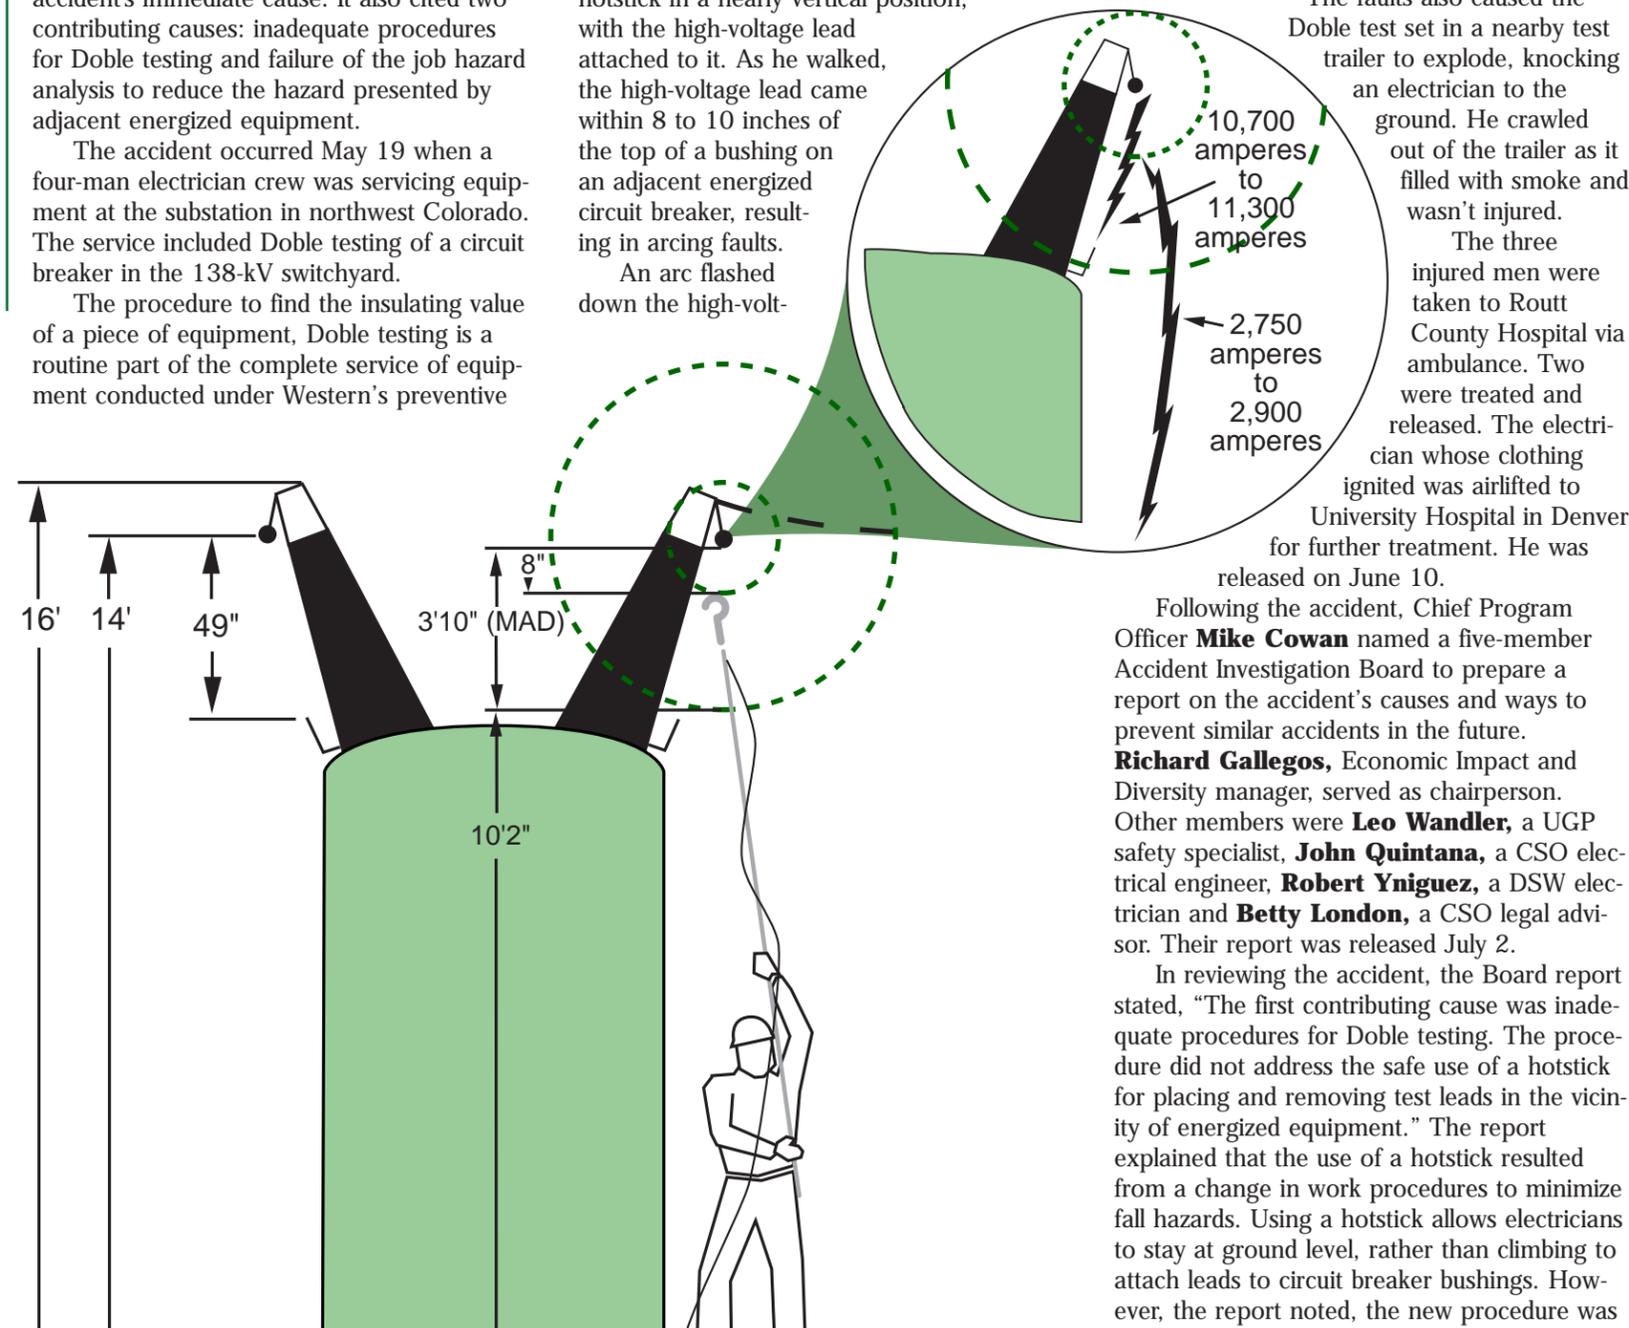
The board identified that failure as the accident's immediate cause. It also cited two contributing causes: inadequate procedures for Doble testing and failure of the job hazard analysis to reduce the hazard presented by adjacent energized equipment.

As the electrician was moving the Doble test set's high-voltage lead from one side of the breaker to the other, he walked backward to take up slack. He carried an 11-foot-long hotstick in a nearly vertical position, with the high-voltage lead attached to it. As he walked, the high-voltage lead came within 8 to 10 inches of the top of a bushing on an adjacent energized circuit breaker, resulting in arcing faults.

This drawing shows how the accident at Hayden Substation happened. It shows the position of the electrician relative to the circuit breaker's bushing.

5. When using a hotstick to place or remove the high voltage lead during Doble testing of breakers and transformers, a procedure should be developed such as the Board's immediate corrective procedure recommendation to ensure that all areas of safety are considered.

On May 27, the Board issued a recommendation to maintenance personnel for an immediate corrective procedure to address safe use of hotsticks when placing and removing Doble test leads.
