## Electric shock injures SN lineman

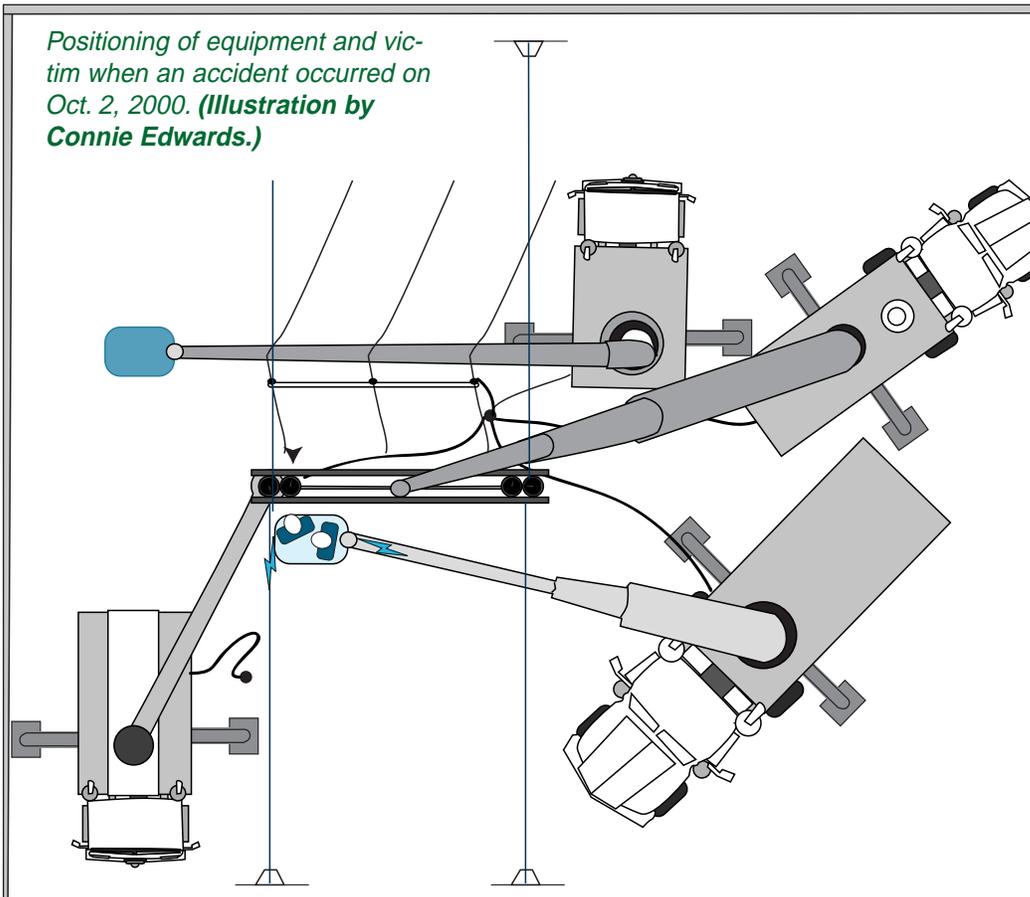
According to the accident report, "The victim might have bridged a voltage difference of 1,000 volts. The voltage difference between the established grounding system (the grounded guy wire) and the unbonded (unconnected) guy wire bracket was caused by the induced voltage conditions that existed at the worksite."

The root cause of the incident was a lack of understanding for the need to establish an equipotential zone at the work-site. In this case, guy wires and pole grounds should have been connected to the established grounding system.

*Positioning of equipment and victim when an accident occurred on Oct. 2, 2000. (Illustration by Connie Edwards.)*

- ◆ Management must ensure Western employees adequately understand the induced voltage effects and the hazards that may be imposed on working personnel, if the hazards are not mitigated.
- ◆ Western must include language in its safety documents to clearly address the need to establish an equipotential zone at the worksite.
