# Sunflower Wind Project: A Class III Intensive Cultural Resources Inventory in Morton and Stark Counties, North Dakota

*Prepared by:*  
Brittany Brooks, RPA

Beaver Creek Archaeology, Inc.  
Bismarck, North Dakota

November, 2013

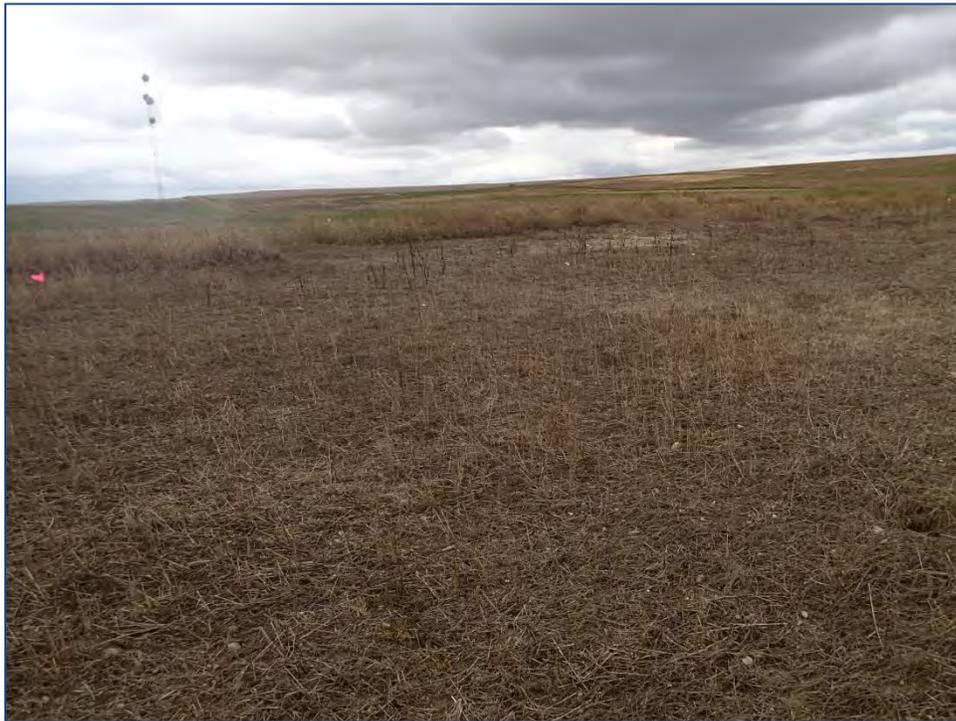
**Figure 11.** Site 32MO1379 overview. View to the west.

Site 32MO1379 was first recorded in 2004 by MAC in 2004 and was updated by BCA during this inventory. The site is situated on a southern-exposed downhill slope within 238m of an intermittent stream. The site is located in agricultural fields. Site 32MO1379 consists of a sparse lithic scatter with Knife River Flint (KRF) tools and debitage. During the current cultural inventory, it was noted that the site boundary is much smaller than previously recorded, eliminating the majority of the site to the south and west of the original boundary.

Although the site has not been formally evaluated for eligibility, BCA has recommended the site as potentially eligible as it has potential to provide an existing context that can allow for the interpretation of scientific data.

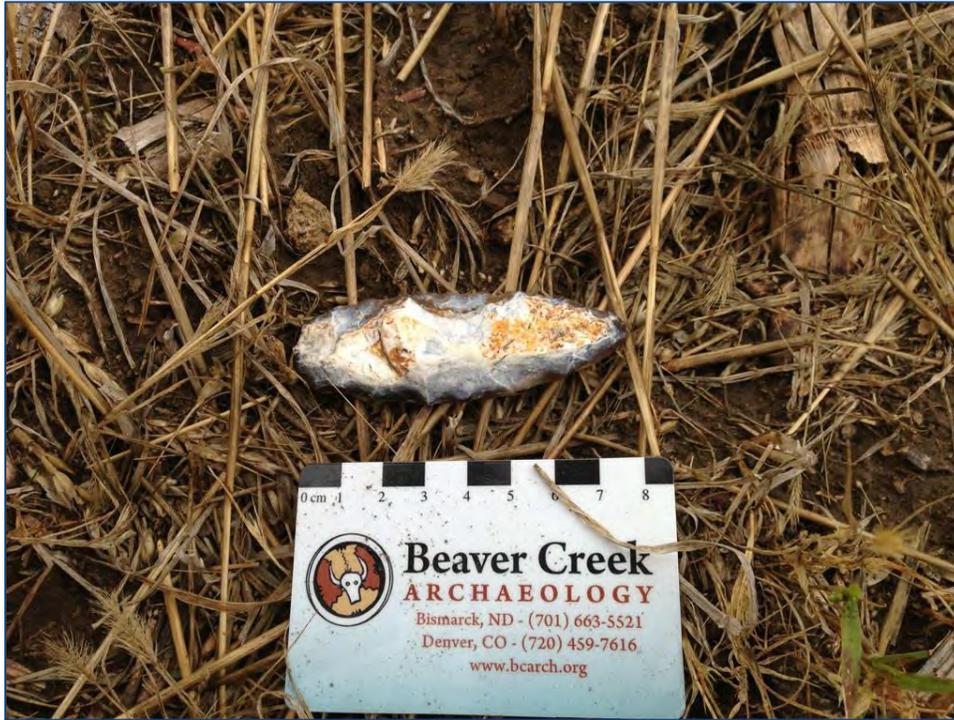
**Figure 25.** View of isolated find 32MOx553.

The site consists of one Knife River Flint (KRF) knife in a plowed field. The site condition is poor as disturbance seems to have occurred through years of plowing. Isolated Finds are not eligible to the NRH, and is therefore not recommended to be avoided.

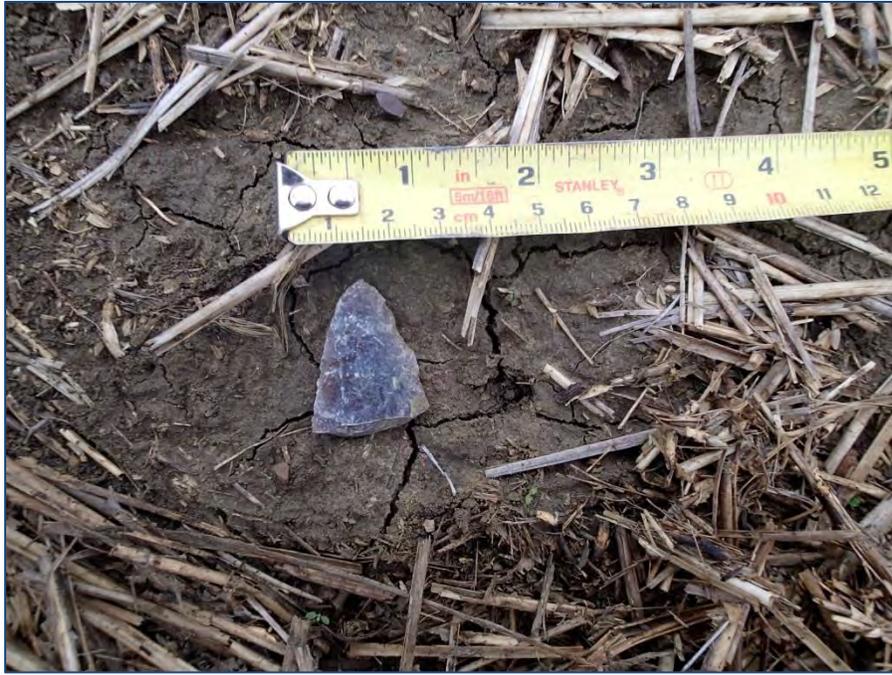
**Figure 27.** View of isolated find 32MOx554.

The site consists of a broken KRF projectile point in a plowed field. The site condition is poor as disturbance seems to have occurred through years of plowing. Isolated Finds are not eligible to the NRHP, and is therefore not recommended to be avoided.

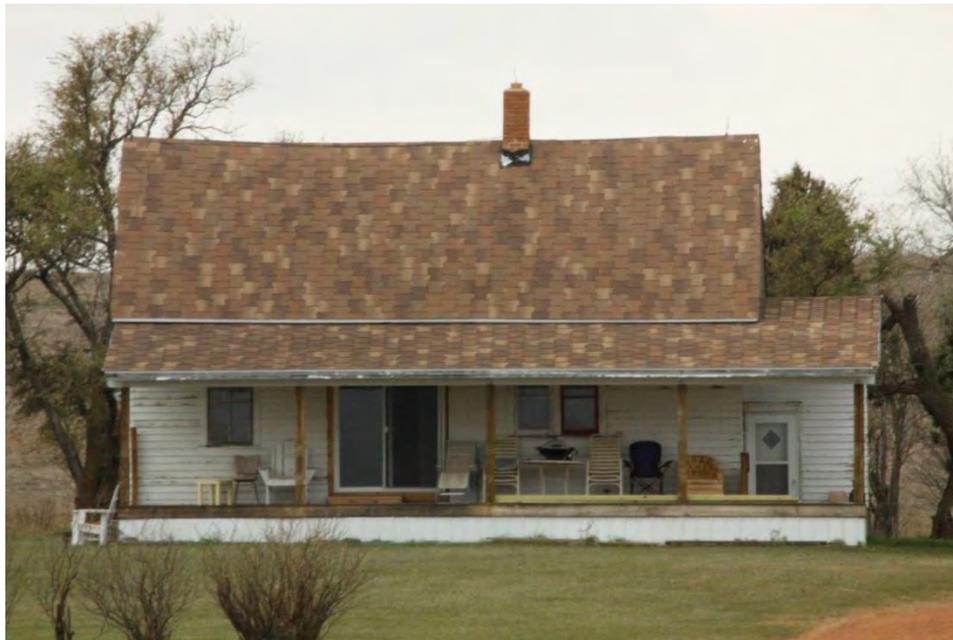
**Figure 29.** View of house at Location 1. View to the west.

The structure is a residential 1.5 story, single unit dwelling, with wood framing and horizontal wood siding. The windows at the front (east side) of the house are three-over-one fixed windows. The original door has been replaced with sliding glass doors. A one story addition to the house and porch has been made on the right (north) side of the house. The addition is visible with alignment of the horizontal wood siding. The wood posts supporting the porch have also been replaced based on the color and weathering of the posts. The gabled roof has been updated with asphalt shingles. The chimney consists of brick and is situated on the slope. There is also a lightning rod at the north end of the roof. Due to the alterations, the structure retains little integrity. The farmhouse does not meet any of the criteria for eligibility to the NRHP.

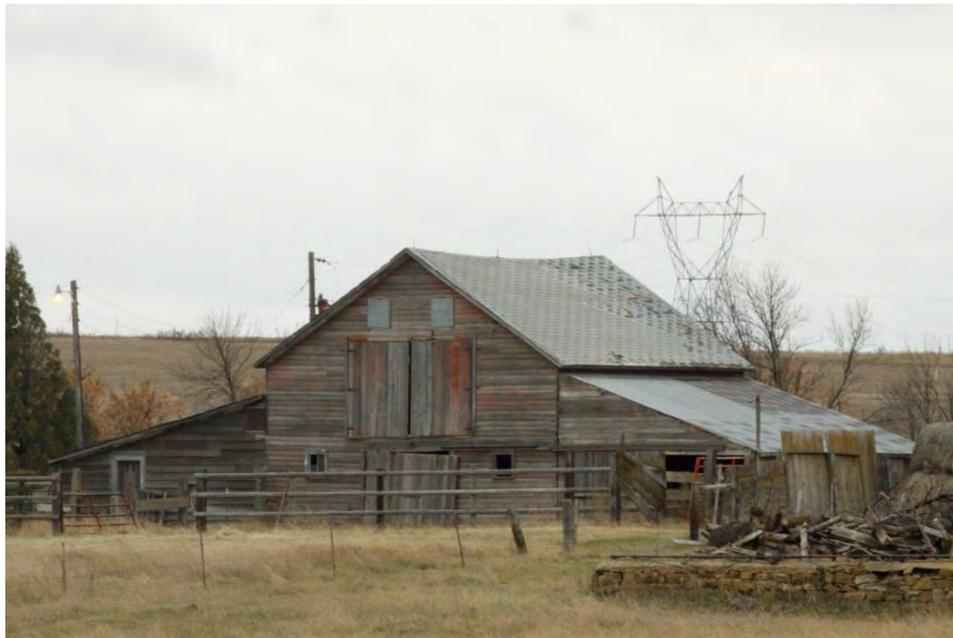
**Figure 30.** View of barn at Location 1. View to the north.

The barn at the location is not eligible for the NRHP due to the deterioration of the structure as well as the alterations that have occurred to the structure.

The structure is a 2.5 story gabled transverse-crib barn with wood framing and horizontal wood siding. The entrance is at the gabled end with a hay loft above. The window openings are still intact; however, the majority of the windows are boarded up, missing the window glass, or missing a pane and two are shuttered. Sheds have been added to the outer walls (east and west sides). The sheds were not added to the original barn at the same time. The shed on the right (east) was likely added first based on the similarity of the horizontal wood siding between the shed and the original barn. The shed on the left (west) was added later based on the height of the horizontal wood siding and the lower roof height in comparison to the right (east) shed. The original barn's roof was updated with asphalt shingles. There are three lightning rods on the ridge of the roof. The north side of the roof is in need of repair. The shed roofs are covered in aluminum sheeting. Due to the deterioration and alterations, the structure retains very little integrity. The barn does not meet any of the criteria for eligibility to the NRHP.

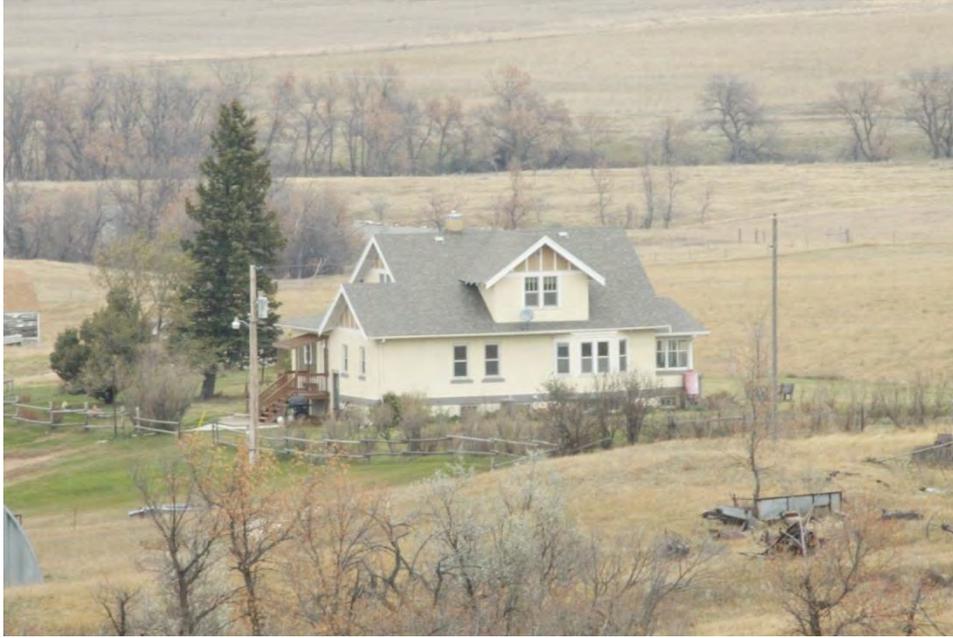
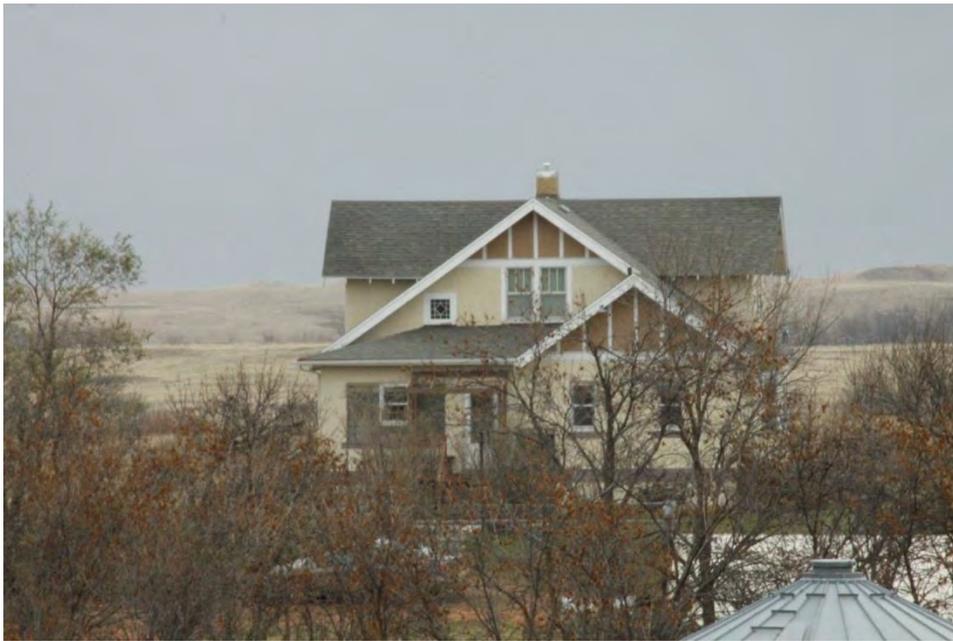
**Figure 31.** View of house at Location 2. View to the northeast.

The structure is a residential two story, single unit dwelling, with wood framing and horizontal vinyl or steel siding. The original horizontal wood siding was replaced with the vinyl or steel siding. The windows on the second floor of the house are three-over-one double hung windows. There is one fixed window on the second floor that is the original sash glazing pattern window. The first floor windows, which have been replaced, are one-over-one double hung windows. The doors have also been replaced. On the right (south) side of the structure are four one-over-one bay windows, which have also been replaced. The basement windows are end vent windows. Additions have been made to the front and rear of the house. A one story gabled addition to the front right as well as to the back of the house. The original front porch is now covered and the new stoop and made of wood with a wood awning. The cross-gabled roof has been updated with asphalt shingles. The cross-gabled roof has exposed rafters and the gable ends have a Tudor style pattern. The chimney consists of brick and is situated on the ridge. Due to the alterations, the structure retains little integrity. The farmhouse does not meet any of the criteria for eligibility to the NRHP.

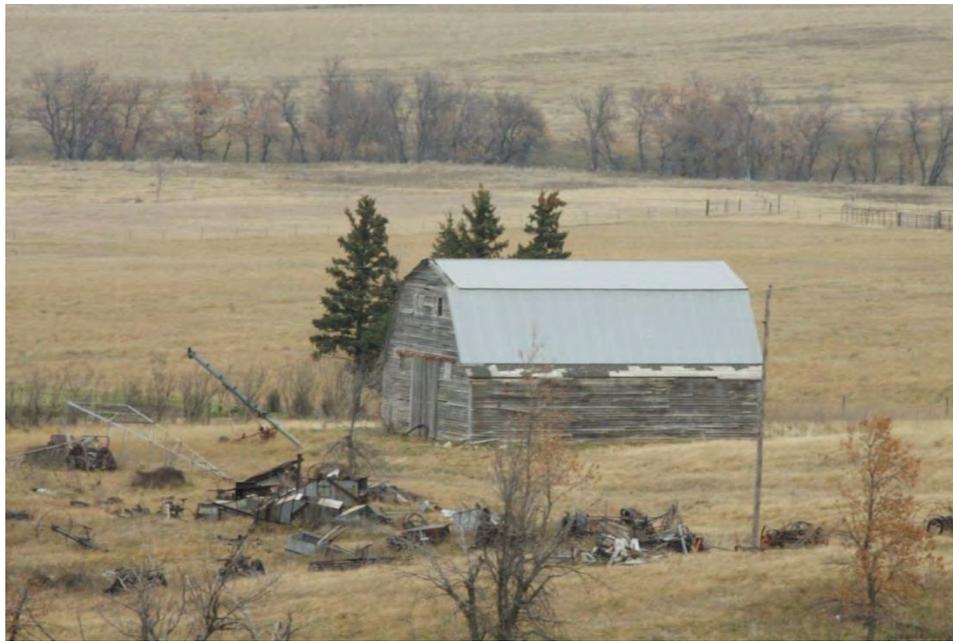
**Figure 33.** View of Barn 1 at Location 2. View to the southeast.

This barn at the location is not eligible for the NRHP due to the deterioration of the structure. The structure is a 2 story gambrel roof transvers-crib barn with wood framing and horizontal wood siding. The entrance is at the gambrel end. The windows on the second story are six-pane casement windows and the windows on either side of the barn entrance are four-pane casement windows. The roof is gambrel with flared eaves. The original roof has been replaced with aluminum sheeting and asphalt shingles on the flared eaves. The roof is in need of repair. The walls of the barn are in need of repair as some of the horizontal boards are missing. Due to the deterioration, the structure retains very little integrity. The barn does not meet any of the criteria for eligibility to the NRHP.

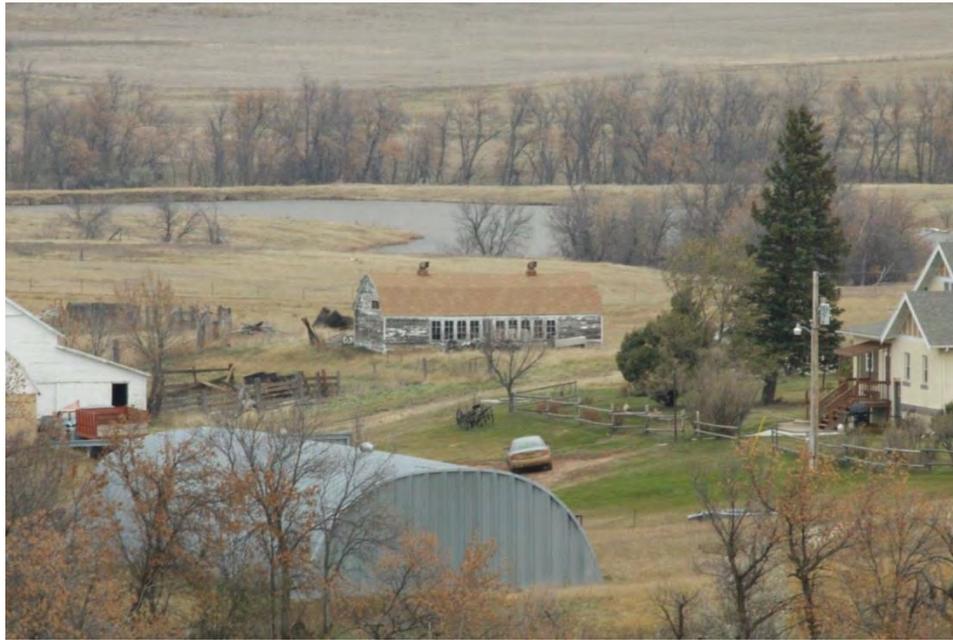
**Figure 34.** View of Barn 2 of Location 2. View to the northeast.

The structure is a 1.5 story gambrel roof transverse-crib barn with wood framing and horizontal wood siding. The barn looks to have been white washed at one point. The entrance to the barn on the left (west) side has been boarded up. There is a small window at the gambrel end. There is a ribbon of 10 six-pane casement windows on the south side of the barn. These windows are likely not the original barn windows based on how large they are. The original roof has been replaced with asphalt shingles. There are two ventilators on the ridge of the roof. Based on the size and shape of the barn as well as the windows, the barn was at one point, likely a calving barn. Due to the deterioration and alteration, the structure retains very little integrity. The barn does not meet any of the criteria for eligibility to the NRHP.

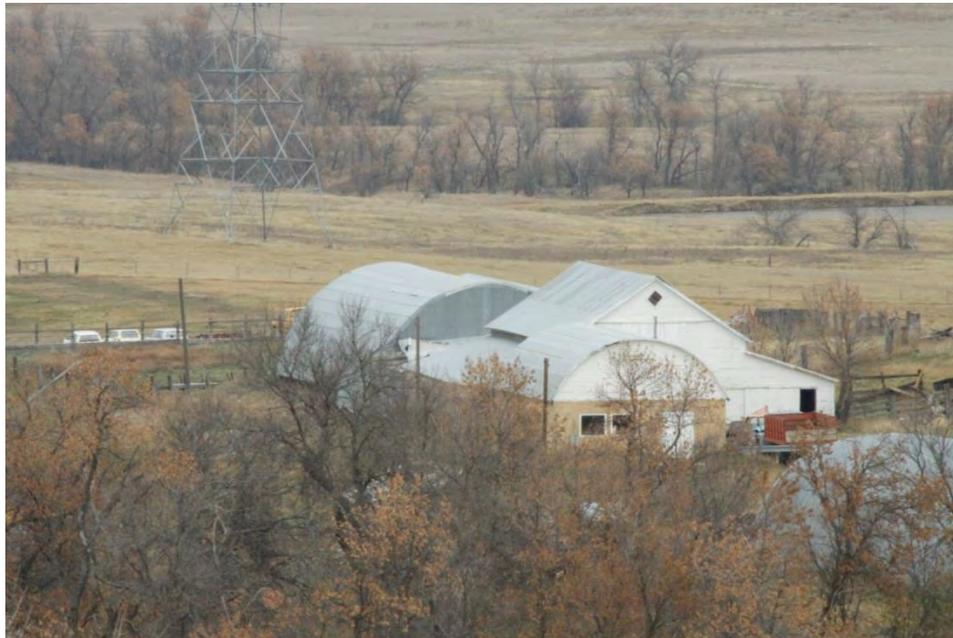
**Figure 35.** View of Barn 3 of Location 2. View to the northeast.

The structure is a 2.5 story gable roof transverse-crib barn with wood framing and horizontal wood siding. The entrance is at the gable end with a hay loft above. There is a diamond-shaped fixed window at the gable end. Other window openings at the gable end have been boarded up. Sheds have been added to the outer walls. The original roof has been replaced with aluminum sheeting. The shed roofs also have aluminum sheeting. A metal Quonset was added to the rear west side of the barn and a brick, wood, and metal Quonset was added to the front west side of the barn. The Quonsets are modern additions to the barn. Due to the alterations, the structure retains not integrity. The barn does not meet any of the criteria for eligibility to the NRHP.

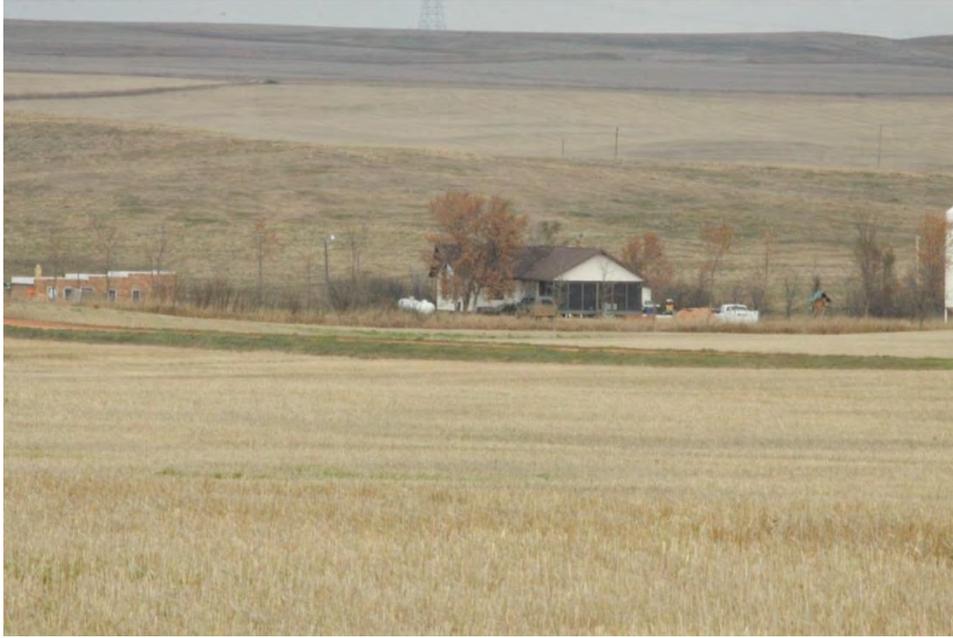
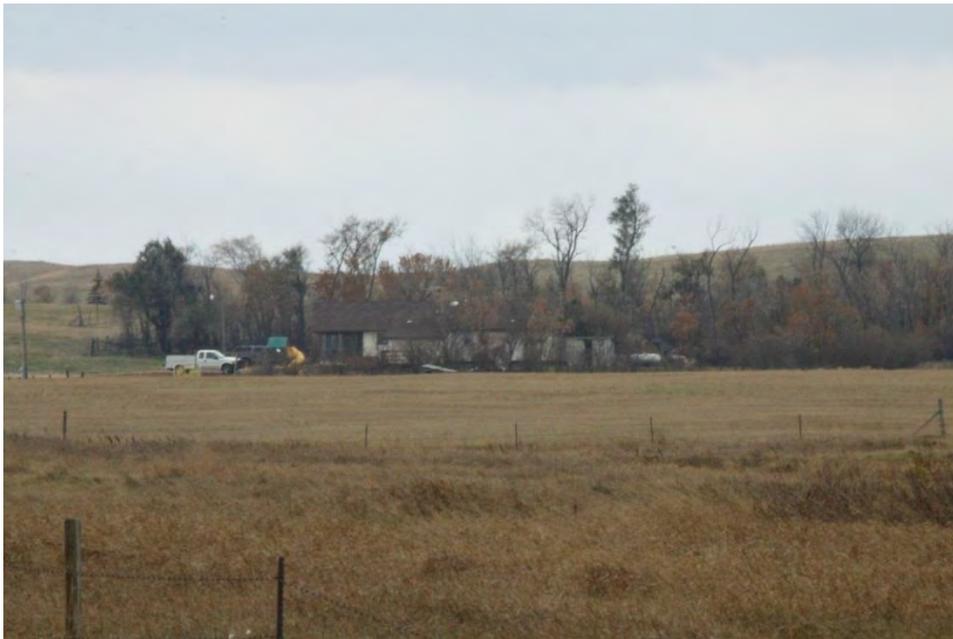
**Figure 36.** View of House at Location 3. View to the northeast.

The structure is a residential one story, single unit dwelling with a wood frame and vinyl siding. Several additions were made to the farmhouse. There is an addition to the rear (north side) of the house. A small addition, with a shed roof, was made to the east side of the house. The front was added to and enclosed. The windows have been replaced and are now double hung one-over-one windows. The original gabled roof has been replaced with asphalt shingles. The chimney consists of brick and is situated on the slope. Due to the alterations, the structure retains little integrity. The farmhouse does not meet any of the criteria for eligibility to the NRHP.

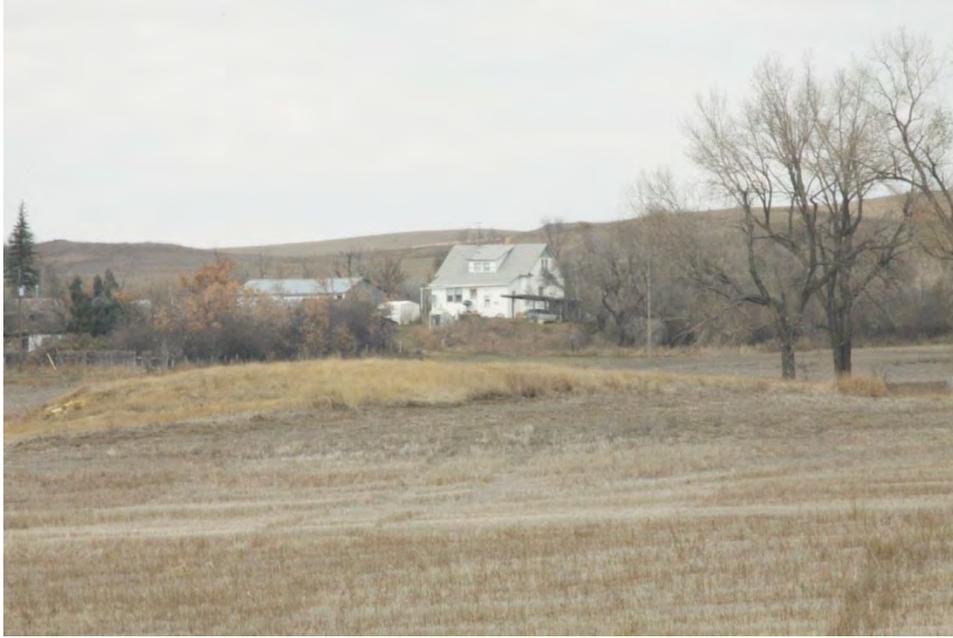
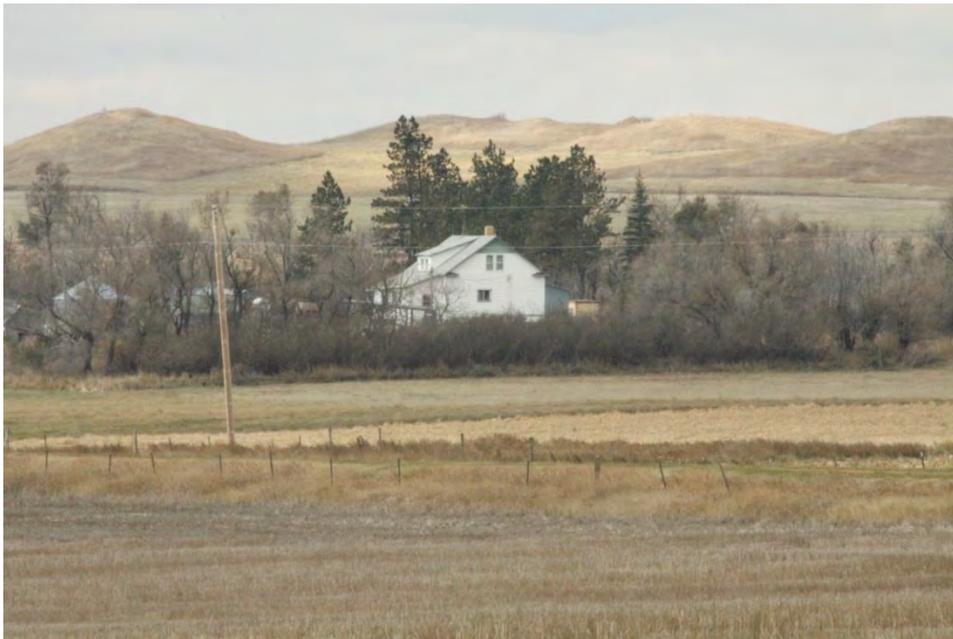
**Figure 38.** View of House 1 at Location 4. View to the north.

The structure is a residential 1.5 story, single unit dwelling, with wood framing and horizontal wood siding. The original windows have been replaced with double hung one-over-one windows and at least one window is a sliding one-by-one. There is a shed dormer with paired windows is location at the front (south side) of the house. The doors to the house have also been replaced. The gabled roof has cornice returns at the gable end. The chimney consists of brick and is situated on the slope. There are also lightning rods on the ridge of the roof. A couple of additions have been made to the structure. A one story addition with a shed roof is located at the rear (north side) of the house. The front porch is now covered and has a shed roof. Due to the alterations, the structure retains little integrity. The farmhouse does not meet any of the criteria for eligibility to the NRHP.

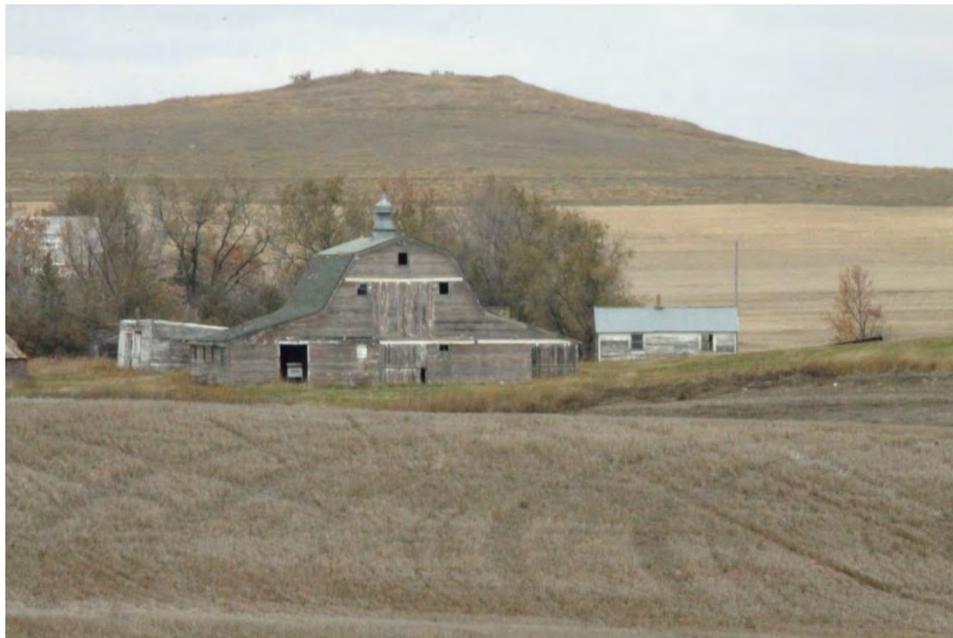
**Figure 40.** View of the Barn at Location 4. View to the north.

The barn at the location is not eligible for the NRHP due to the deterioration of the structure. The structure is a 2.5 story gambrel transverse-crib barn with wood framing and horizontal wood siding. The entrance is at the gambrel end with a hay loft above. The window openings are still intact; however, the majority of the windows are boarded up, missing the window glass, or missing a couple of panes. The original gambrel roof has been replaced with asphalt shingles. There is a metal ventilator on the ridge of the roof. The barn and outer wall sheds were constructed at the same time. Due to the deterioration, the structure retains little integrity. The barn does not meet any of the criteria for eligibility to the NRHP.

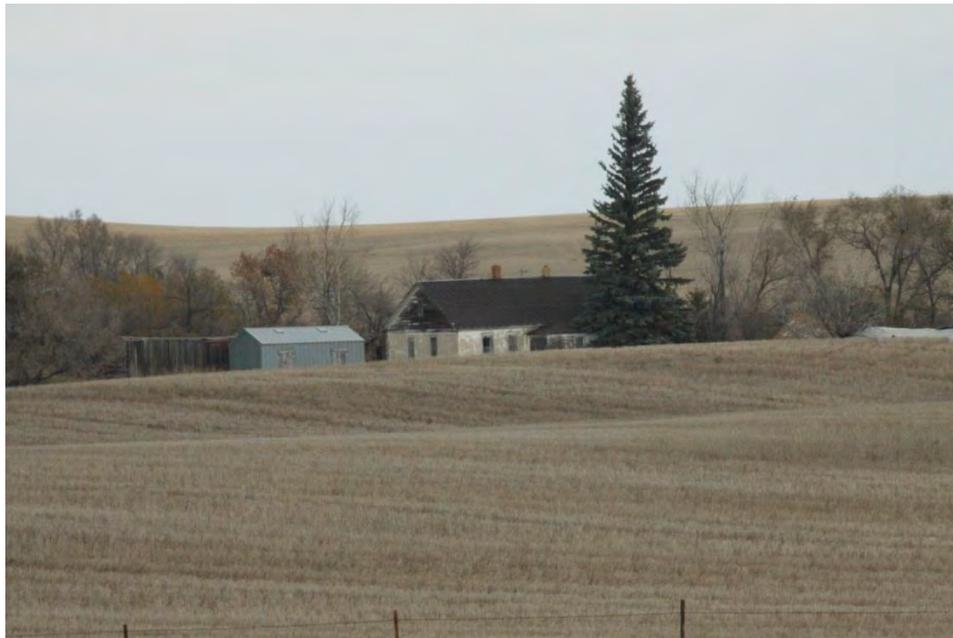
**Figure 41.** View of House 2 at Location 4. View to the northeast.

The structure is an abandoned residential 1.5 story, single dwelling side gabled unit, with wood framing and stucco wall. The window openings are still intact with double hung two-over-two windows. Some of the window panes are missing. The original gabled roof has been replaced with asphalt shingles. There are two brick chimneys situated on the ridge of the roof. The chimneys are made of different types of brick and were not built at the same time. In the gable the walls consist of horizontal wood siding. An addition was made to the south side of the house with a hipped roof. Due to the deterioration and alterations, the structure retains very little integrity. The farmhouse does not meet any of the criteria for eligibility to the NRHP.

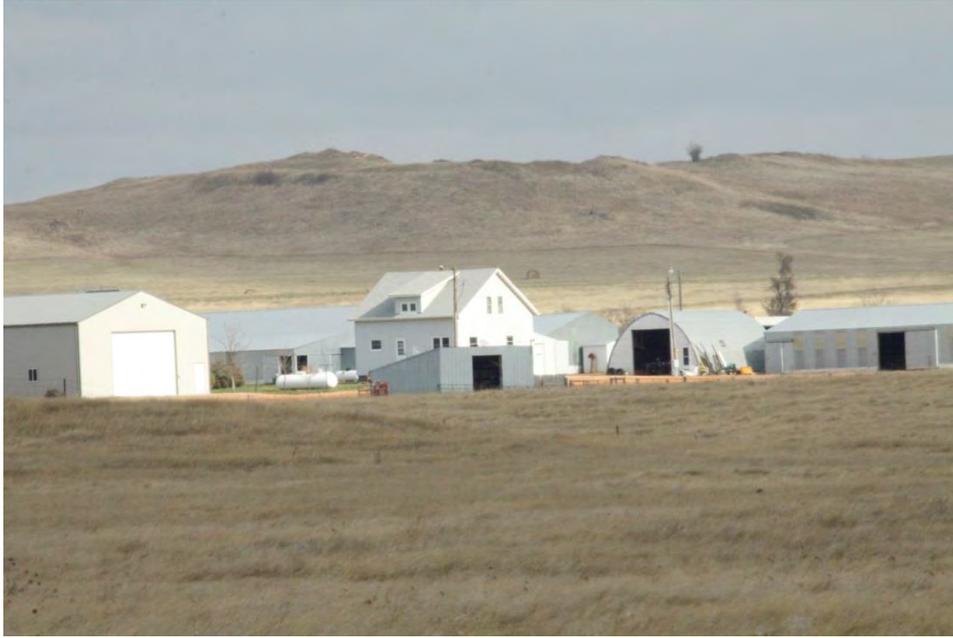
**Figure 42.** View of house at Location 5. View to the east.

The structure is a 1.5 story, single unit dwelling, with wood frame and horizontal vinyl siding. The original siding horizontal wood siding was replaced with the horizontal vinyl siding. The original windows have been replaced, primarily, with double hung one-over-one windows. The shed dormer windows are sliding side-by-side windows. The original doors have also been replaced. The original gabled roof has been replaced with asphalt shingles. An addition of an attached garage with a shed roof has been added to the farmhouse. Due to the alterations, the structure retains very little integrity. The farmhouse does not meet any of the criteria for eligibility to the NRHP.

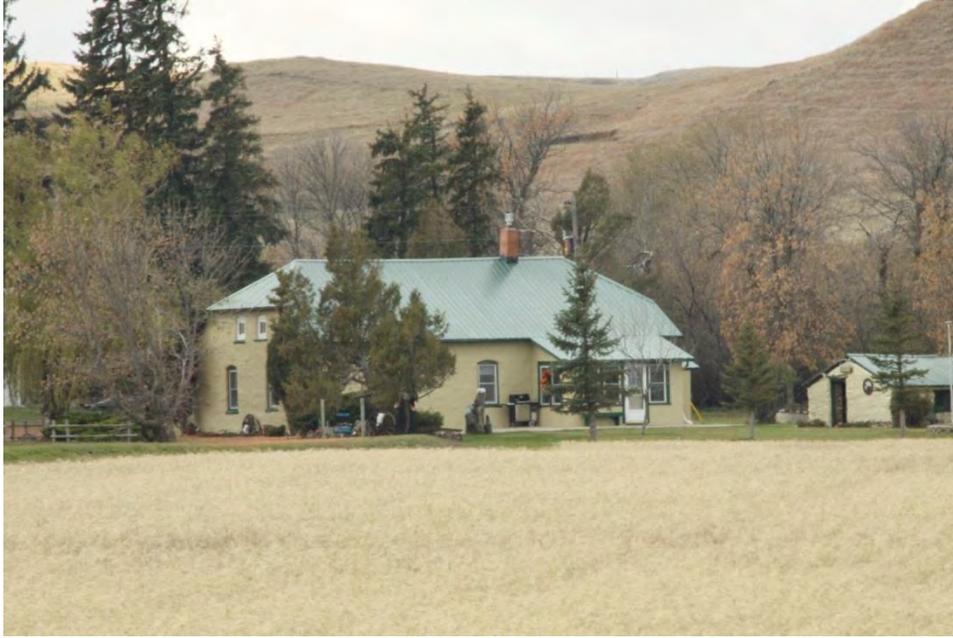
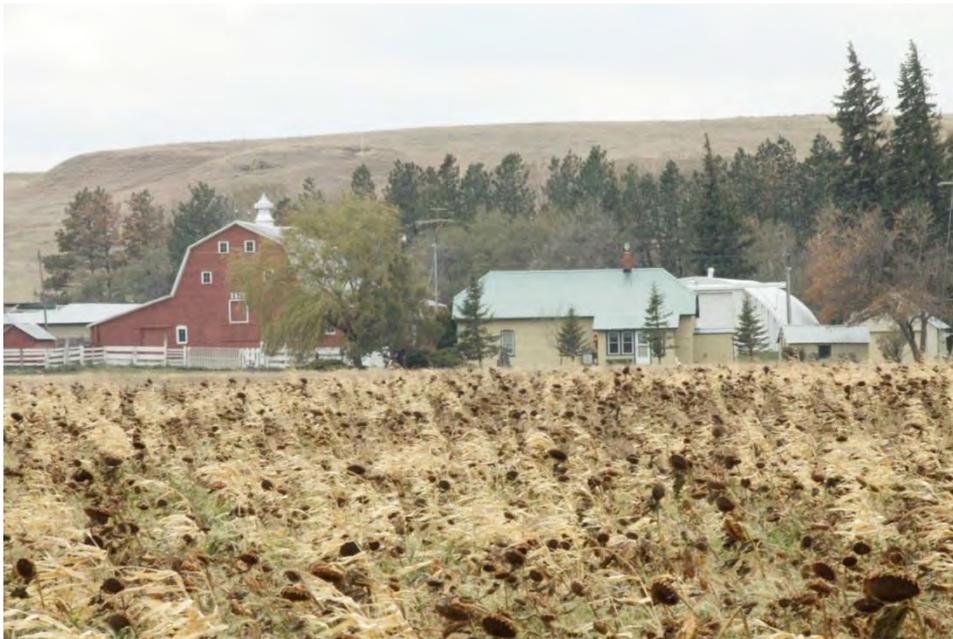
**Figure 44.** View of the house at Location 6. View to the northwest.

The structure is a residential 1.5 story, single dwelling unit, with wood framing and stucco walls. The original windows have been replaced with double hung one-over-one windows. The original windows were one-over-one segmental arch windows. The original half story windows have been replaced with sliding windows. The doors have also been replaced. The structure has a half hipped roof. The original roof has been replaced with colored vertical steel sheeting. The brick chimney is located on the ridge of the roof. There are a couple of additions to the structure. There is an addition with a gable roof on the northwest side of the farmhouse. Another addition is located on the northeast side of the house. On this addition, the differences in the window opening between the addition and the original house are visible. Due to the alterations, the structure retains little integrity. The farmhouse does not meet any of the criteria for eligibility to the NRHP.

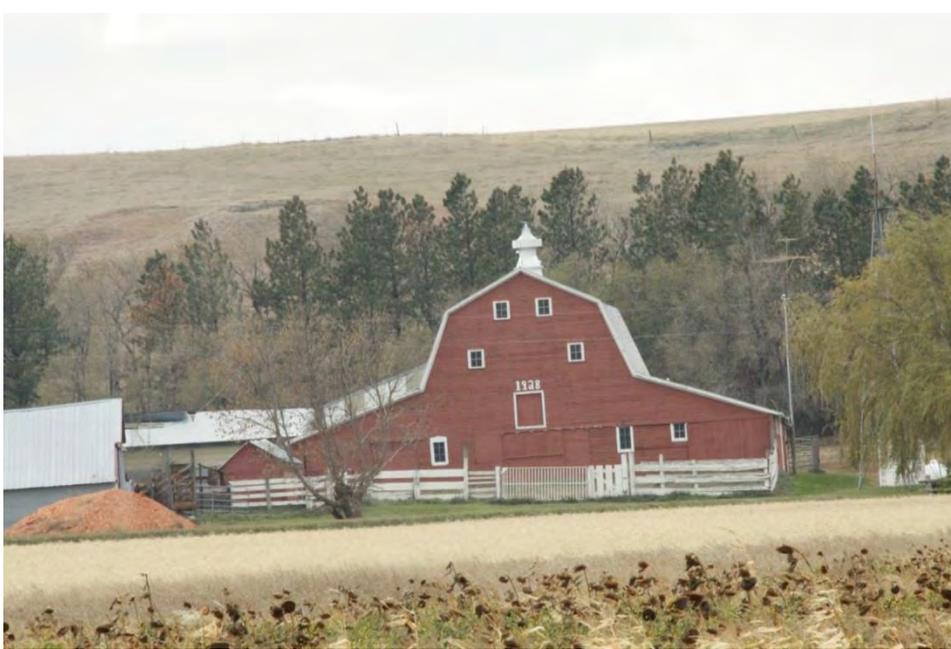
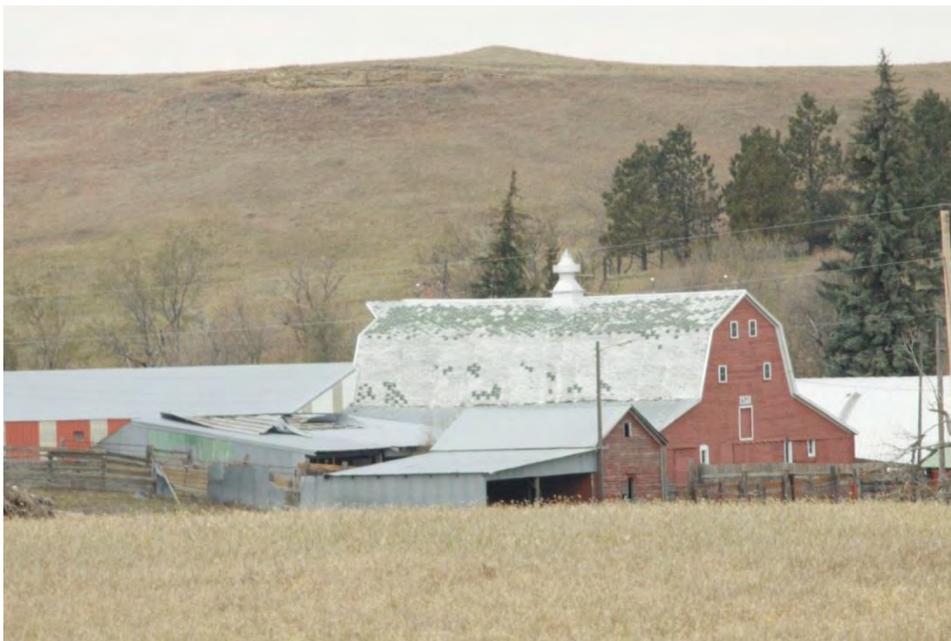
**Figure 46.** View of barn at Location 6. View to the west.

The structure, built in 1928, is a three story gambrel transverse-crib barn with wood framing and horizontal wood siding. Some of the wood siding is in need of repair. The entrance is at the gambrel end with a hay loft. The most of the window openings and windows are still intact. All of the windows are either four pane casement windows or six pane casement windows. The barn and outer wall sheds were constructed at the same time. The original gambrel roof has been replaced with asphalt shingles, while the shed have aluminum sheeting. The roof is in need of repair as most of the asphalt shingles are missing. There is a metal ventilator in the ridge of the roof. There are also lightning rods along the ridge of the roof. At the southwest end of the barn, there is a hay hood. There are two additional metal outbuildings with gable roofs attached to the barn. Due to the alterations, the structure retains little integrity. The barn does not meet any of the criteria for eligibility to the NRHP.

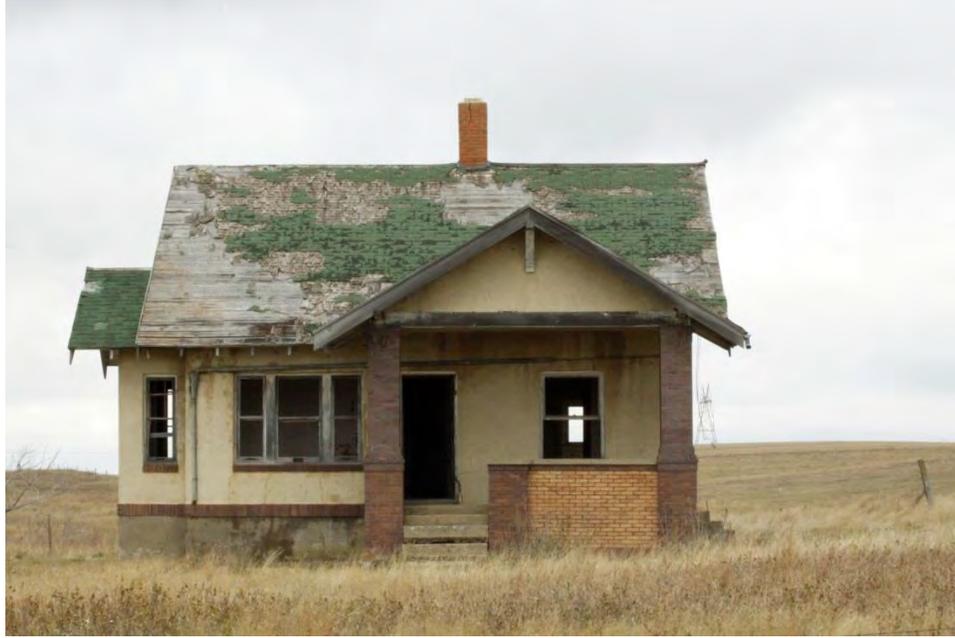
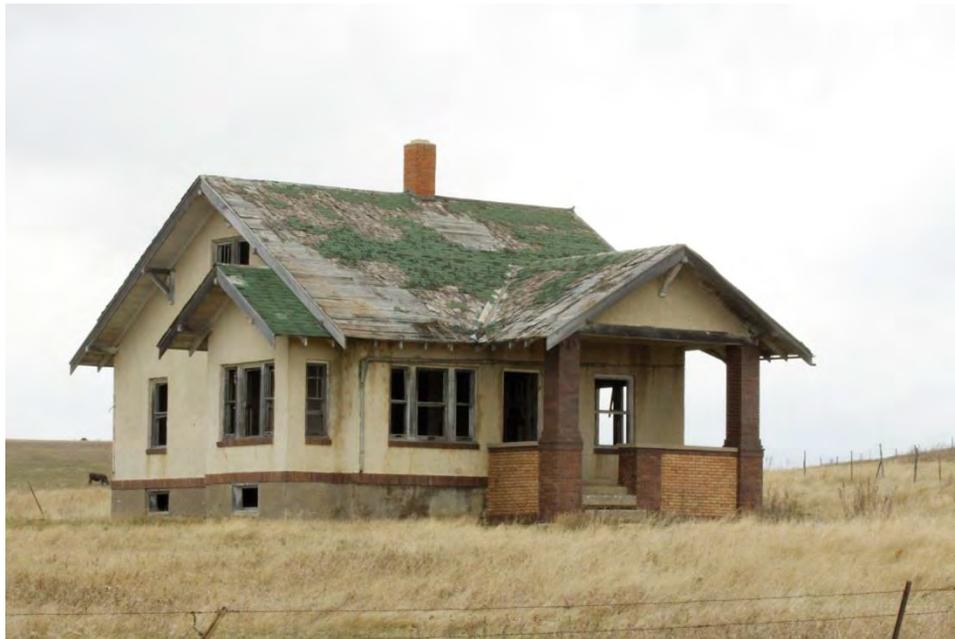
**Figure 48.** View of house at Location 7. View to the north.

Feature 1 is a side gable stucco house, with a wood frame, that is 10m by 15m. The house has brick accents between the stucco and the poured concrete foundation, and under the windows. The front porch is also primarily constructed with brick. The gable style roof has green asphalt shingles on top of the original wooden shingles, some of the shingles have deteriorated and fallen off. The windows on the first and second floor are double hung. The basement windows are missing the glass and some of the frames. The house has an intact red brick chimney. The back door at one time had an enclosing around it made of concrete blocks, but that enclosing has collapsed. The interior of the house does not have a lot remaining from the former tenants. The interior walls and ceilings are deteriorating, the front room has wood trimmings and most of the house has hard wood floors. The house has lost integrity due to poor condition. The house has no significant architectural design nor can it be associated with an important person or event. Therefore, the house is recommended ineligible for the NRHP.

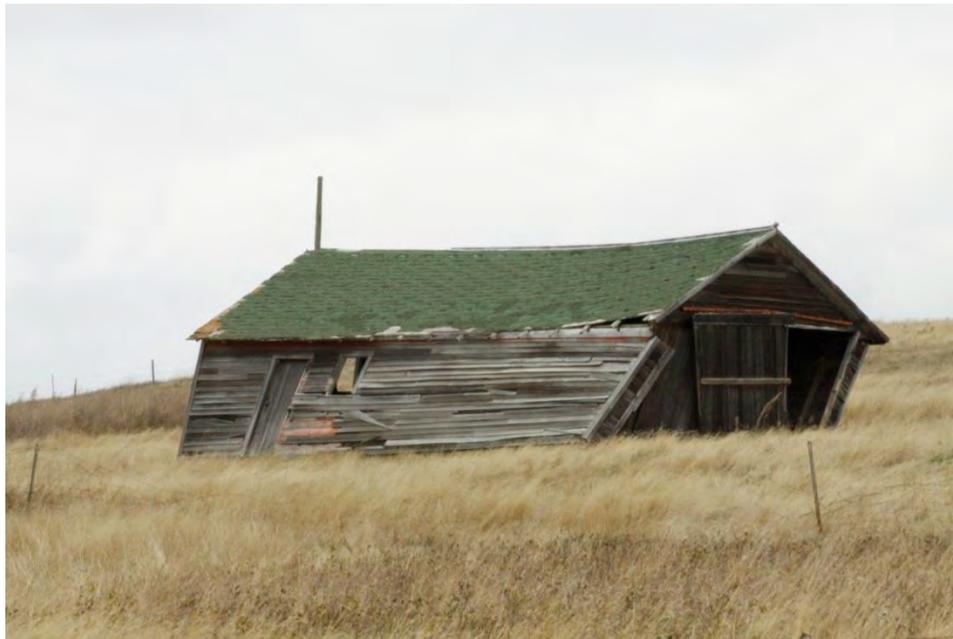
**Figure 50.** View of barn at Location 7. View to the northeast.

Feature 2 is a barn that is 7m by 10m with 1.5 stories. The barn is overall in poor condition and has begun to collapse. The barn has a poured concrete foundation. The barn is has a wood frame and horizontal wood siding. The front/south side of the barn has a sliding wooden door with vertical wood siding that is starting to fall apart. The barn has another door on the west side that is still intact. The gable style roof has green asphalt shingles, the majority of which are still intact. The original window openings are intact, but no glass remains. The barn siding was originally painted red, and some of the color is still visible. At some point new siding was put over the original siding in places to replace deteriorating walls and to help stabilize the structure. The barn has lost integrity due to poor condition and alterations. The barn has no significant architectural design nor can it be associated with an important person or event. Therefore, the barn is recommended ineligible for the NRHP.

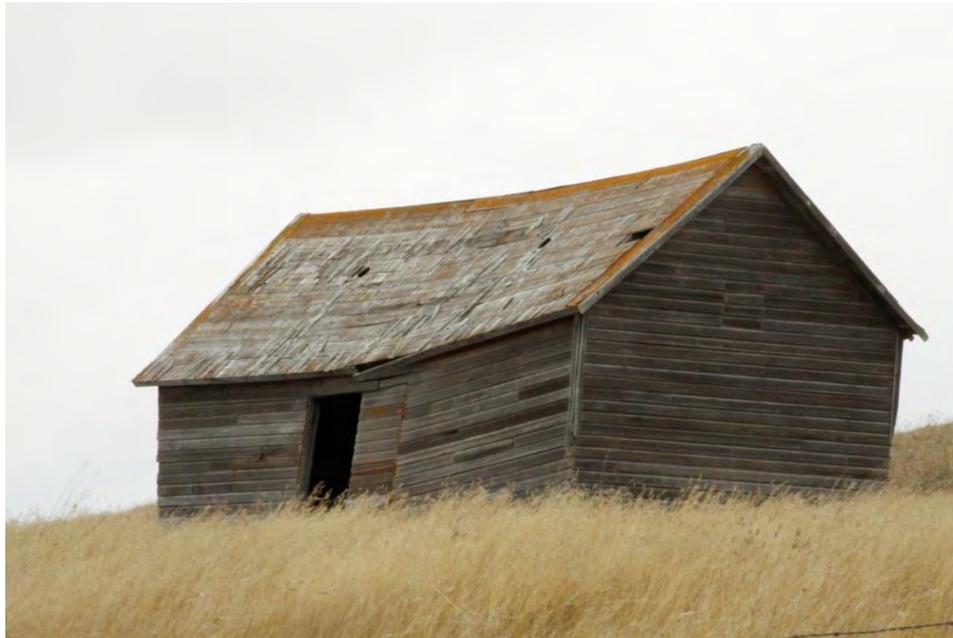
**Figure 51.** View of granary at Location 7. View to the northeast.

Feature 3 is a granary that is 5m by 9m with a wood frame and horizontal wood siding. The granary is in very poor condition and has begun to collapse. The granaries windows have been boarded up or covered with metal sheeting. The gable type roof has wood shingles, most of which have fallen off. There are holes in the roof, siding and floors of the granary. The granary may have been moved from another location as it is sitting on top of some blocks of wood. The granary has lost integrity due to poor condition. The granary has no significant architectural design nor can it be associated with an important person or event. Therefore, the granary is recommended ineligible for the NRHP.

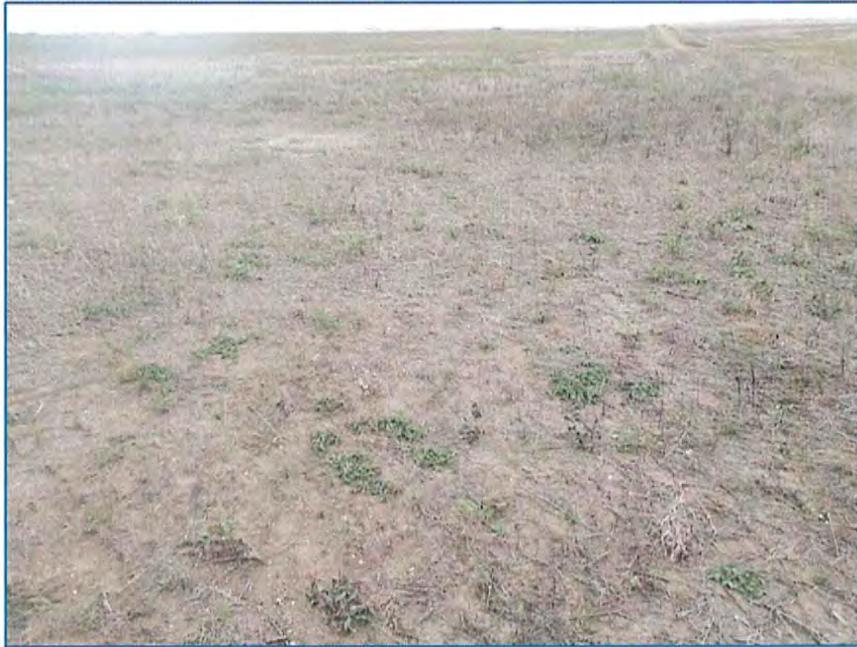
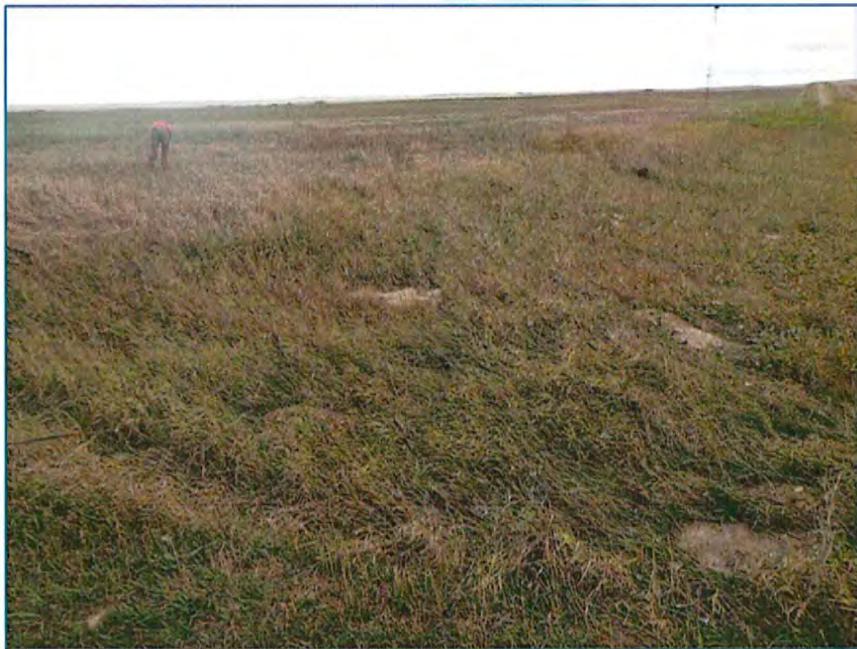
**Figure 1: Site Overview East**

Site 32MO1379 was reinvestigated. The site consists of 9 pieces of lithic debitage (all krf), one flake tool made of dark red chert, and one krf endscraper. The boundaries of the site are now much smaller than previously recorded, eliminating the majority of the site to the south and west of the original boundary. The site sits on top of the landform, bisected by a two-track.
