1. Manuscript Number:
2. SHPO Reference #: 14-0606
3. Author: James Sexton, Ph. D.
4. Title: Wilton IV Wind Energy Center: A Class II Architectural Inventory In Burleigh County, North Dakota (Addendum)
5. Report Date: August 2014
6. Number of Pages: 77
7. Type: II
8. Acres: 22332 acres
9. Legal Location(s):

**Wilton IV Wind Energy Center:  
A Class II Architectural Reconnaissance Survey  
In Burleigh County, North Dakota  
(Addendum)**

**September 2014**

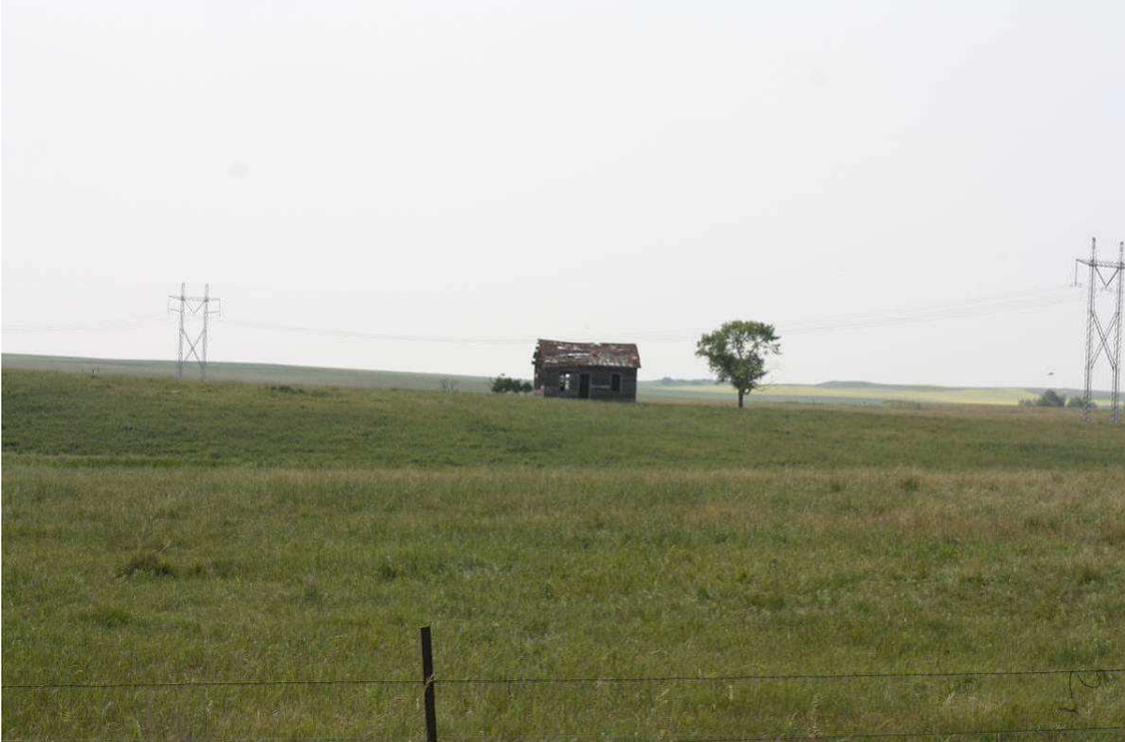
**Photograph 1-- Looking west at Tt1 (July 9, 2014).**

Tt 1 is an isolated historic building located in the southeast quarter of the southeast quarter of Section 2, Township 141 N, Range 78W. A building appeared in this location in the 1969 plat map. It shows an empty square, suggesting that the building had been abandoned by that time.

The property retains integrity of location, setting, and materials. However, the state of disrepair of the building diminishes the integrity of design, workmanship, and feeling. Additionally, it is not known to be associated with any historic events important to local, state or national history (Criterion A), does not have significant or unusual architecture (Criterion C), nor is it thought to have significant potential to yield historical information (Criterion D). Further research may yield information about those who lived here; at this time no association with a significant historical figure is known (Criterion B). This property is recommended by Tetra Tech as not eligible for listing in the NRHP.

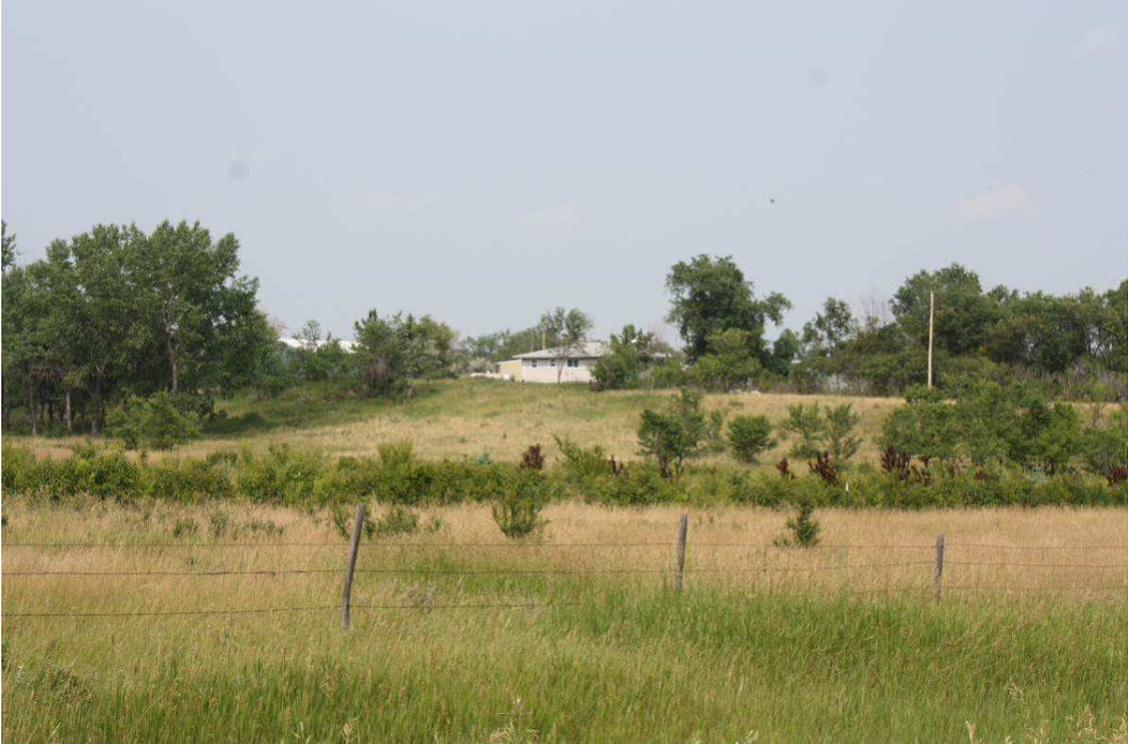
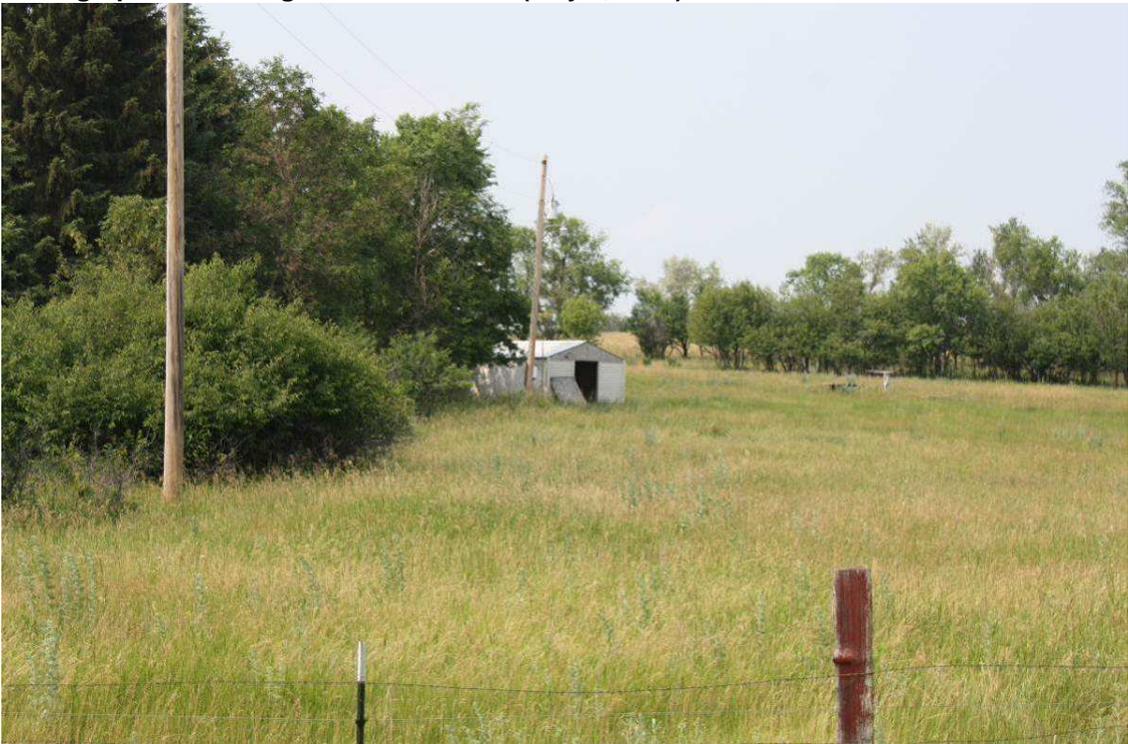
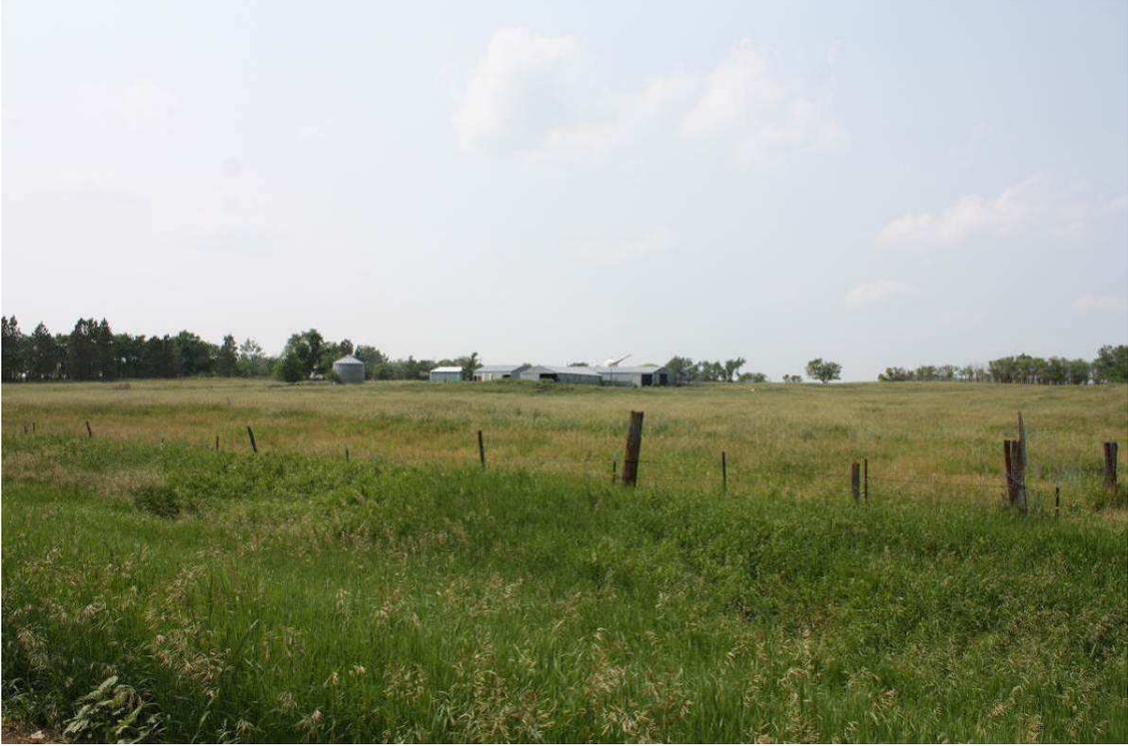
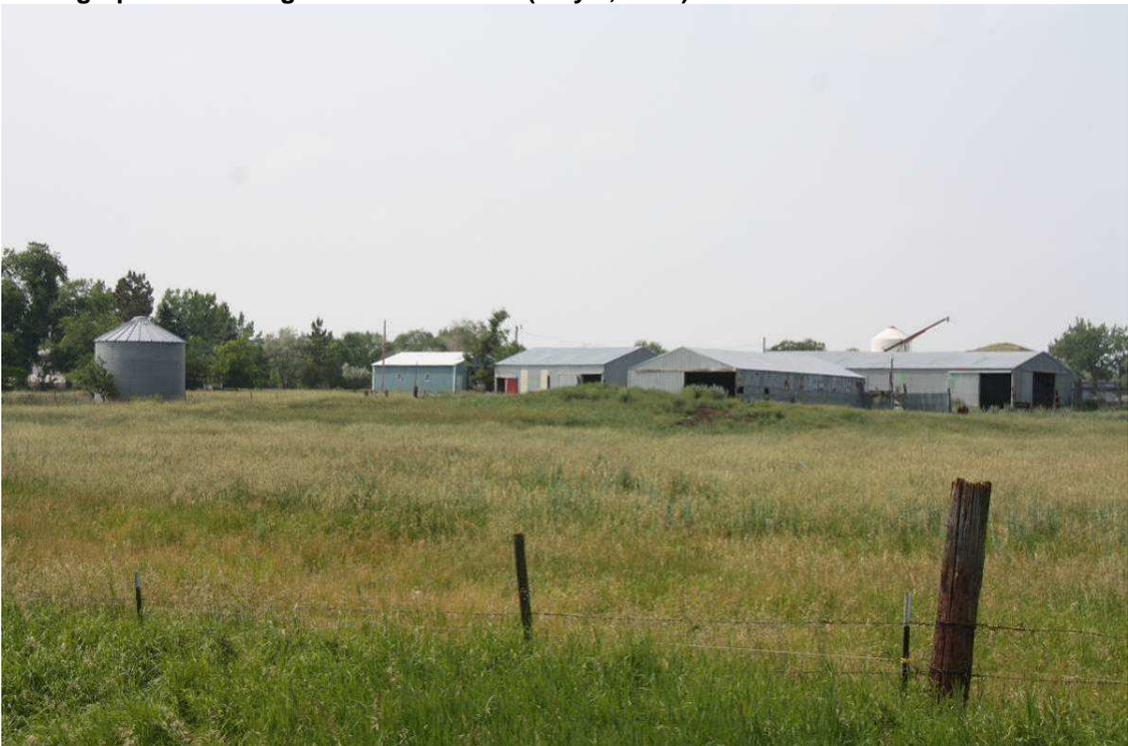
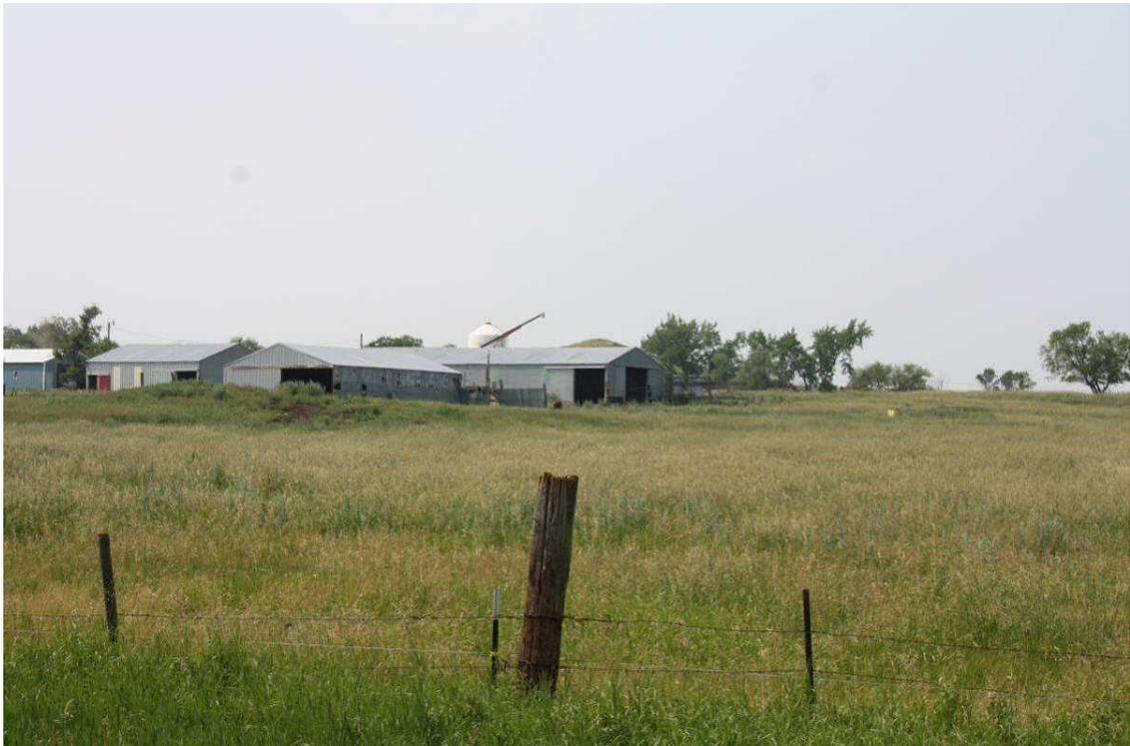
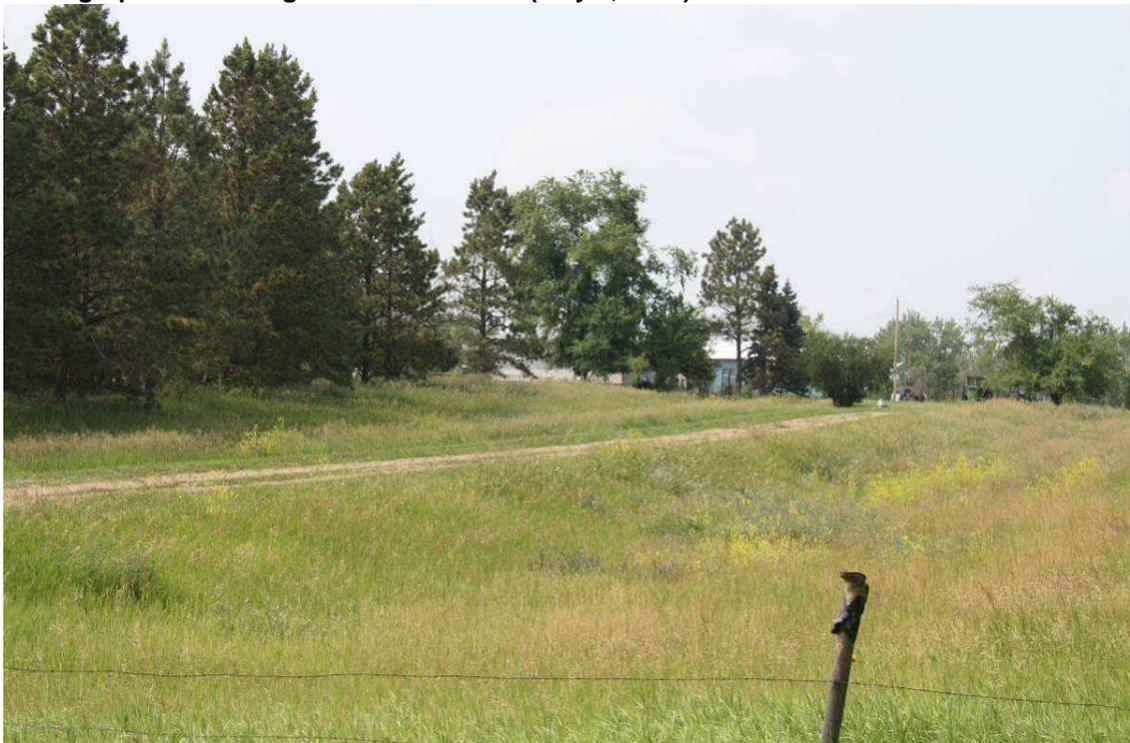
Photograph 2-- Looking northeast at Tt 2. (July 9, 2014)

Photograph 3-- Looking northwest at Tt2. (July 9, 2014)

**Photograph 4-- Looking northwest at Tt 2. (July 9, 2014)**

**Photograph 5-- Looking northwest at Tt 2. (July 9, 2014)**

**Photograph 6-- Looking northwest at Tt 2. (July 9, 2014)**

**Photograph 7-- Looking northwest at Tt 2. (July 9, 2014)**

TT2 is a historic farmstead located in the southwest quarter of the southwest quarter of Section 6, Township 141N, Range 77W. Buildings have appeared in this location since at least 1912, when the George A. Ogle plat map showed “Jno. Anderson” owning a strip of land along the southern edge of this section as well as much of the northern half of section 7. In 1969, the Directory Services map showed Paul Borgois, Jr. owning a house located in this general area.

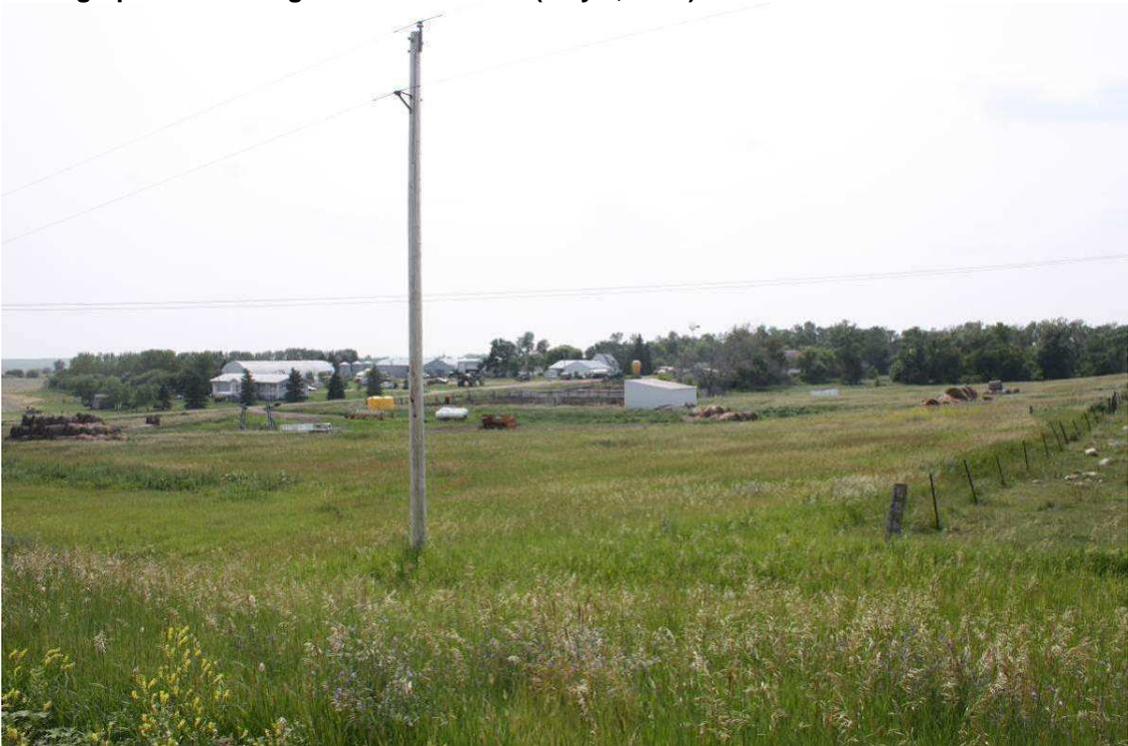
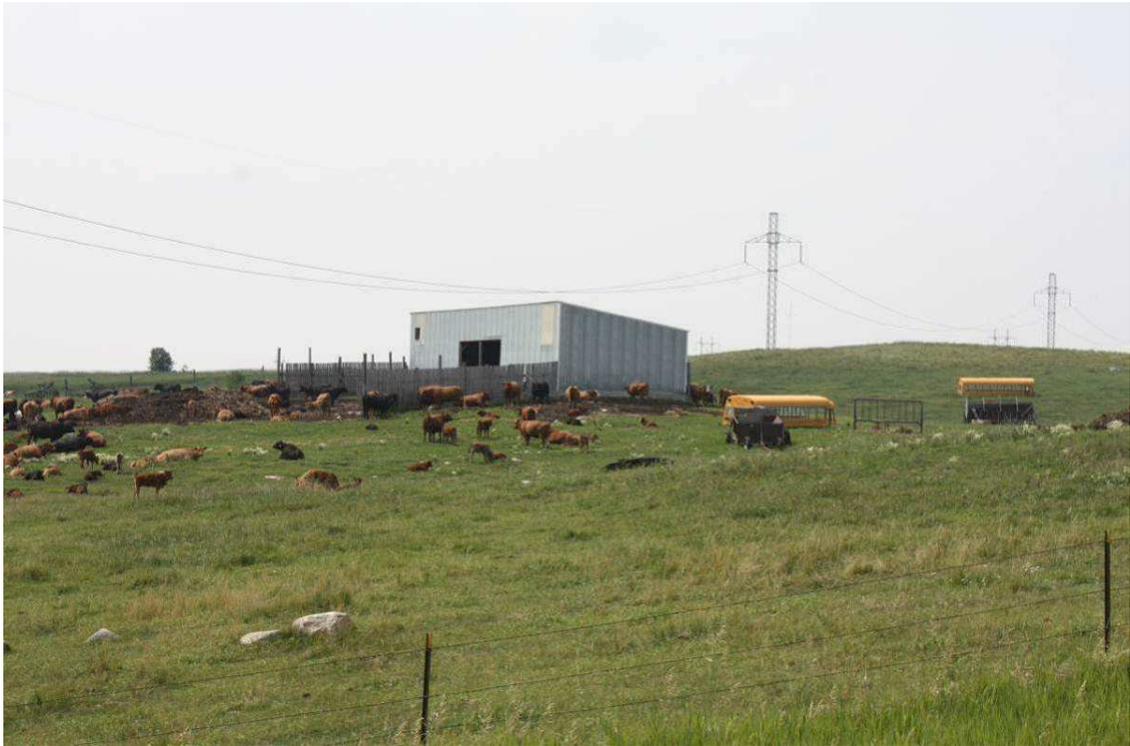
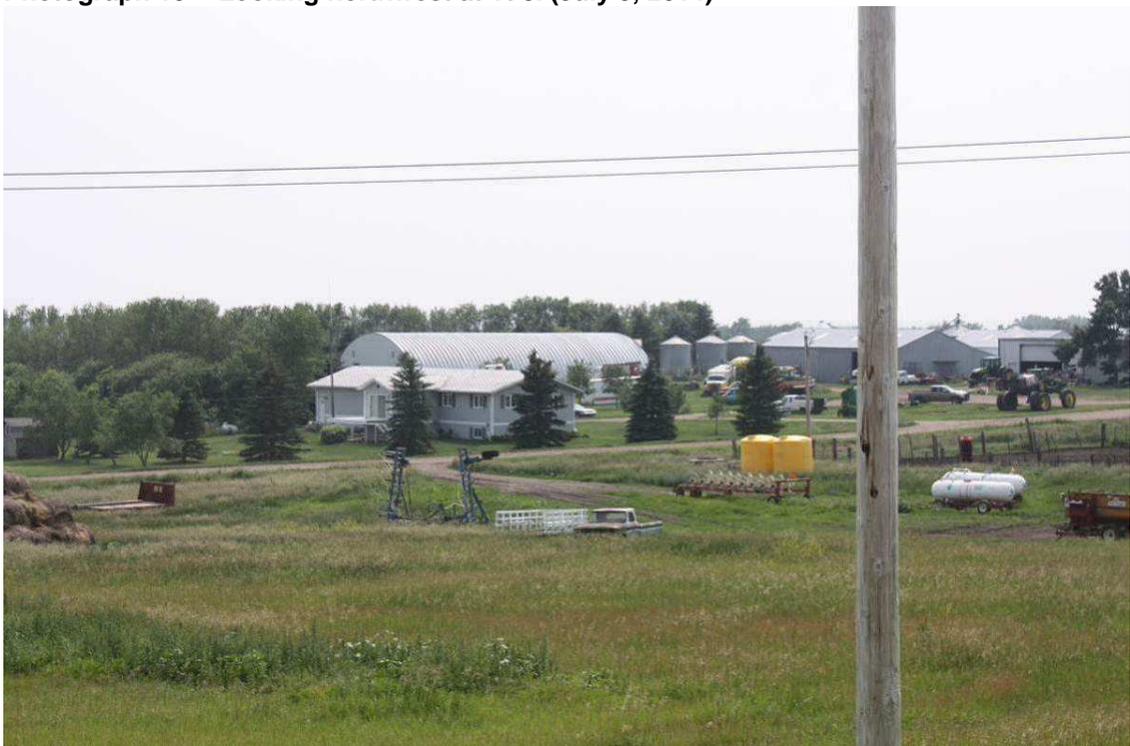
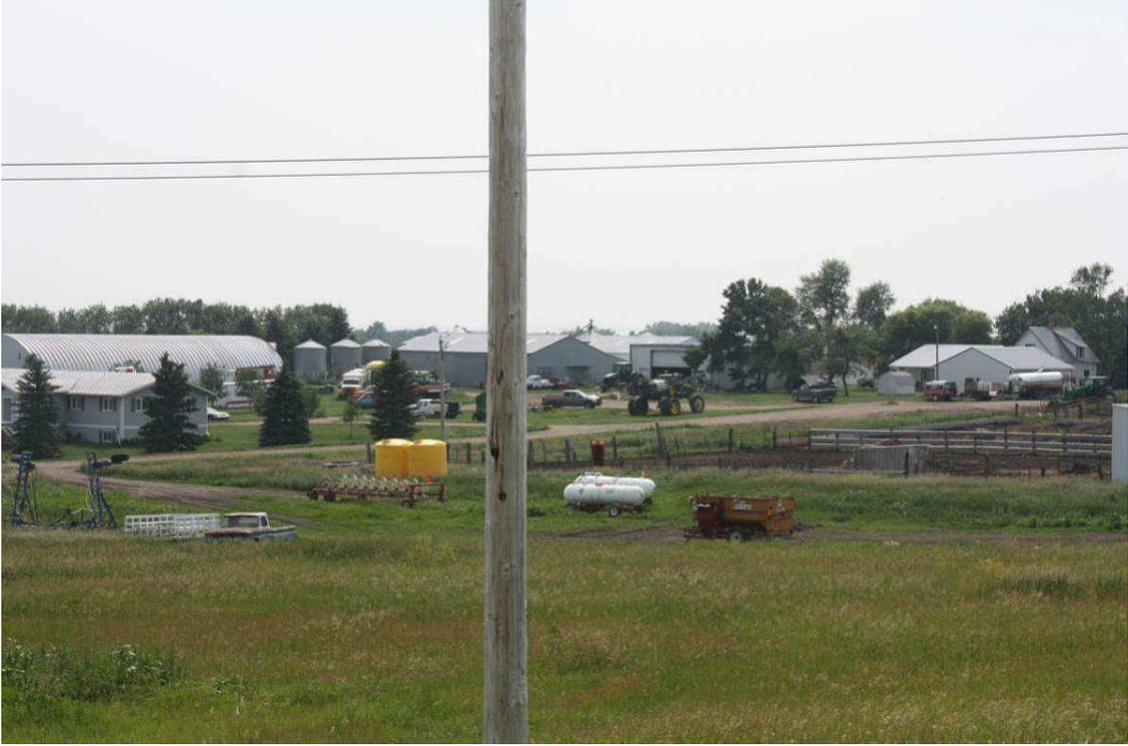
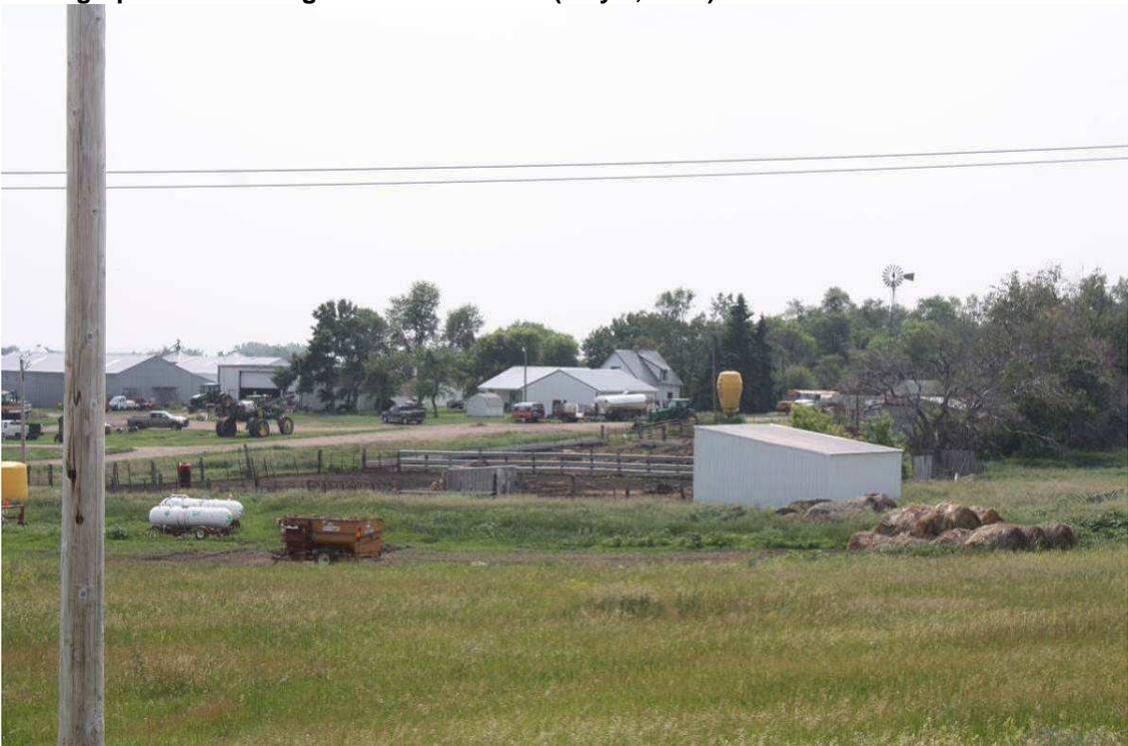
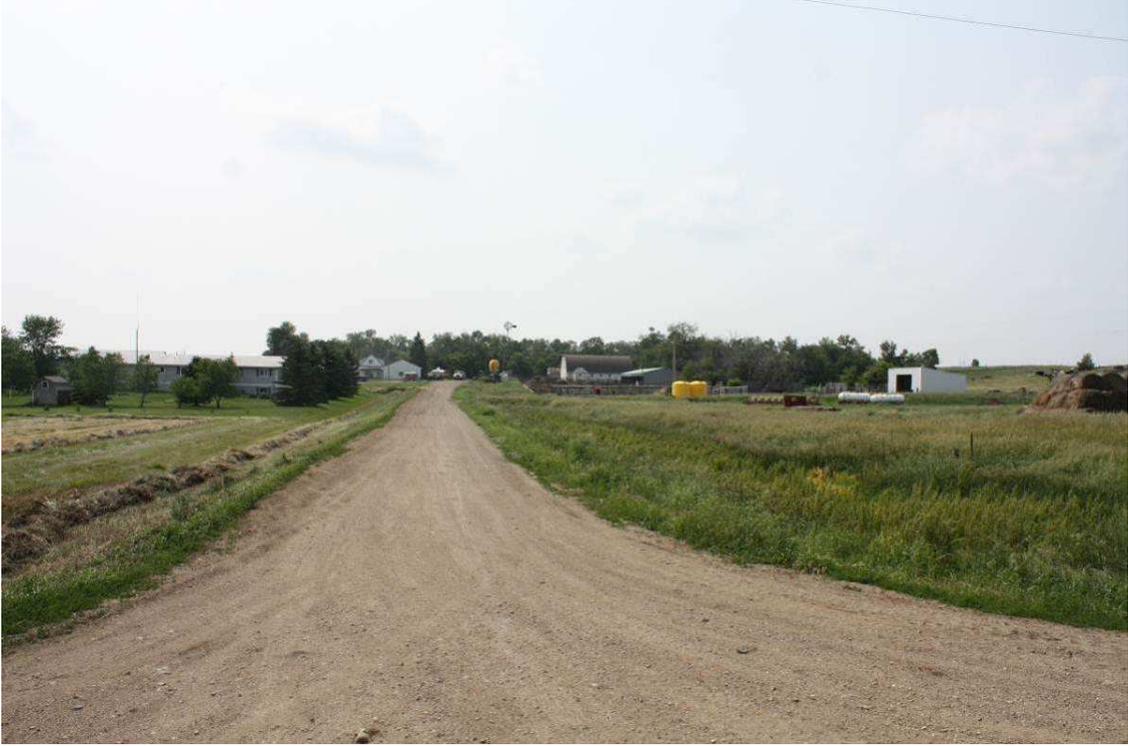
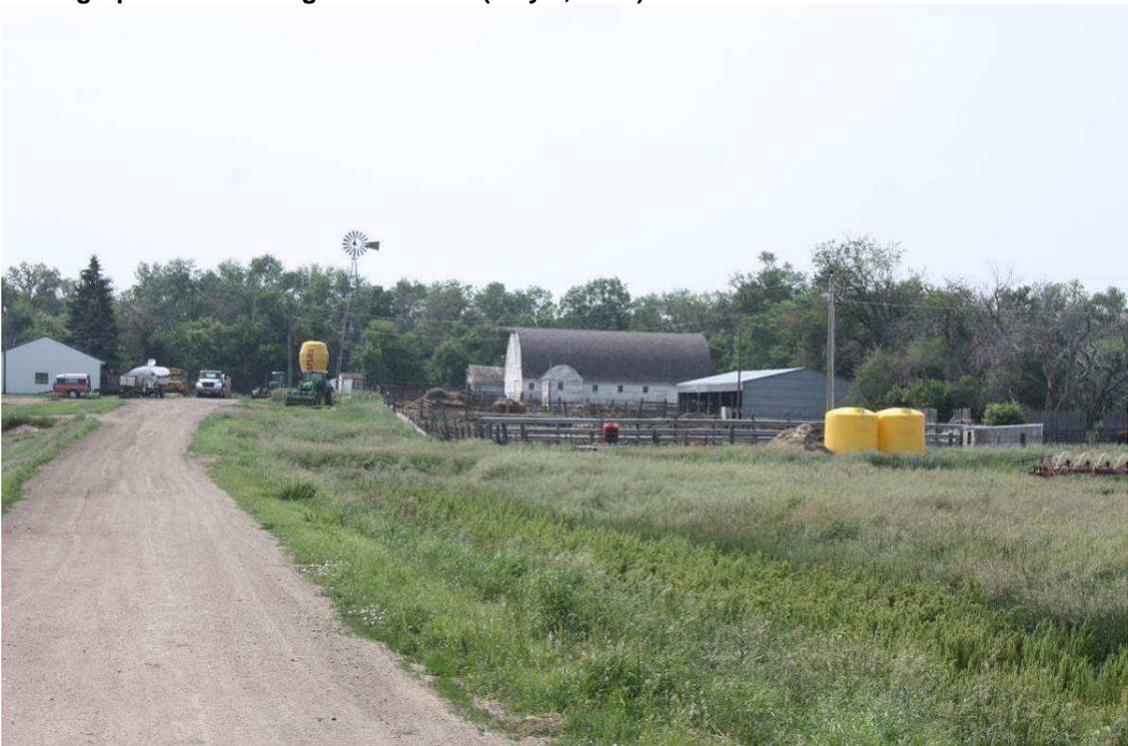
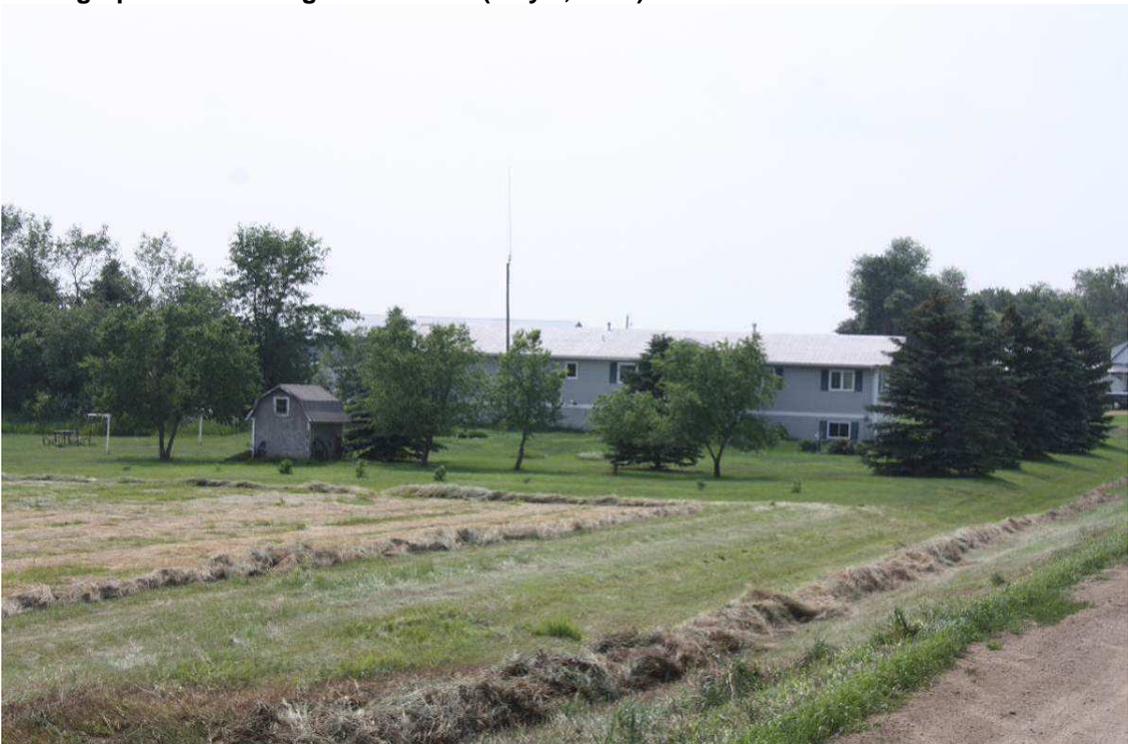
Photograph 9 -- Looking southwest at Tt 3. (July 9, 2014)

**Photograph 10 -- Looking northwest at Tt 3. (July 9, 2014)**

**Photograph 11 -- Looking southwest at Tt 3. (July 9, 2014)**

**Photograph 12 -- Looking southwest at Tt 3. (July 9, 2014)**

**Photograph 13 -- Looking southwest at Tt 3. (July 9, 2014)**

**Photograph 14 -- Looking west at Tt 3. (July 9, 2014)**

**Photograph 15 -- Looking west at Tt 3. (July 9, 2014)**

**Photograph 17 -- Looking southwest at Tt 3. (July 9, 2014)**

Tt 3 is a historic farmstead located in the northeast quarter of the northeast quarter of Section 6, Township 141, Range 77W. Buildings have appeared in this location since at least 1912, when the George Ogle plat map showed "A.T. Spangberg" owning a quarter section in this location. By 1969, the land was owned by Lee Sundquist.

The property retains integrity of location and setting. However, the introduction of a new main house and many new outbuildings diminishes the integrity of design, workmanship, materials, and feeling of the property. Additionally, it is not known to be associated with any historic events important to local, state or national history (Criterion A), does not have significant or unusual architecture (Criterion C), nor is it thought to have significant potential to yield historical information (Criterion D). Further research may yield information about those who lived here; at this time no association with a significant historical figure is known (Criterion B). This farmstead is recommended by Tetra Tech as not eligible for listing in the NRHP.

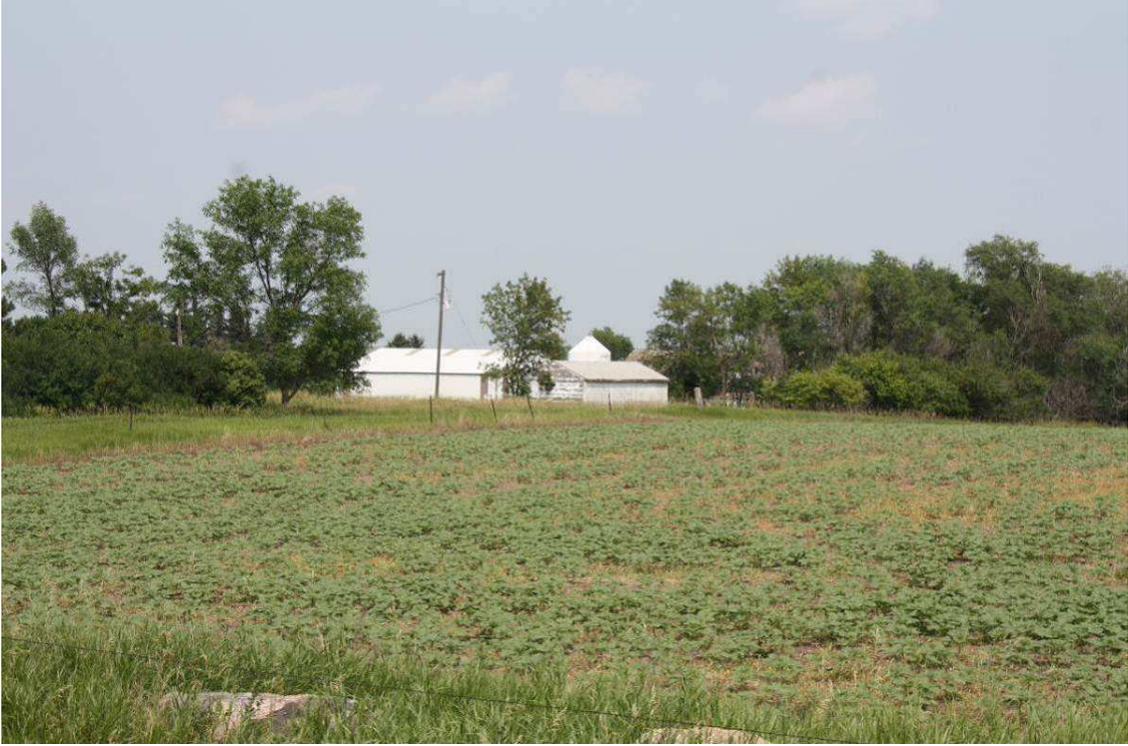
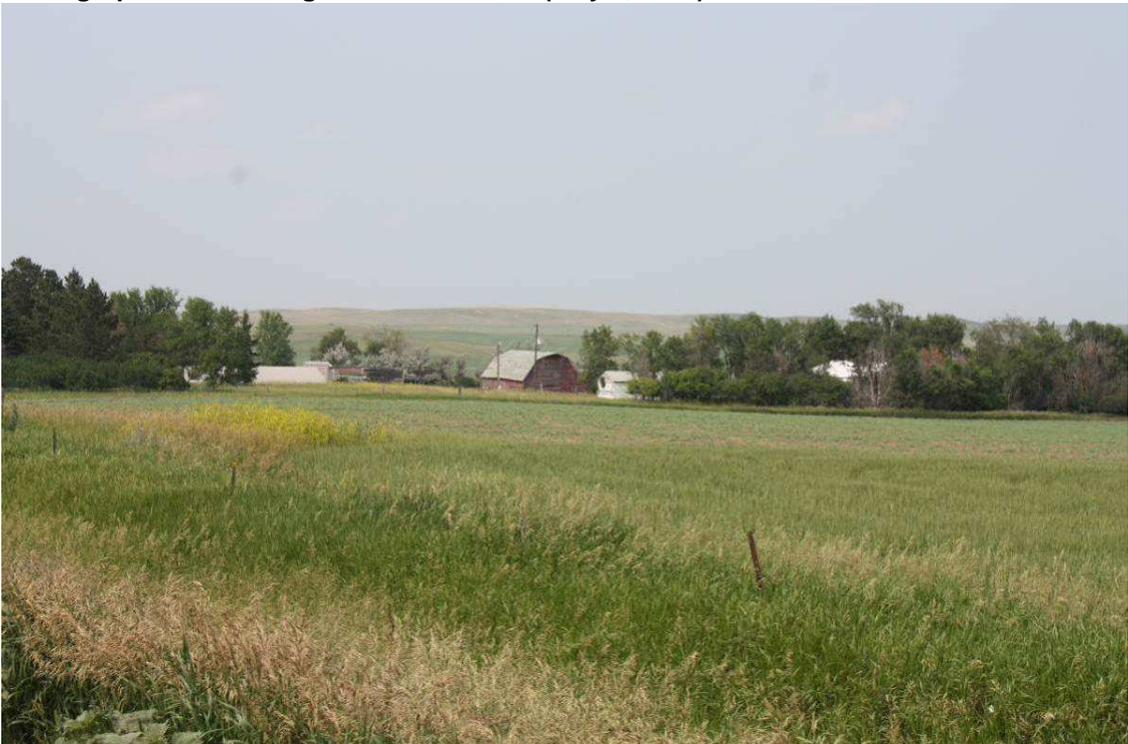
Photograph 18 -- Looking northeast at Tt 4. (July 9, 2014)

Photograph 19 -- Looking northeast at TT 4. (July 9, 2014)

Tt 4 is a historic farmstead located in the eastern half of the southeast quarter of Section 32, Township 141N, Range 77W. Buildings have appeared in this location since at least 1969, when the directory Services plat map showed "Raymond Norris" residing in this part of the quarter section.

The building is well screened by shelter belts. What is visible suggests that the property retains integrity of location, setting, and materials. However, views from the public right-of-way and aerial photographs suggest that several modern outbuildings have been introduced that diminish the integrity of design, workmanship, and feeling. Additionally, it is not known to be associated with any historic events important to local, state or national history (Criterion A), does not have significant or unusual architecture (Criterion C), nor is it thought to have significant potential to yield historical information (Criterion D). Further research may yield information about those who lived here; at this time no association with a significant historical figure is known (Criterion B). This farmstead is recommended by Tetra Tech as not eligible for listing in the NRHP.

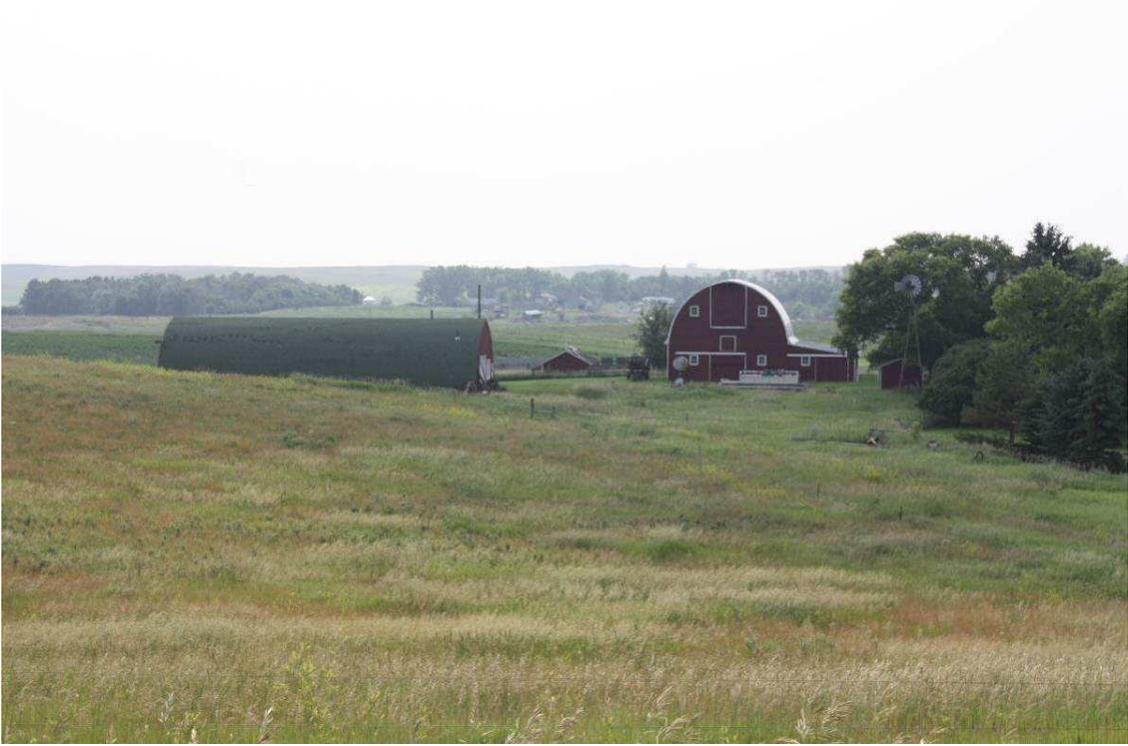
**Photograph 20 -- Looking west at Tt 5. (July 9, 2014)**

Tt 5 is a historic farmstead located in the northeast quarter of the northeast quarter of Section 30, Township 142N, Range 77W. Buildings have appeared in this location since prior to the Directory Services plat map of 1969, which shows “Andrew & Raymond Olson” owning a residence in this quarter section. The residence is currently screened by the shelter belt.

The property retains integrity of location, setting, materials, design, workmanship, and feeling. However, it is not known to be associated with any historic events important to local, state or national history (Criterion A), does not have significant or unusual architecture (Criterion C), nor is it thought to have significant potential to yield historical information (Criterion D). Further research may yield information about those who lived here; at this time no association with a significant historical figure is known (Criterion B). This farmstead is recommended by Tetra Tech as not eligible for listing in the NRHP.

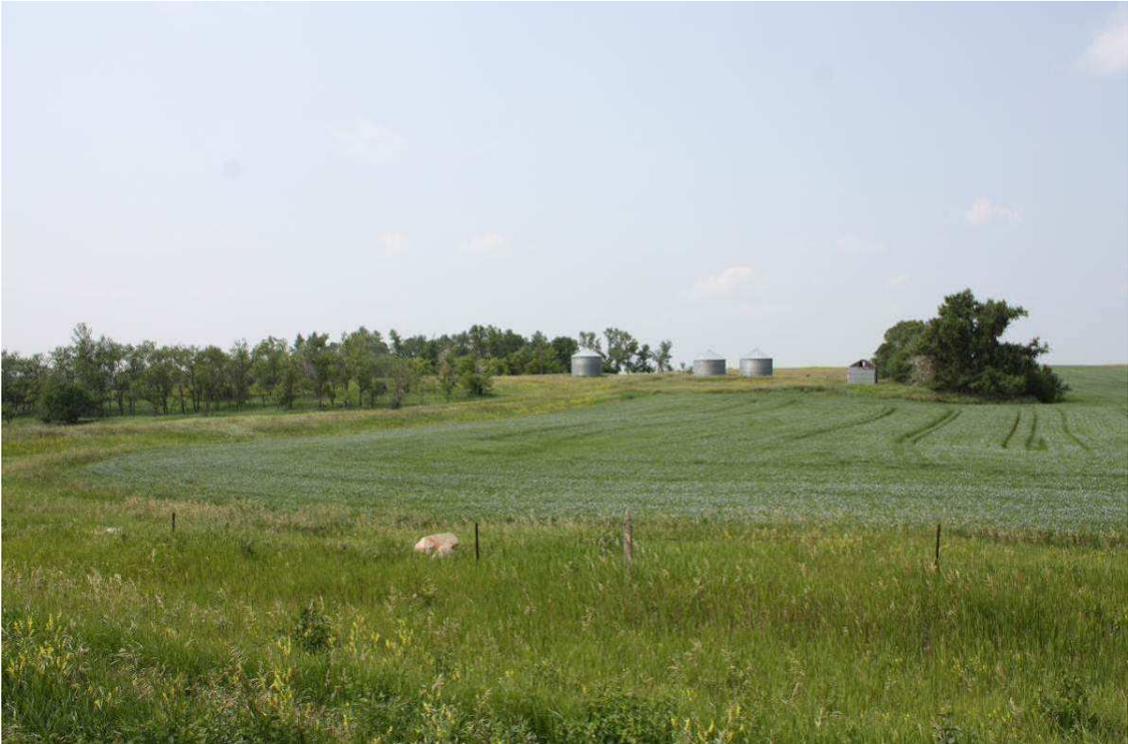
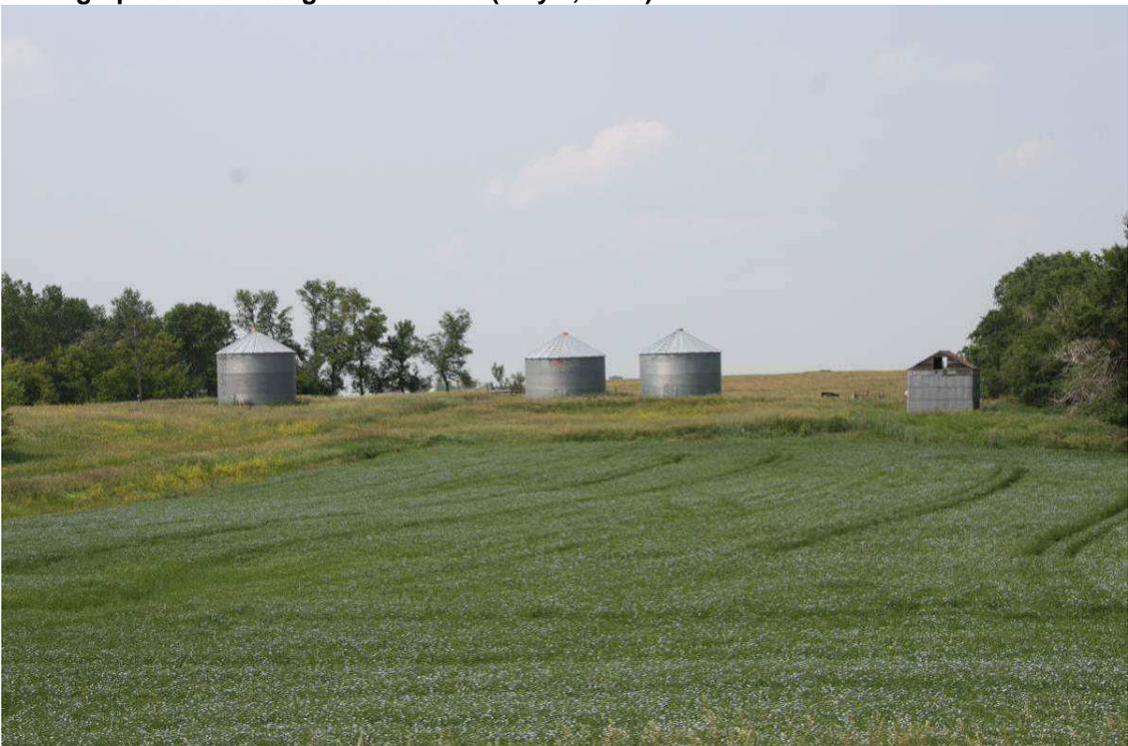
**Photograph 21 -- Looking north at Tt 6. (July 9, 2014)**

**Photograph 22 -- Looking north at Tt 6. (July 9, 2014)**

Tt 6 is a historic farmstead located in the southwest quarter of the southwest quarter of Section 20, Township 142N, Range 77W. Buildings have appeared in this location since prior to the George Ogle plat map of 1912, which shows "Oliver M. Jelip" owning this 200 acres on the western side of this section. In 1969 a house is indicated in this location but no owner is shown. By the time of the site visit the property only contained outbuildings: three grain storage bins and a gable-roofed shed.

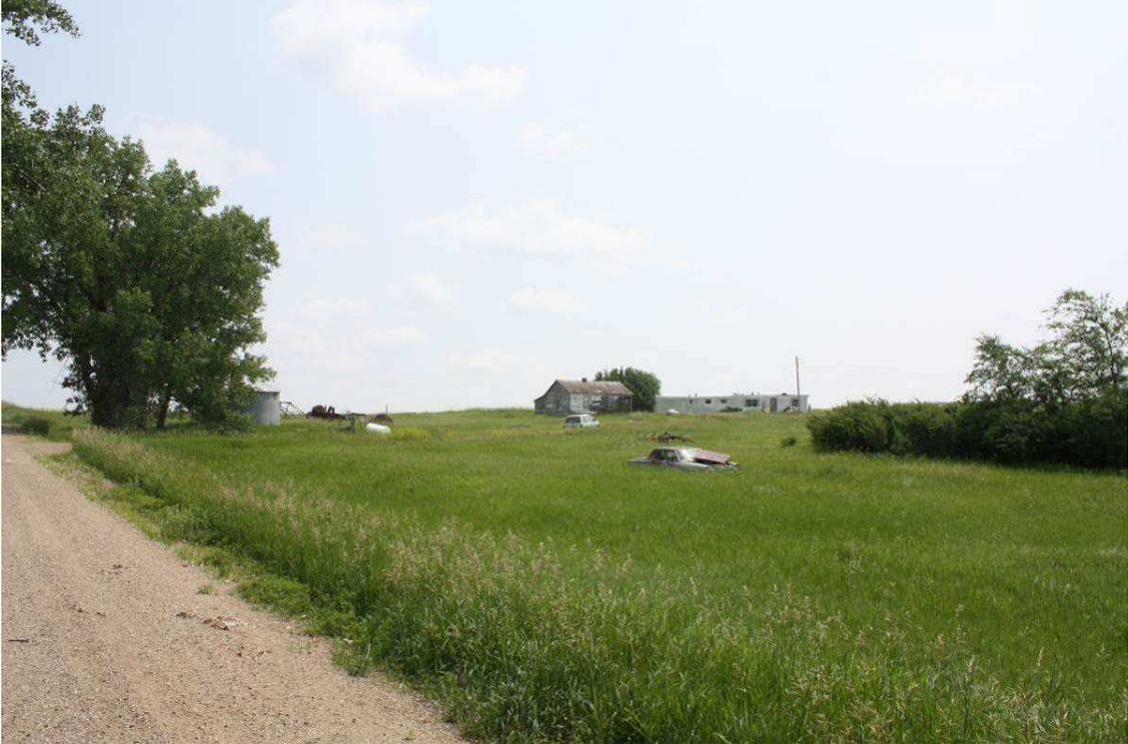
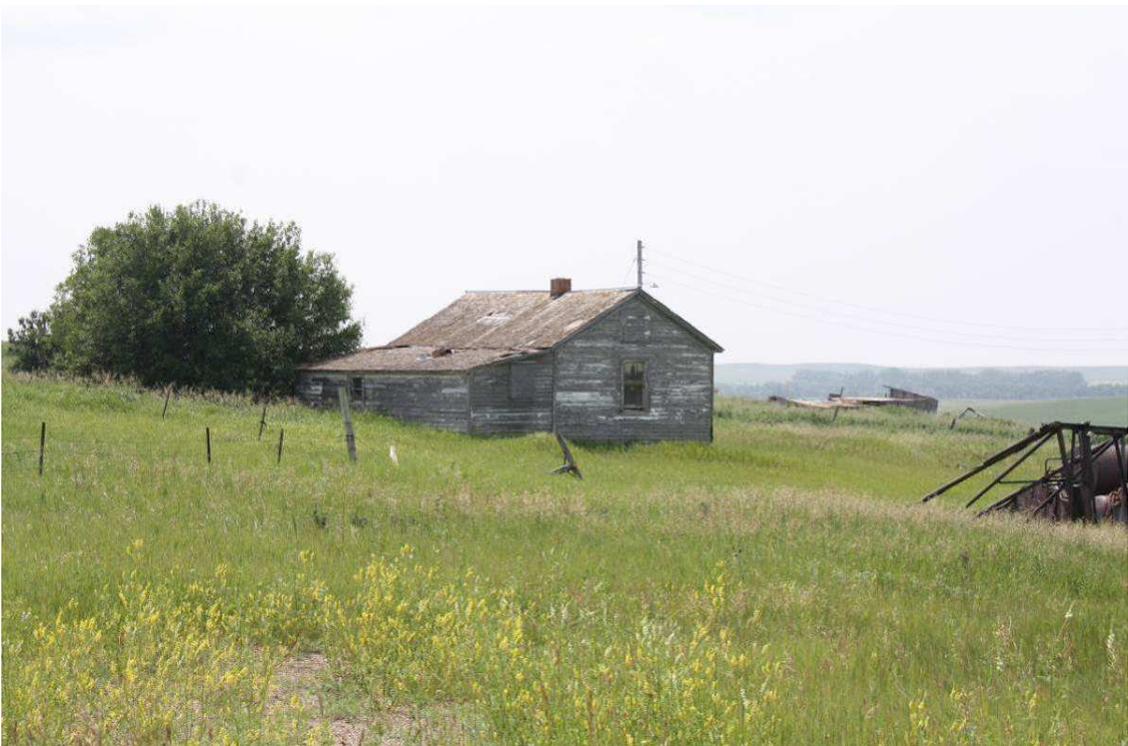
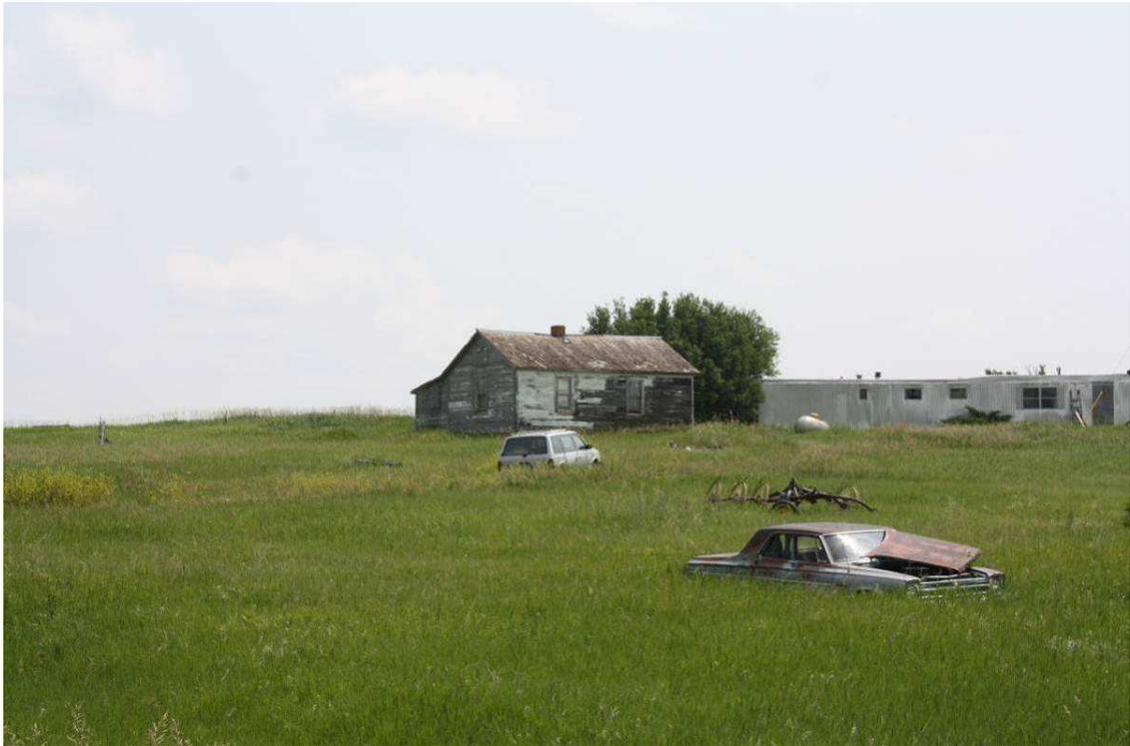
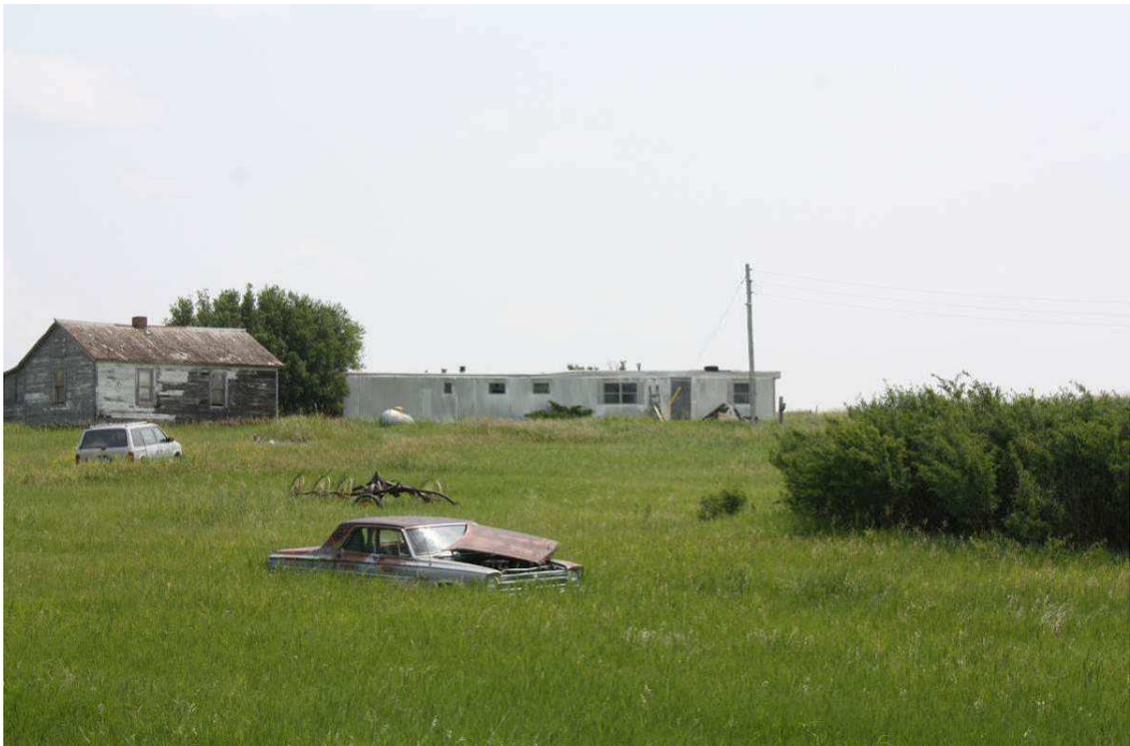
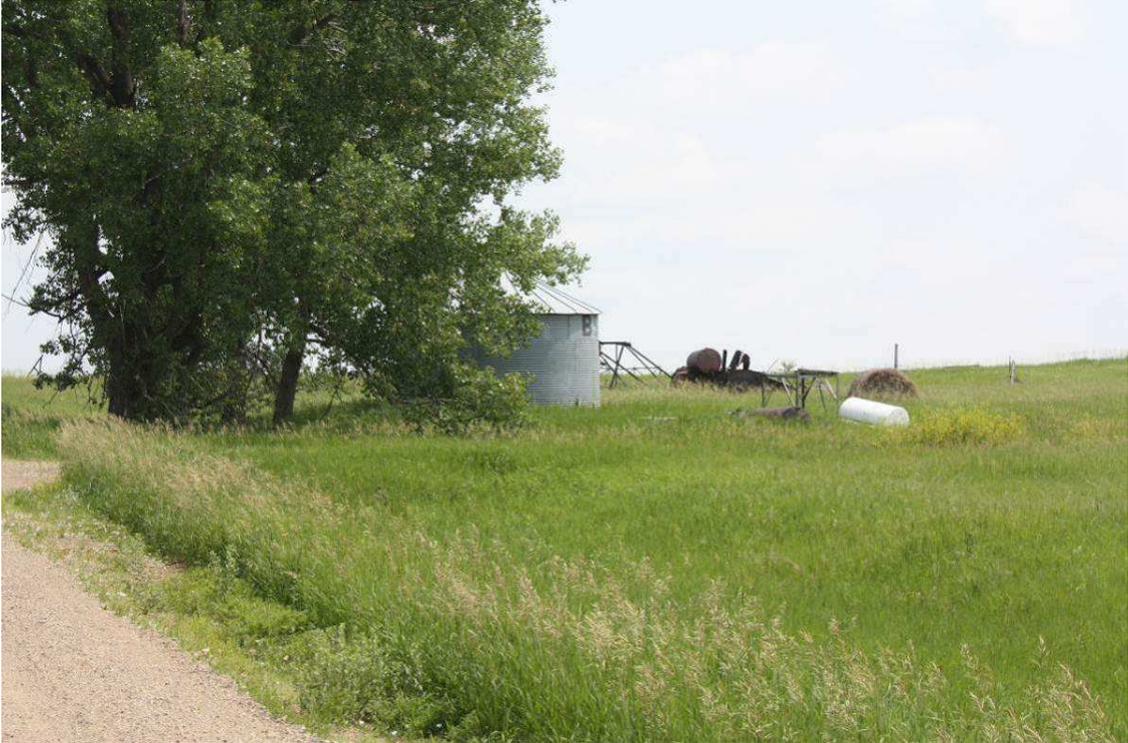
Photograph 23 -- Looking southeast at Tt 7. (July 9, 2014)

Photograph 24 -- Looking southwest at Tt 7. (July 9, 2014)

Photograph 25 -- Looking southeast at Tt 7. (July 9, 2014)

Photograph 26 -- Looking southeast at Tt 7. (July 9, 2014)

**Photograph 27 -- Looking southeast at Tt 7. (July 9, 2014)**

Tt 7 is a historic farmstead located in the northwest quarter of the northwest quarter of Section 20, Township 142N, Range 20W. While no buildings are shown on the George Ogle plat map of 1912, which shows the land as owned by “Carl F. Christianson,” a farm is located here in the 1969 Directory Services plat map; it was owned by Erick Christianson.
