1. Manuscript Number:
2. SHPO Reference #: 14-0606
3. Author: James Sexton, Ph. D.
4. Title: Wilton IV Wind Energy Center: A Class II Architectural Inventory In Burleigh County, North Dakota (Addendum)
5. Report Date: August 2014
6. Number of Pages: 77
7. Type: II
8. Acres: 22332 acres
9. Legal Location(s):

**Wilton IV Wind Energy Center:  
A Class II Architectural Reconnaissance Survey  
In Burleigh County, North Dakota  
(Addendum)**

**September 2014**

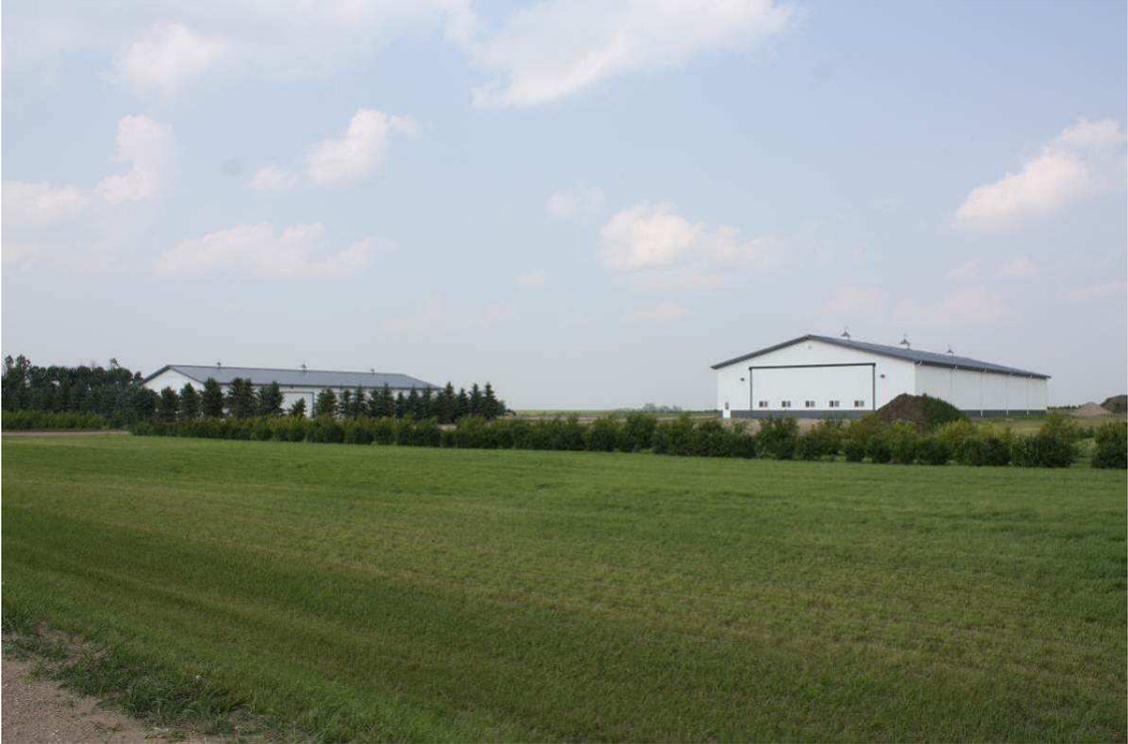
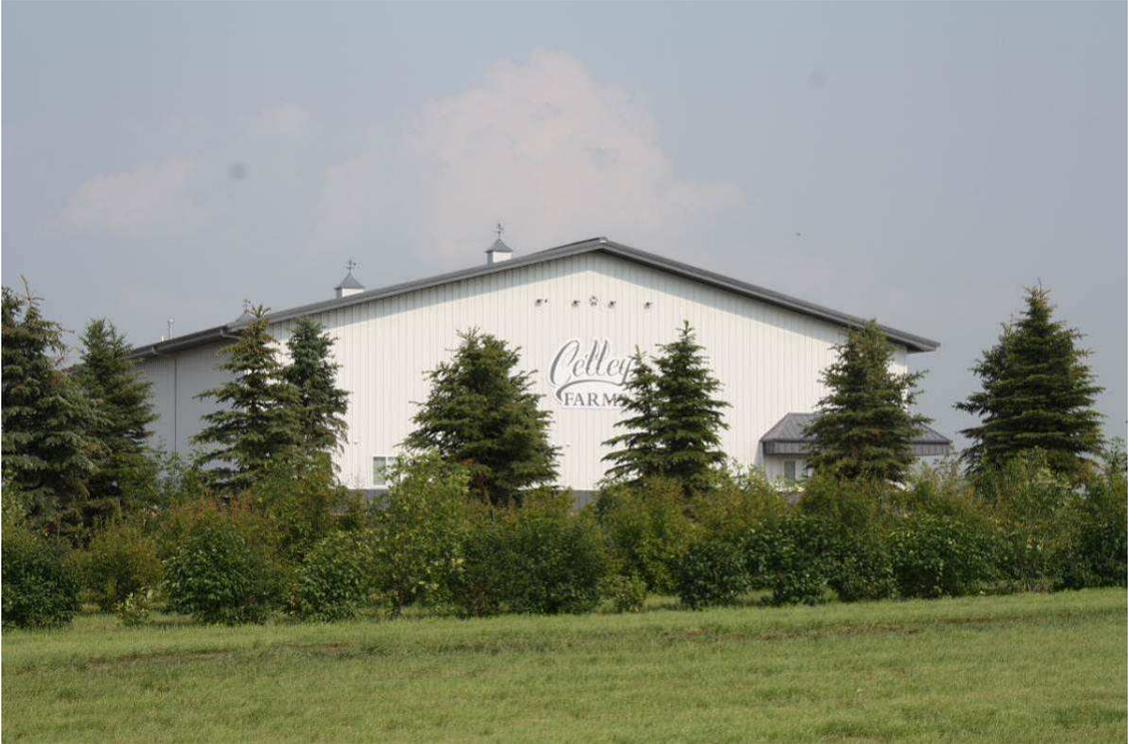
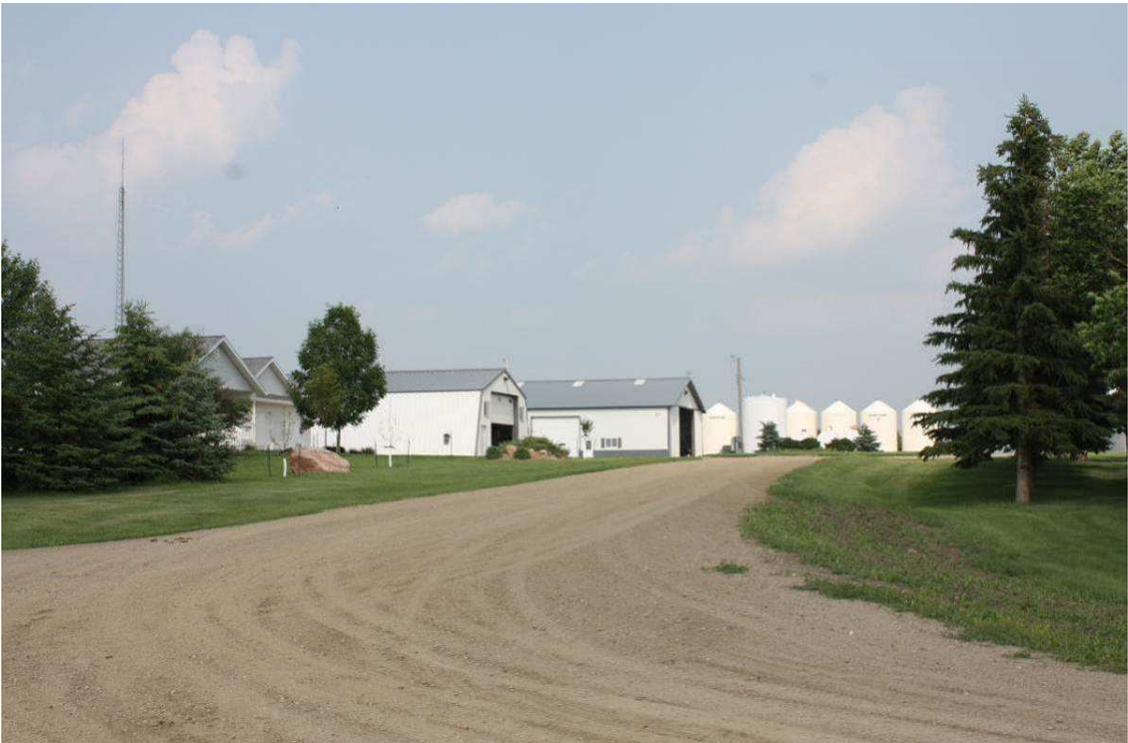
Photograph 28 -- Looking northeast at Tt 8. (July 8, 2014)

**Photograph 30 -- Looking southeast at Tt 8. (July 8, 2014)**

**Photograph 33 -- Looking east at Tt 8. (July 9, 2014)**

Tt 8 is a historic farmstead located in the western half of the western half of Section 6, Township 142N, Range 77W. Buildings have appeared in this location since the George Ogle plat map of 1912, which shows "C.R Perkins" and "Joy Perkins" owning residences in this portion of the section. By 1969 the land was owned by Grant Nelson, whose residence is the only one shown in this section. Aerial photos suggest that a building that looks like a residence was replaced between 1997 and 2003 by a larger, more industrial building. The property now appears to have no residence on it.

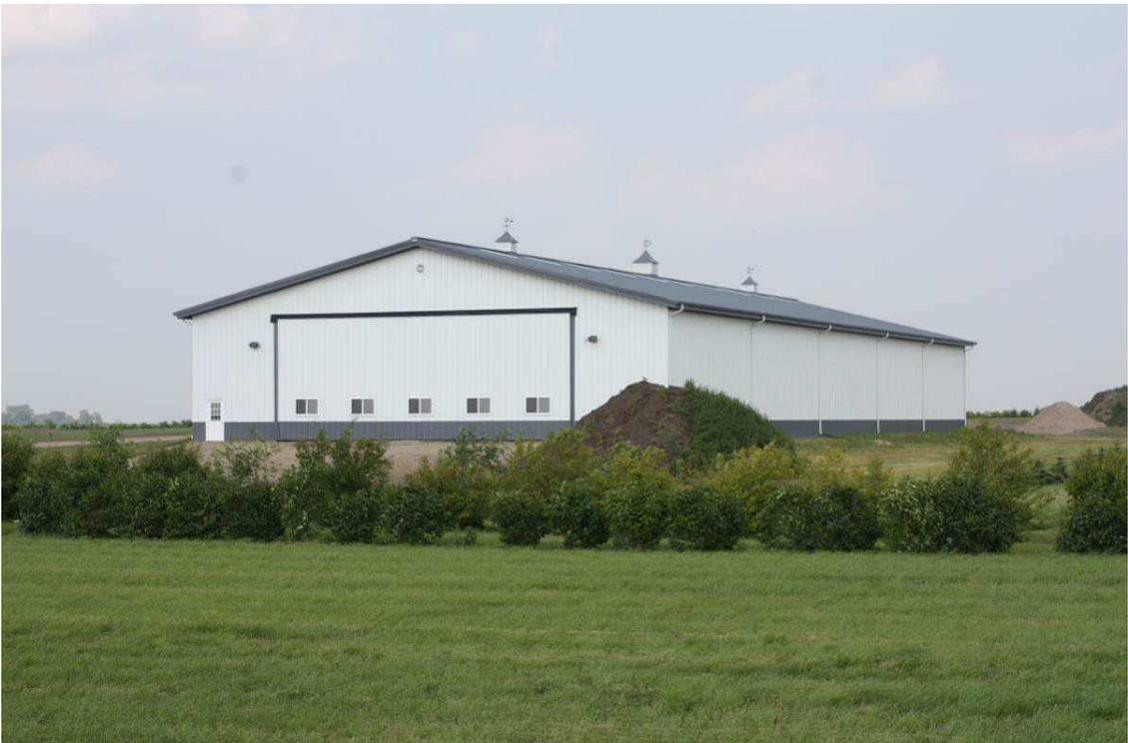
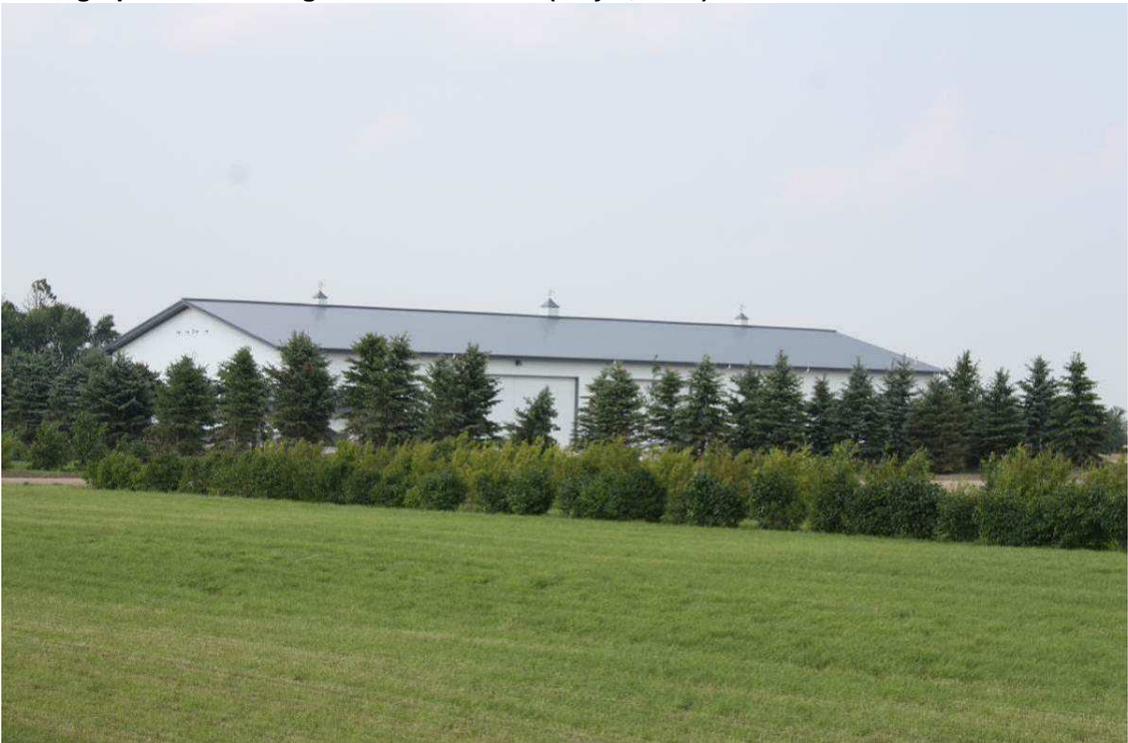
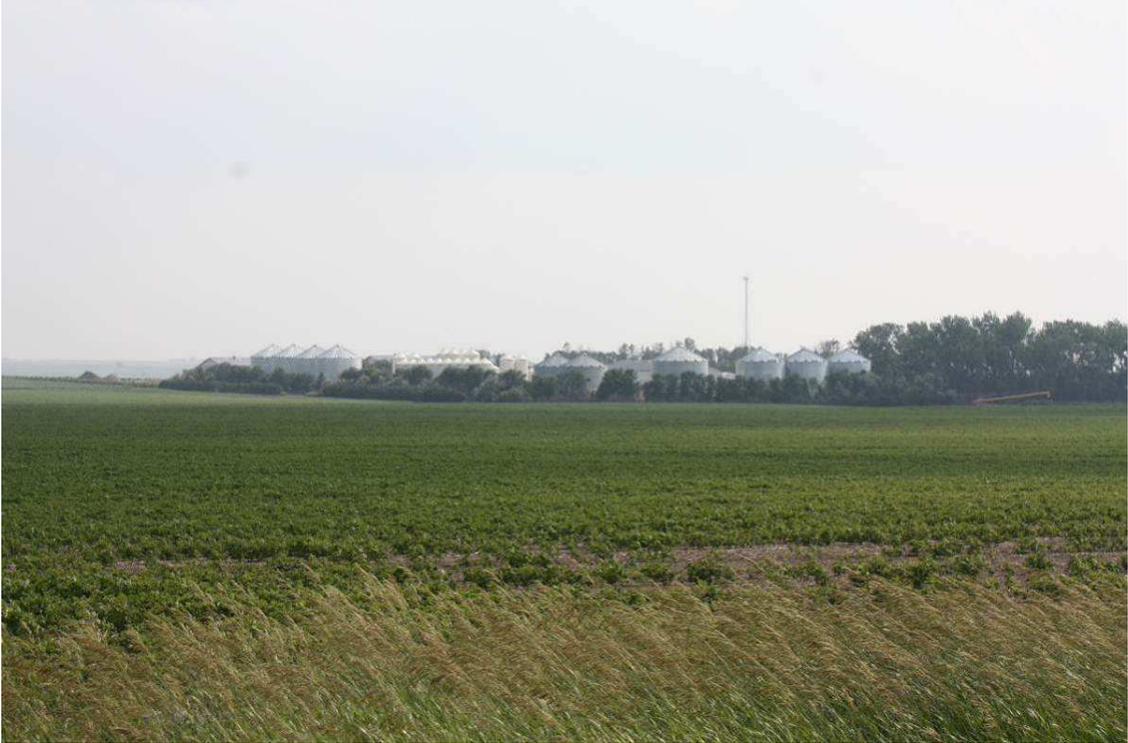
Photograph 29 -- Looking northeast at Tt 8. (July 8, 2014)

**Photograph 31 -- Looking northeast at Tt 8. (July 8, 2014)**

**Photograph 32 -- Looking southwest at Tt 8. (July 9, 2014)**

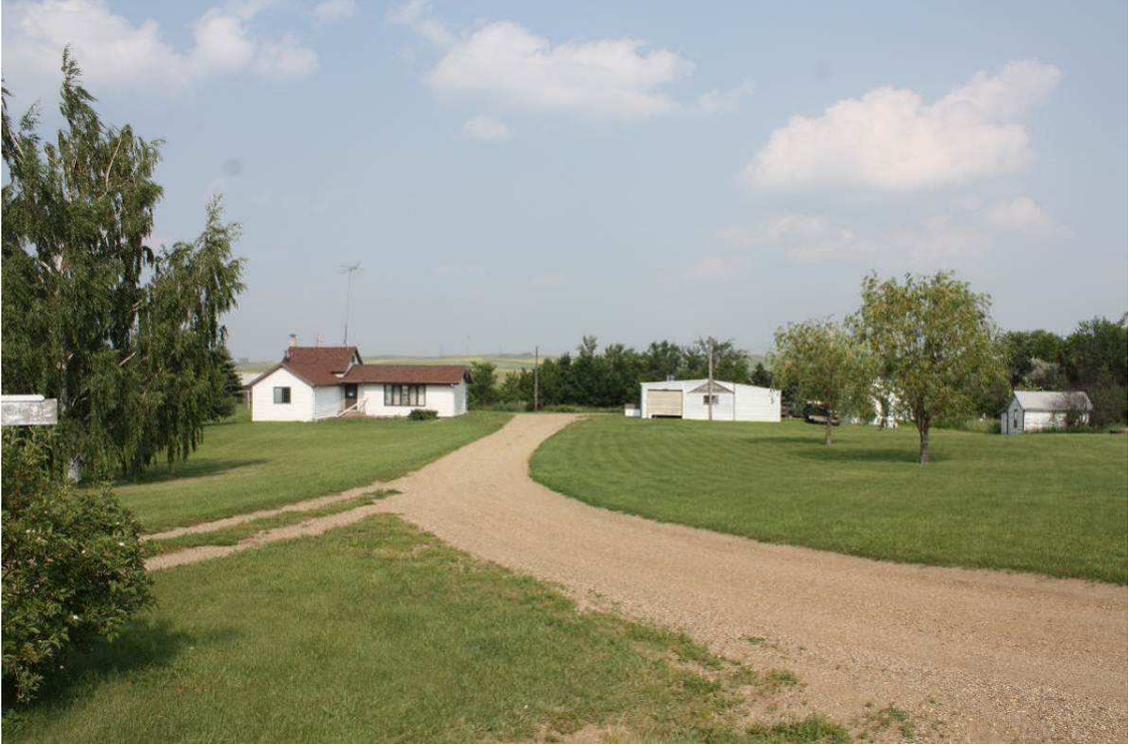
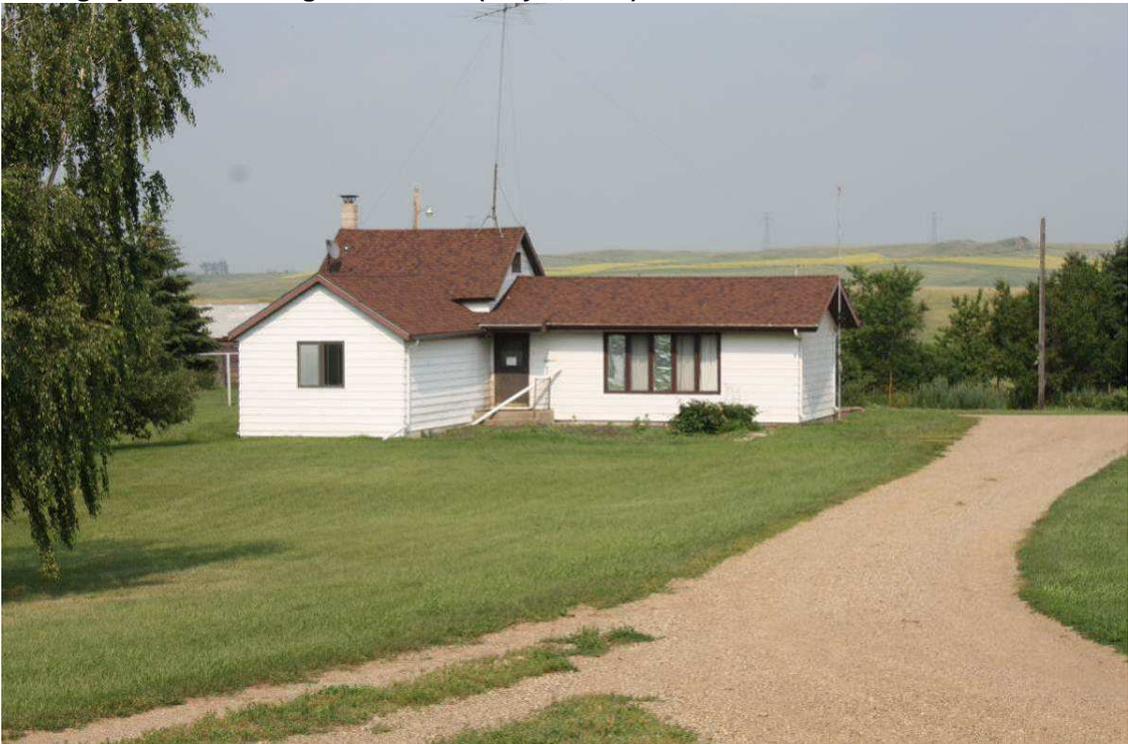
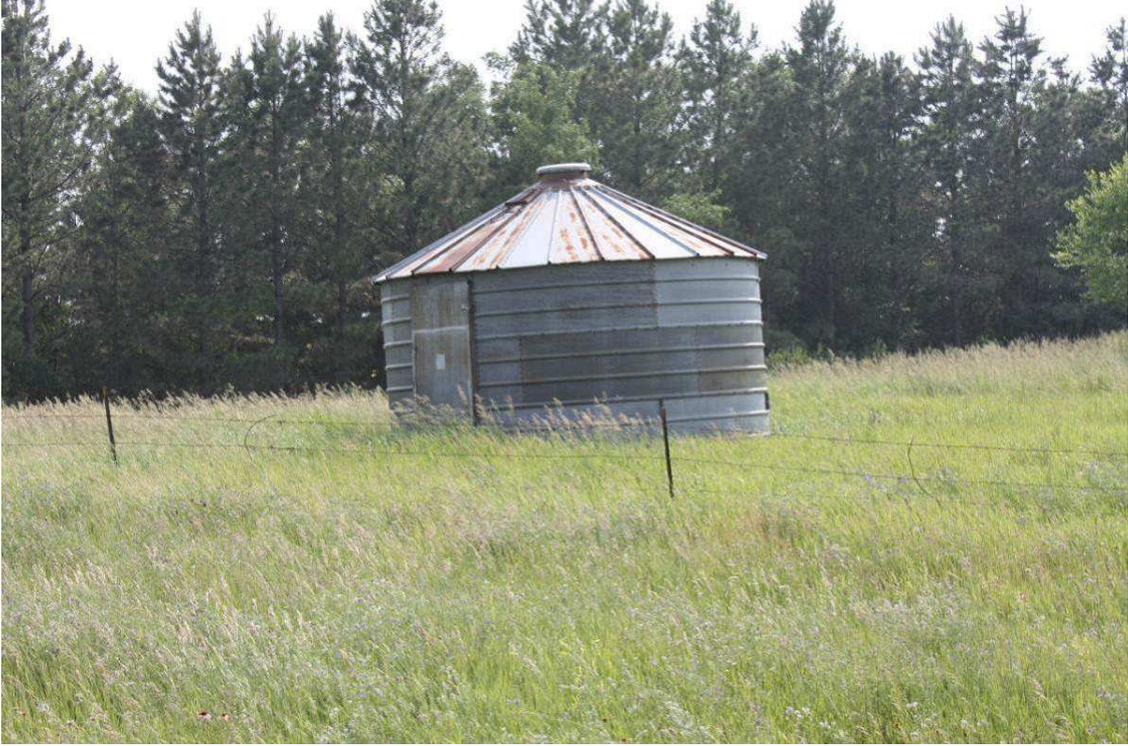
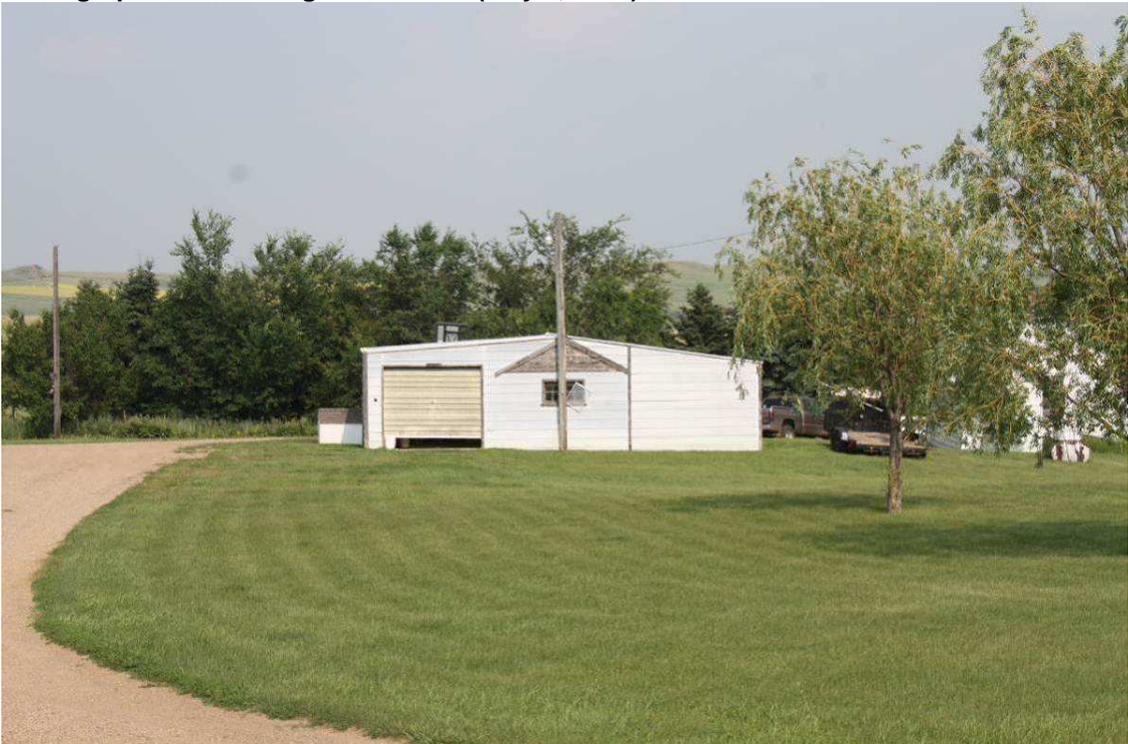
Photograph 34 -- Looking east at Tt 9. (July 8, 2014)

Photograph 35 -- Looking east at Tt 9. (July 8, 2014)

**Photograph 36 -- Looking east at Tt 8. (July 8, 2014)**

**Photograph 37 -- Looking east at Tt 9. (July 8, 2014)**

The property retains integrity of location and setting. However, modifications to many of the buildings, including expansion, replacement siding, and replacement windows, diminishes the integrity of design, workmanship, materials, and feeling. Additionally, it is not known to be associated with any historic events important to local, state or national history (Criterion A), does not have significant or unusual architecture (Criterion C), nor is it thought to have significant potential to yield historical information (Criterion D). Further research may yield information about those who lived here; at this time no association with a significant historical figure is known (Criterion B). This farmstead is recommended by Tetra Tech as not eligible for listing in the NRHP.

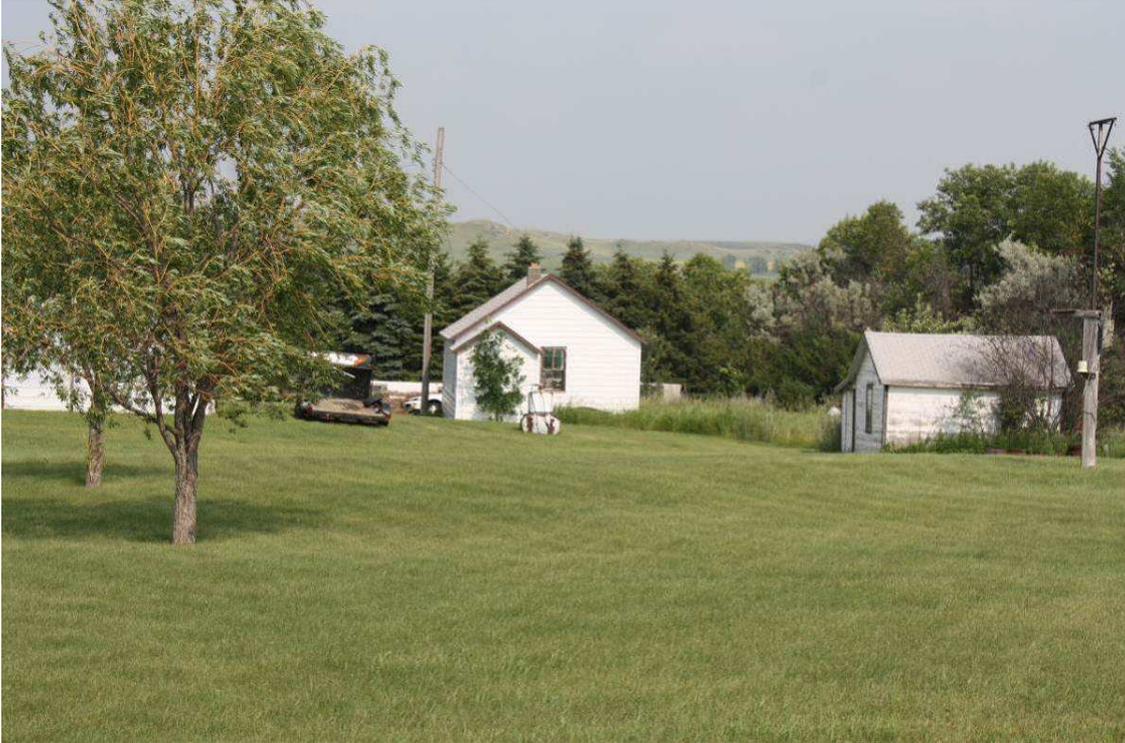
**Photograph 38 -- Looking east at Tt 9. (July 9, 2014)**

Tt 9 is a historic farmstead located in the northeast quarter of the southeast quarter of Section 5, Township 142N, Range 77W. Buildings have appeared in this location since at least 1969, when the Director Service Company plat map shows “Darrell Kling” owning a residence in this location.

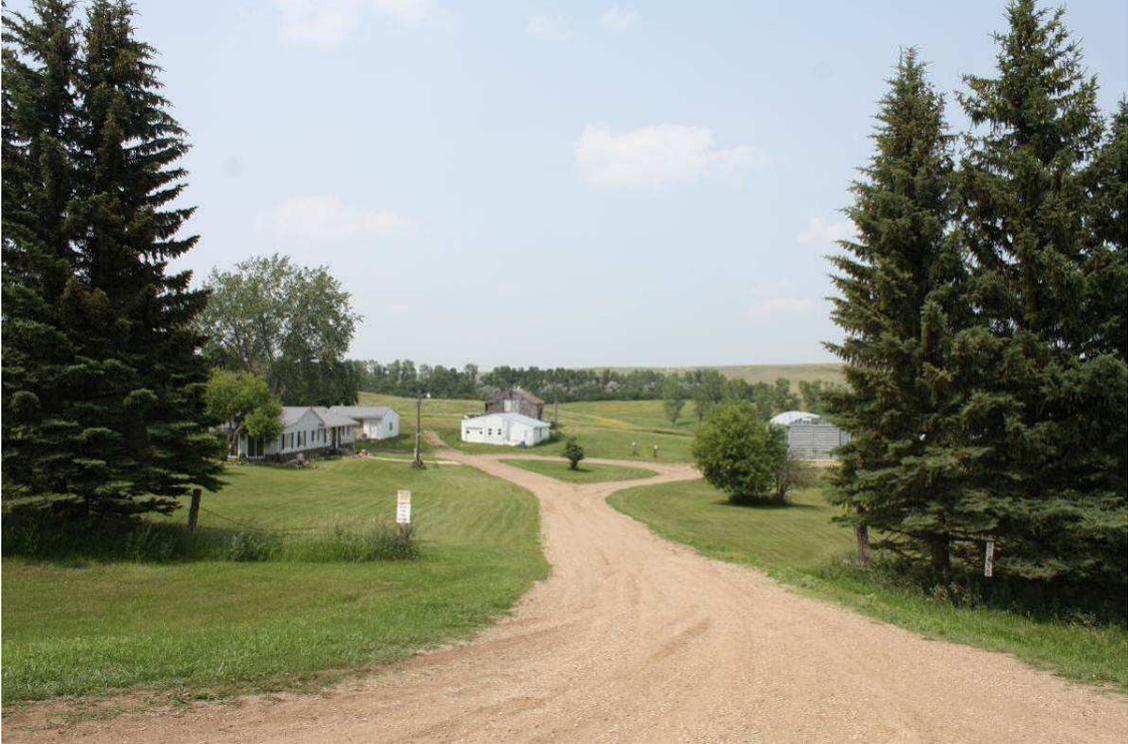
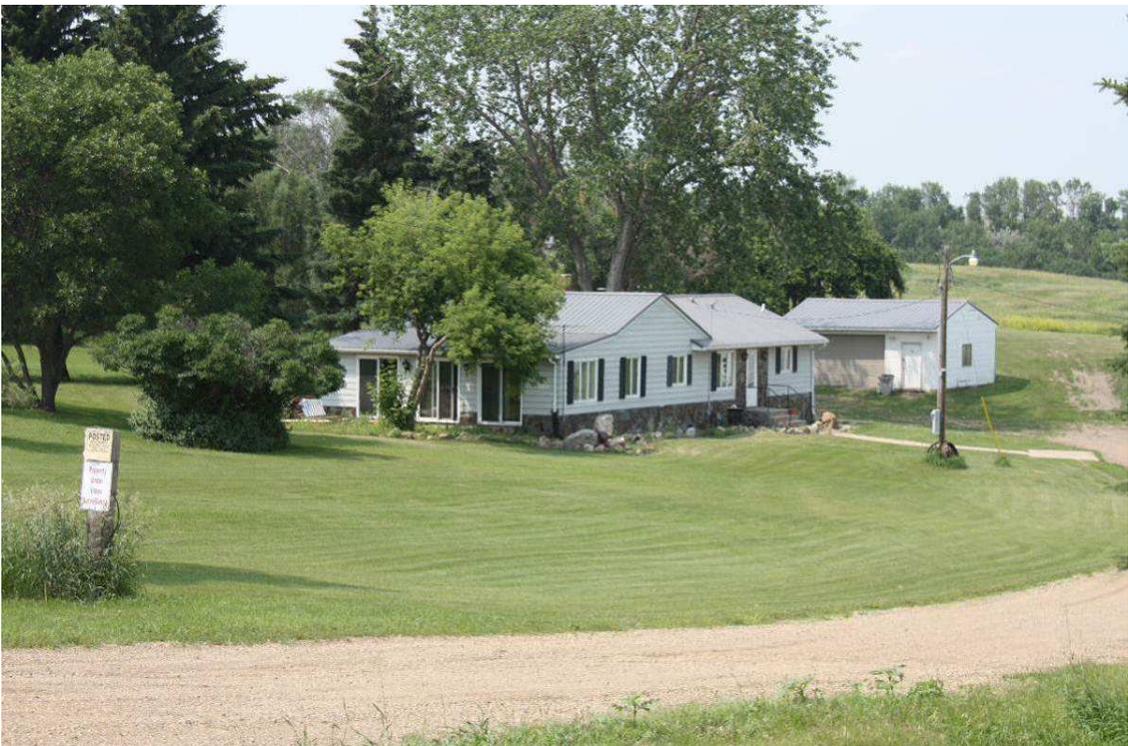
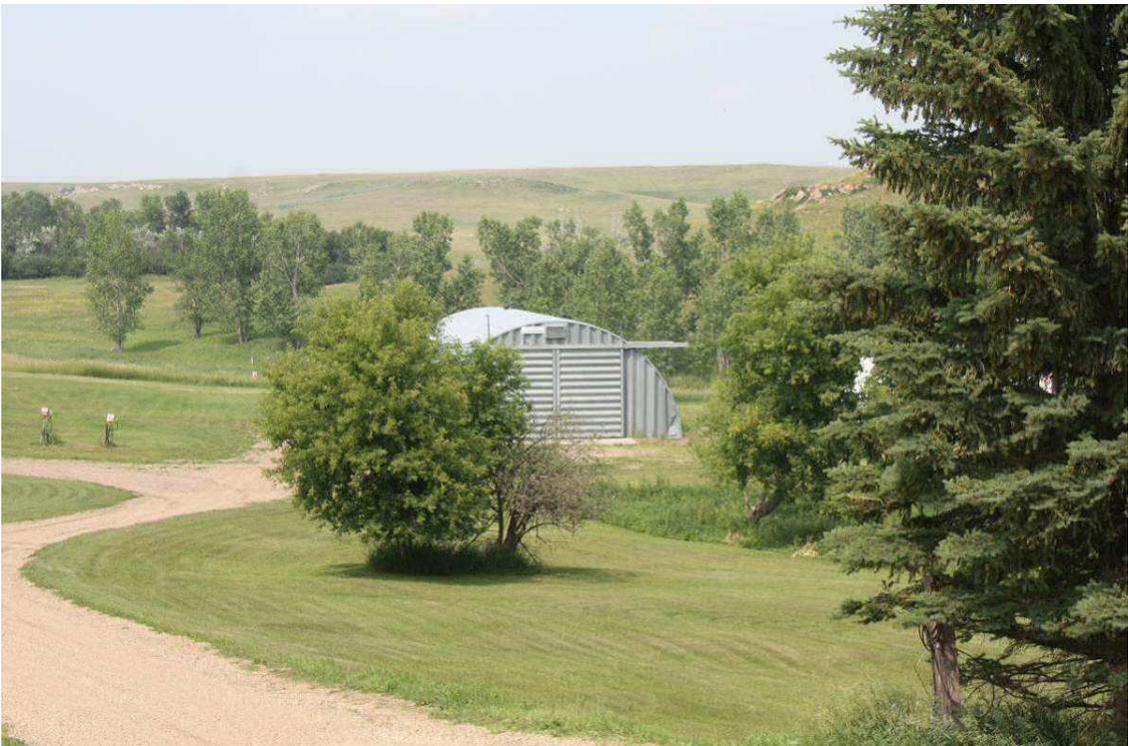
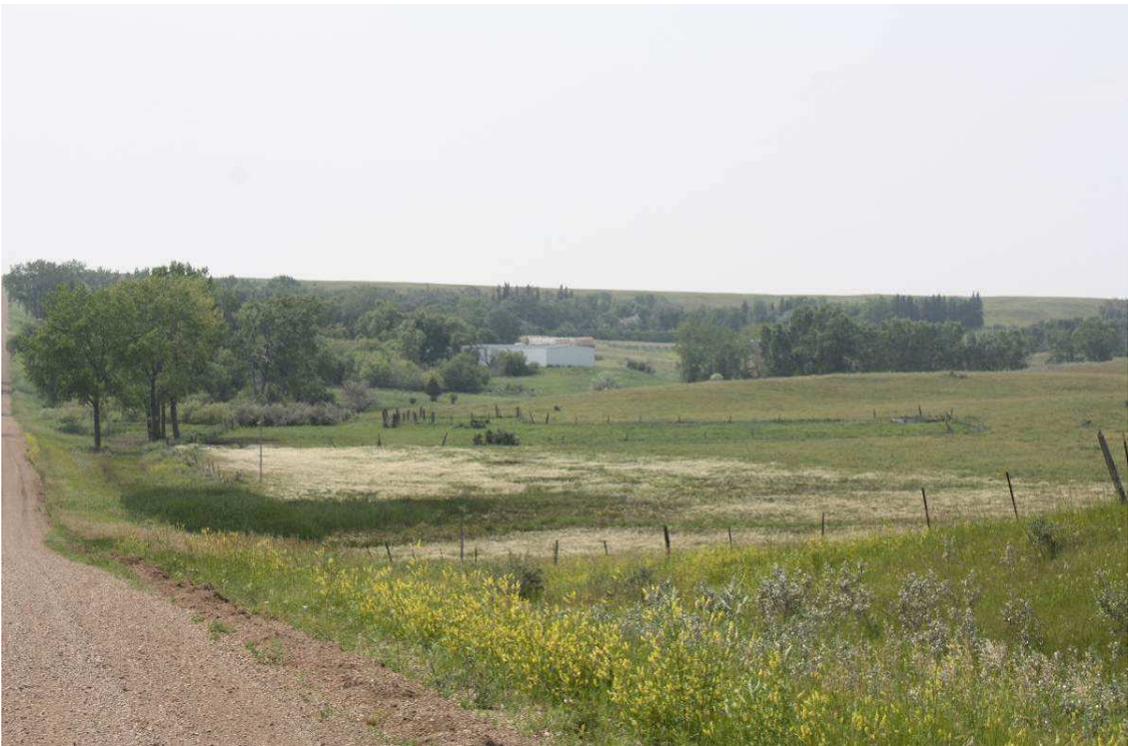
**Photograph 39 -- Looking north at Tt 10. (July 9, 2014)**

**Photograph 40 -- Looking north at Tt 10. (July 9, 2014)**

Photograph 42 -- Looking northeast at Tt 10. (July 9, 2014)

**Photograph 44 -- Looking west at Tt 10. (July 9, 2014)**

Tt 10 is a historic farmstead located in the southwest quarter of the southwest quarter of Section 21, Township 142N, Range 77W. Buildings have appeared in this location since the prior to 1969, when the Directory Services plat map showed "A. Schwartz" owning this quarter section as well as the southern half of the quarter section directly to the west.

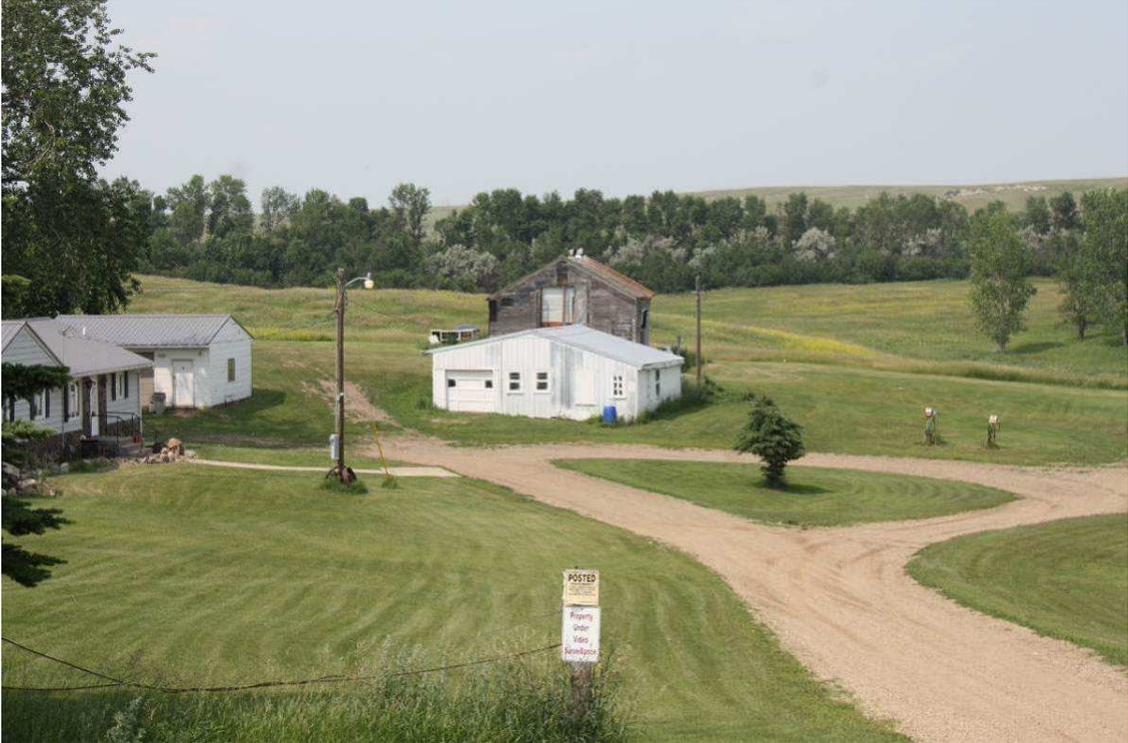
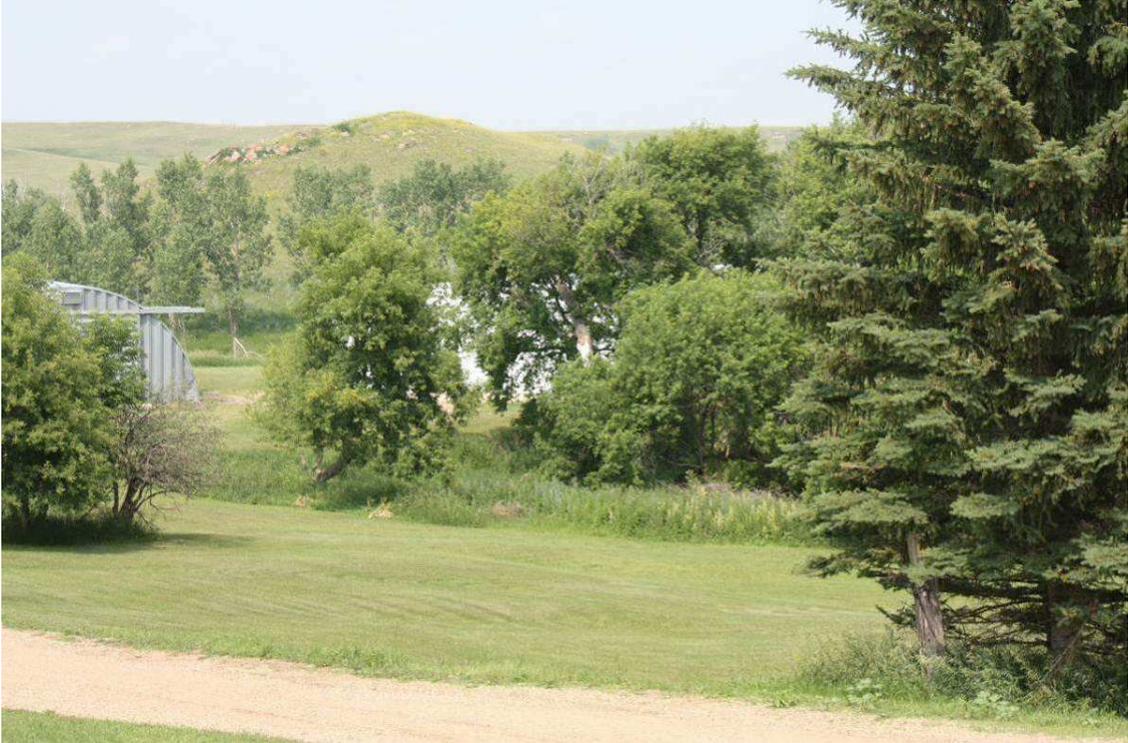
Photograph 41 -- Looking north at Tt 10. (July 9, 2014)

**Photograph 43 -- Looking northeast at Tt 10. (July 9, 2014)**

The property retains integrity of location and setting. However, the introduction of a large new building (visible on aerial photos and from a distance) and the use of new windows and siding on the main house diminishes the integrity of design, workmanship, materials, and feeling. Additionally, it is not known to be associated with any historic events important to local, state or national history (Criterion A), does not have significant or unusual architecture (Criterion C), nor is it thought to have significant potential to yield historical information (Criterion D). Further research may yield information about those who lived here; at this time no association with a significant historical figure is known (Criterion B). This farmstead is recommended by Tetra Tech as not eligible for listing in the NRHP.
