1. Manuscript Number:
2. SHPO Reference #: 14-0606
3. Author: James Sexton, Ph. D.
4. Title: Wilton IV Wind Energy Center: A Class II Architectural Inventory In Burleigh County, North Dakota (Addendum)
5. Report Date: August 2014
6. Number of Pages: 77
7. Type: II
8. Acres: 22332 acres
9. Legal Location(s):

**Wilton IV Wind Energy Center:  
A Class II Architectural Reconnaissance Survey  
In Burleigh County, North Dakota  
(Addendum)**

**September 2014**

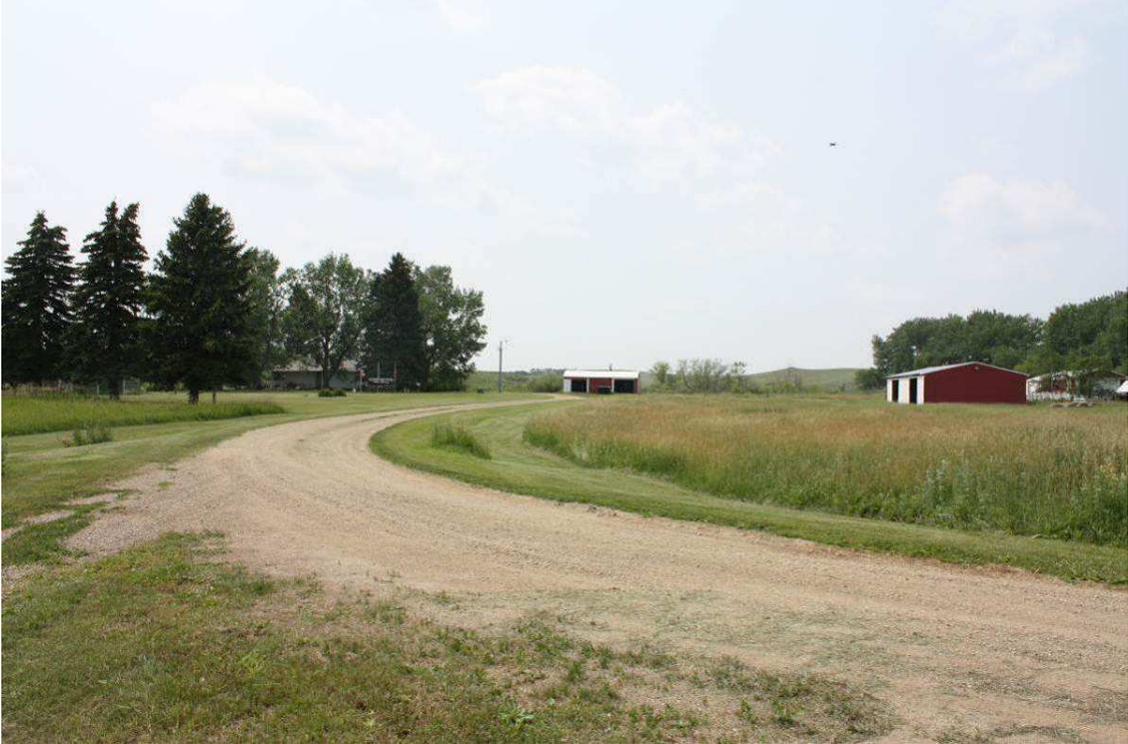
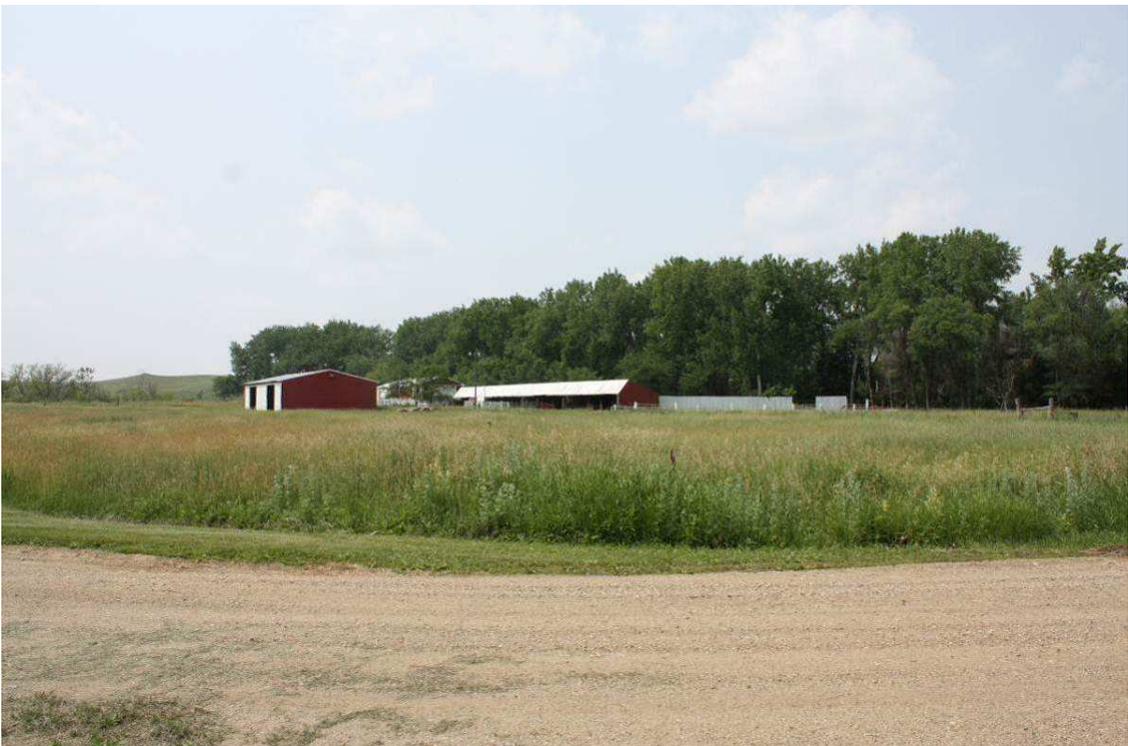
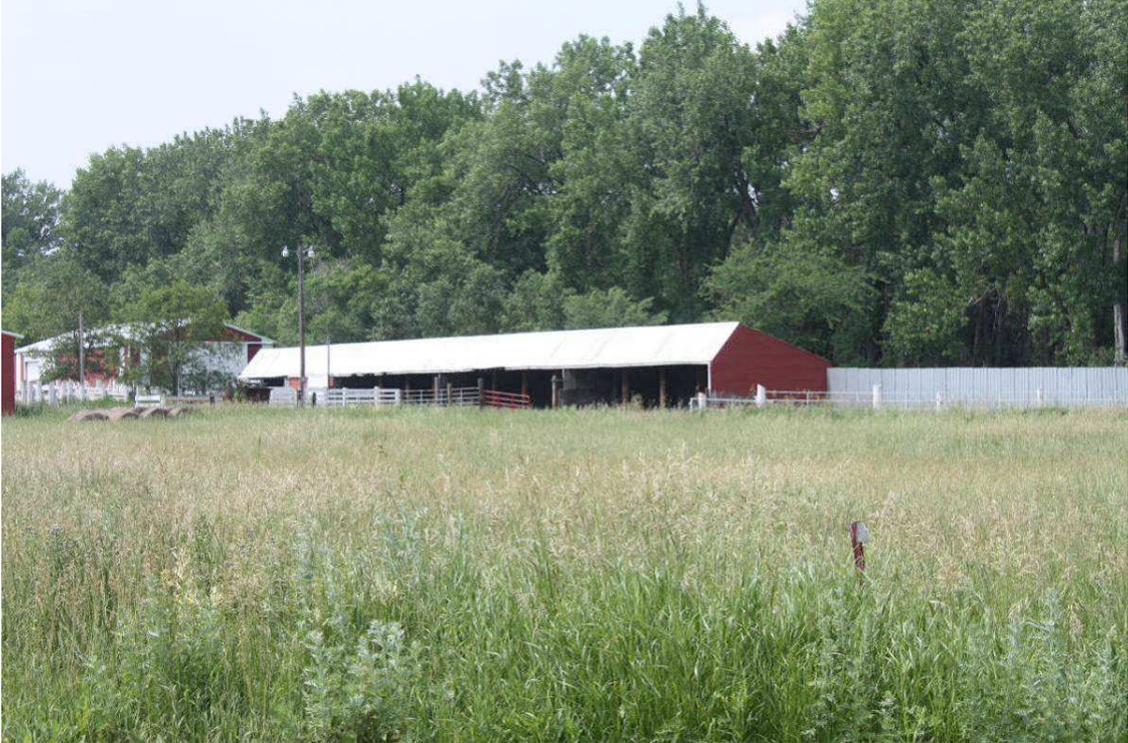
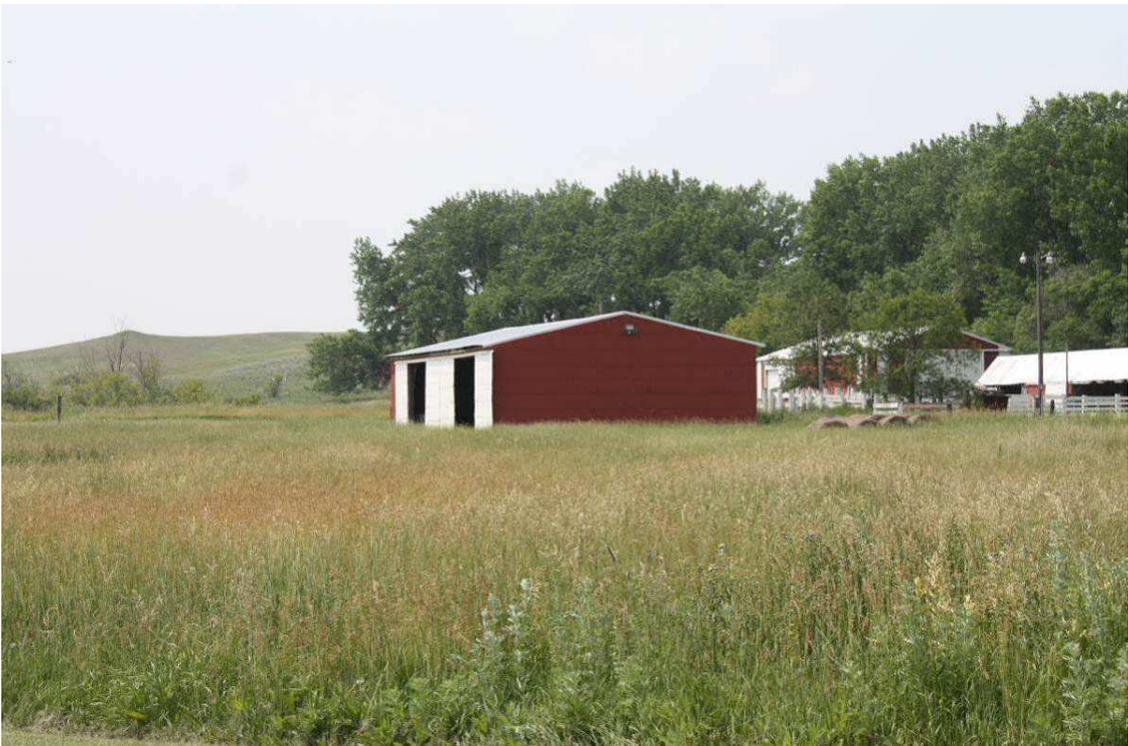
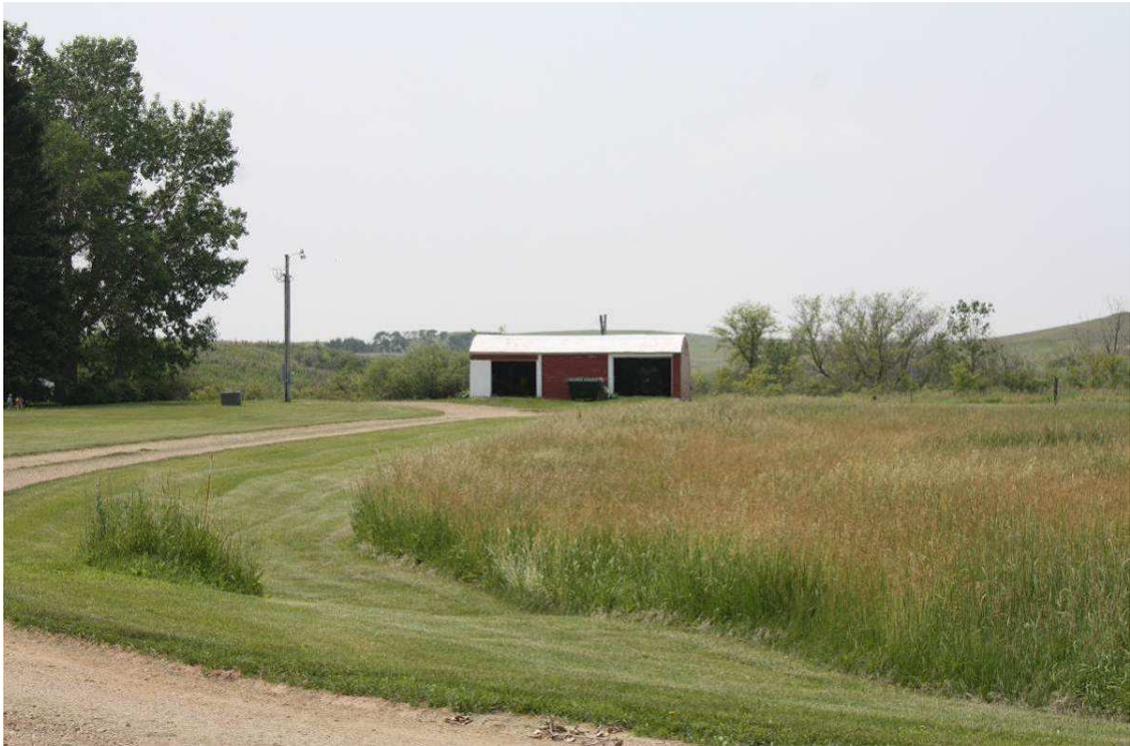
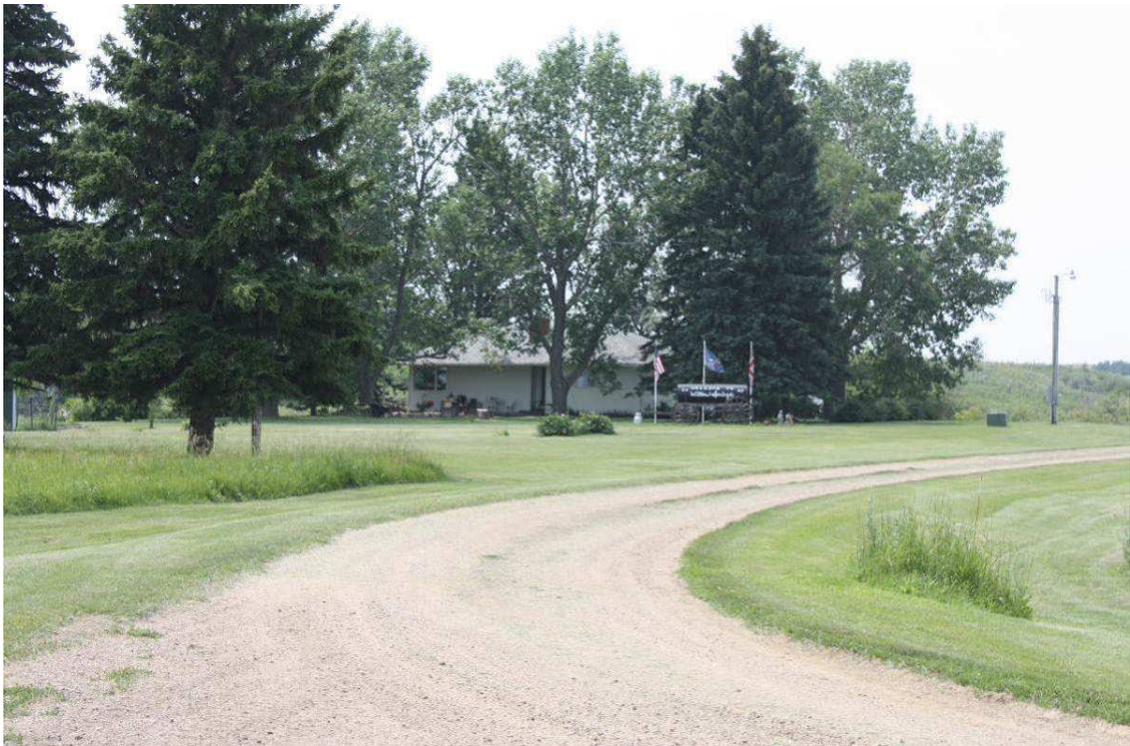
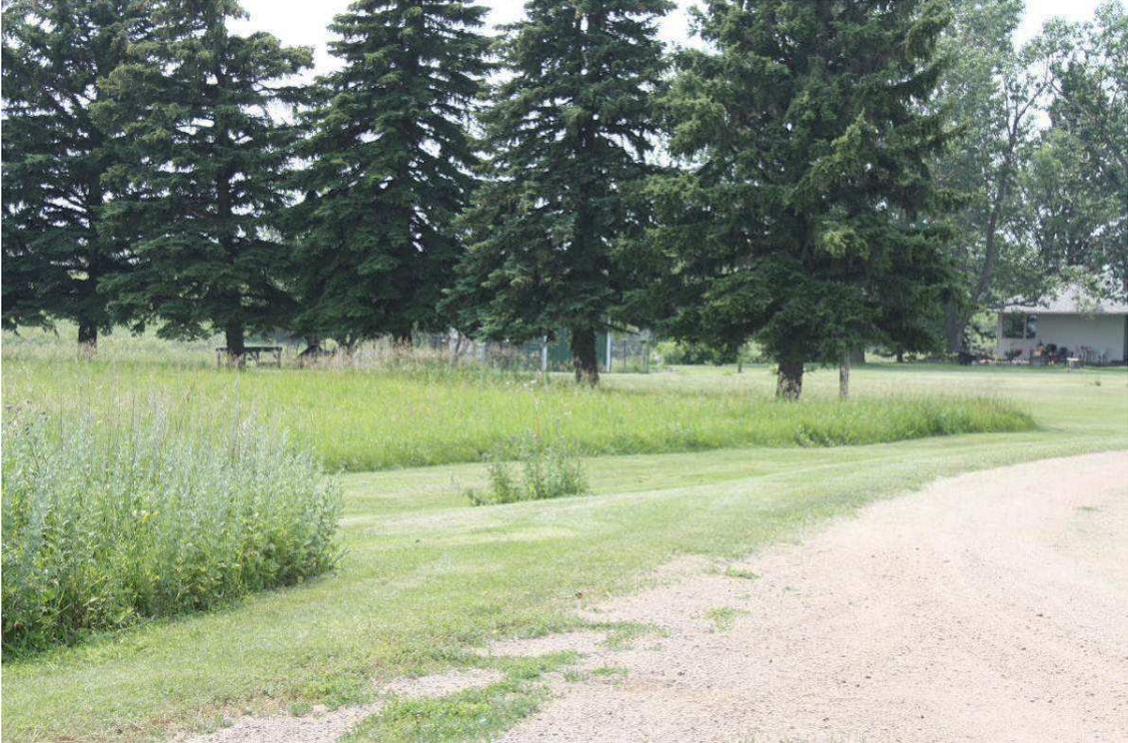
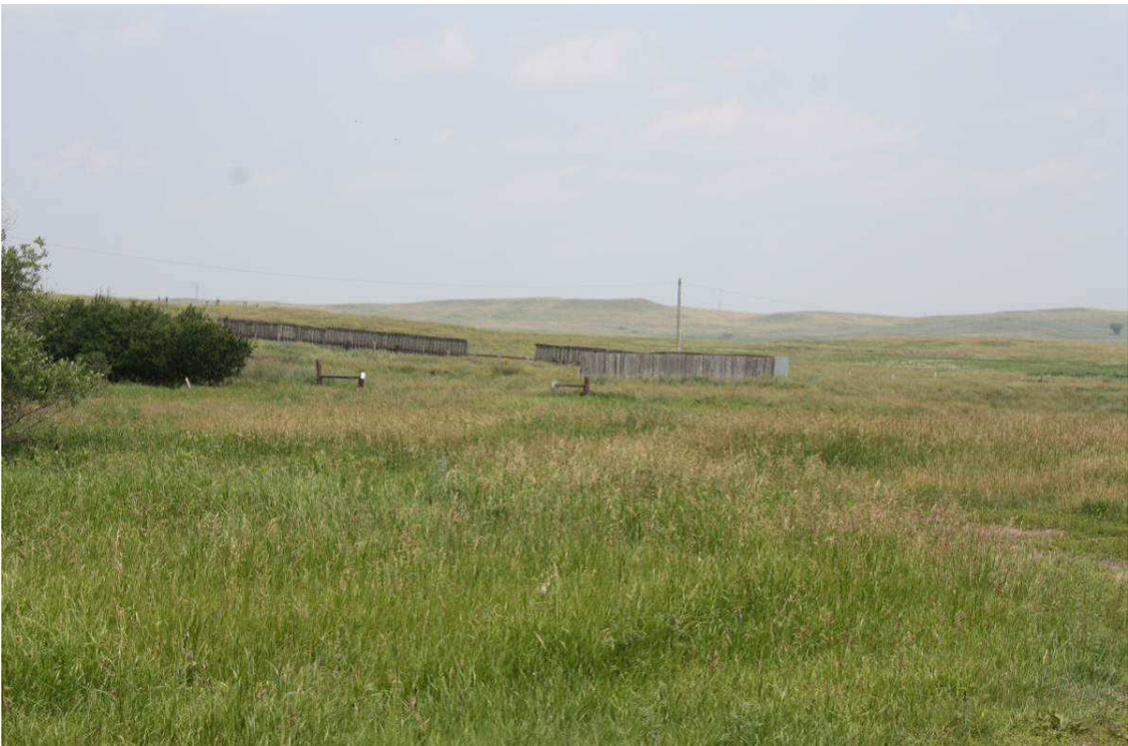
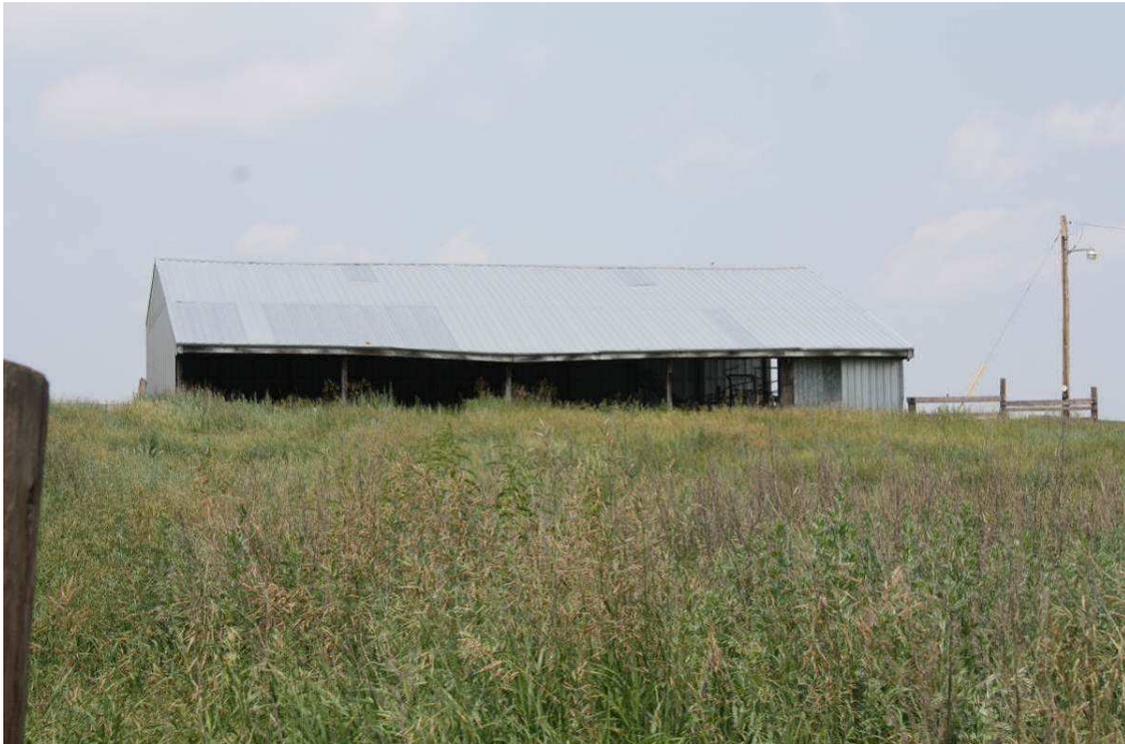
Photograph 45 -- Looking west at Tt 11. (July 9, 2014)

Photograph 46 -- Looking west at Tt 11. (July 9, 2014)

Photograph 47 -- Looking west at Tt 11. (July 9, 2014)

Photograph 48 -- Looking west at Tt 11. (July 9, 2014)

**Photograph 49 -- Looking west at Tt 11. (July 9, 2014)**

**Photograph 50 -- Looking west at Tt 11. (July 9, 2014)**

**Photograph 51 -- Looking west at Tt 11. (July 9, 2014)**

**Photograph 52 -- Looking northeast at Tt 11. (July 9, 2014)**

**Photograph 53 -- Looking north at Tt 11. (July 9, 2014)**

Tt 11 is a historic farmstead located in the southeast quarter of the northeast quarter of Section 16, Township 142N, Range 77W. Buildings have appeared in this location since prior to 1969 when the Directory Services plat map showed "Lawrence Hapkins" owning a residence in this section.

The property retains integrity of location, setting, and feeling. However, the use of modern materials on many of the buildings diminishes the integrity of design, workmanship, and materials. Additionally, it is not known to be associated with any historic events important to local, state or national history (Criterion A), does not have significant or unusual architecture (Criterion C), nor is it thought to have significant potential to yield historical information (Criterion D). Further research may yield information about those who lived here; at this time no association with a significant historical figure is known (Criterion B). This farmstead is recommended by Tetra Tech as not eligible for listing in the NRHP.

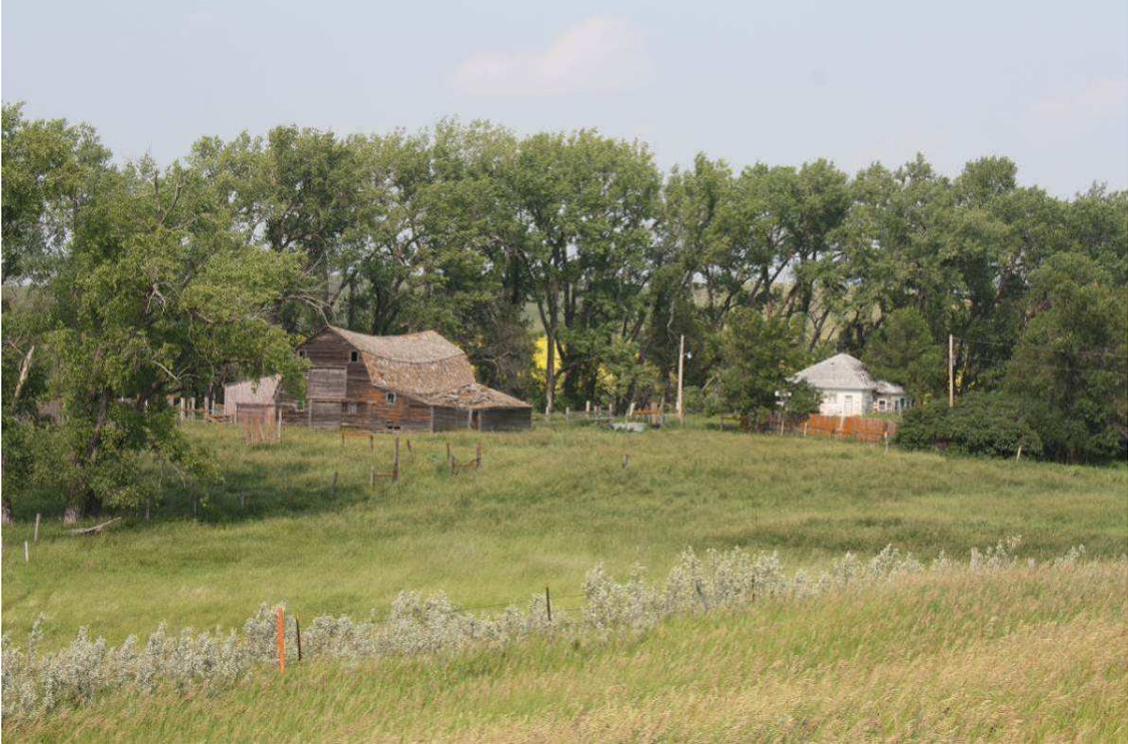
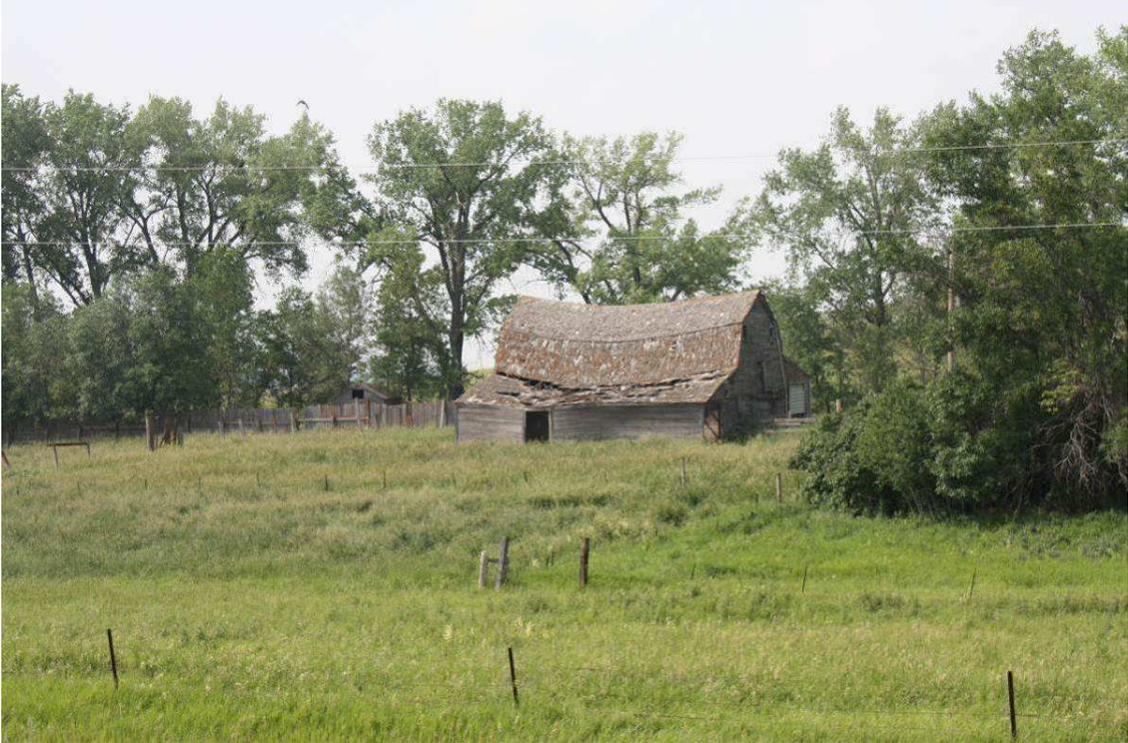
Photograph 54 -- Looking northeast at Tt 12. (July 9, 2014)

Photograph 56 -- Looking northwest at Tt 12. (July 9, 2014)

The property retains integrity of location, setting, and materials. However, the state of disrepair of many of the outbuildings diminishes the integrity of design, workmanship, and feeling. Additionally, it is not known to be associated with any historic events important to local, state or national history (Criterion A), does not have significant or unusual architecture (Criterion C), nor is it thought to have significant potential to yield historical information (Criterion D). Further research may yield information about those who lived here; at this time no association with a significant historical figure is known (Criterion B). This farmstead is recommended by Tetra Tech as not eligible for listing in the NRHP.

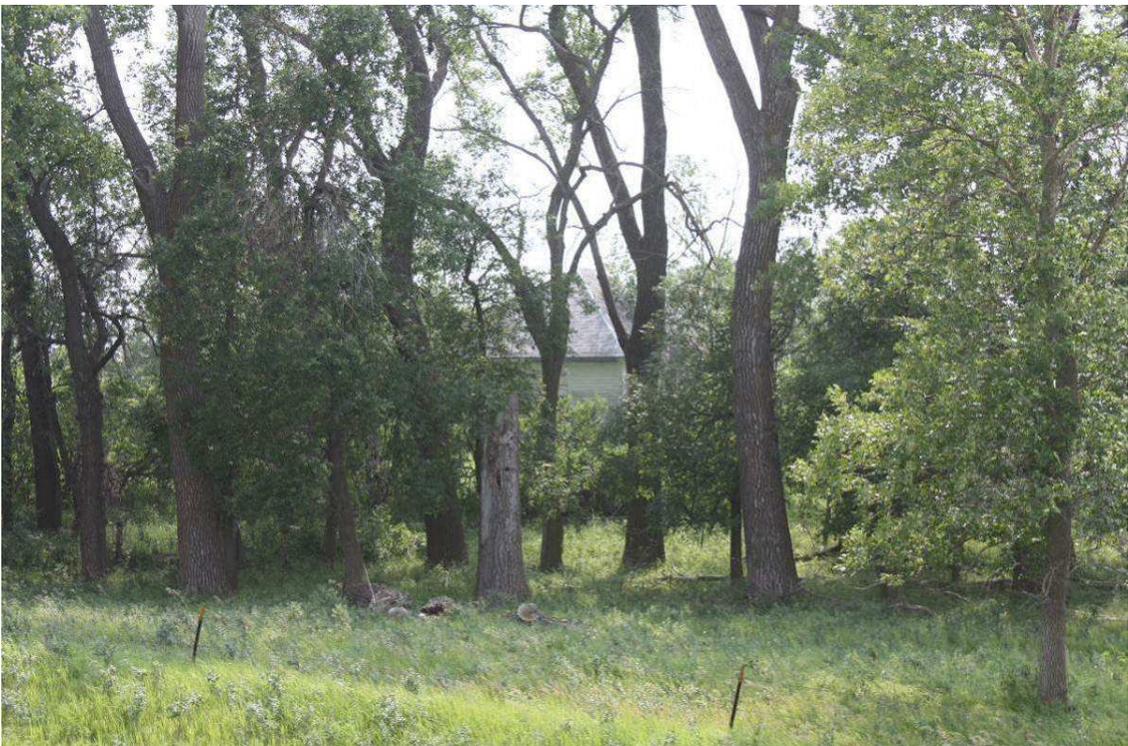
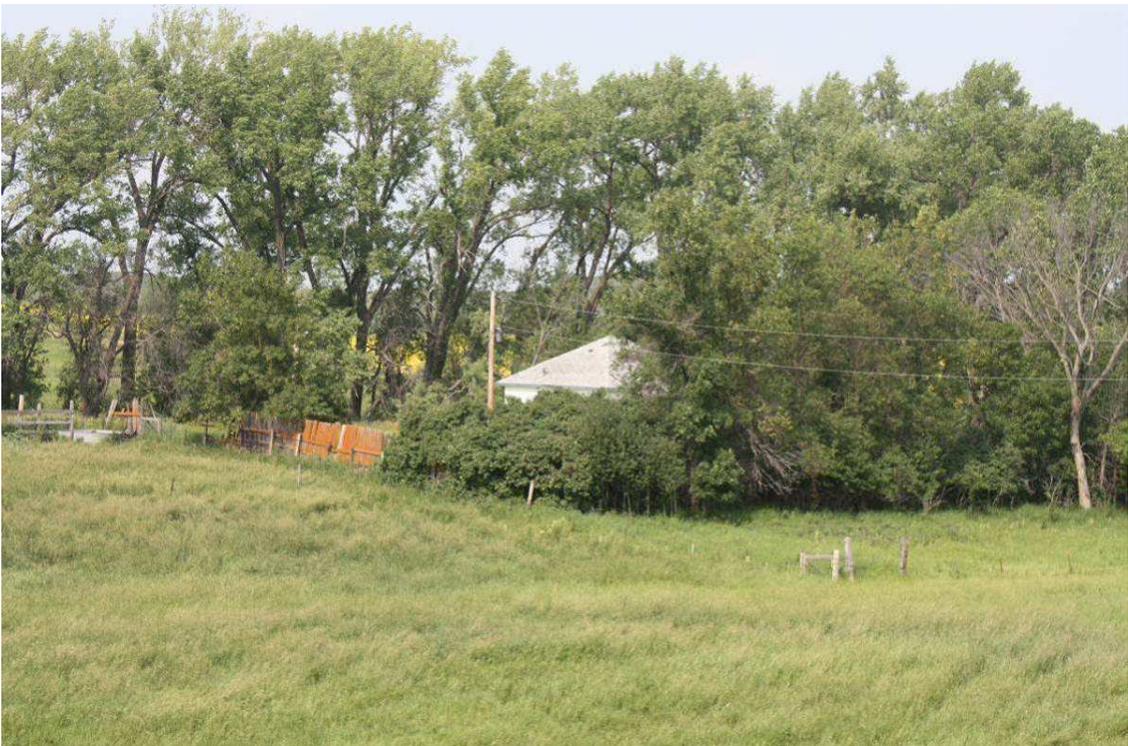
Photograph 55 -- Looking west at Tt 12. (July 9, 2014)

Photograph 57 -- Looking northeast at Tt 12. (July 9, 2014)

Tt 12 is a historic farmstead located in the southeast quarter of the southeast quarter of Section 4, Township 142N, Range 77W. Buildings have appeared in this location since prior to the Directory Services plat map of 1969, which shows "Clyde Little" owning a residence in location.

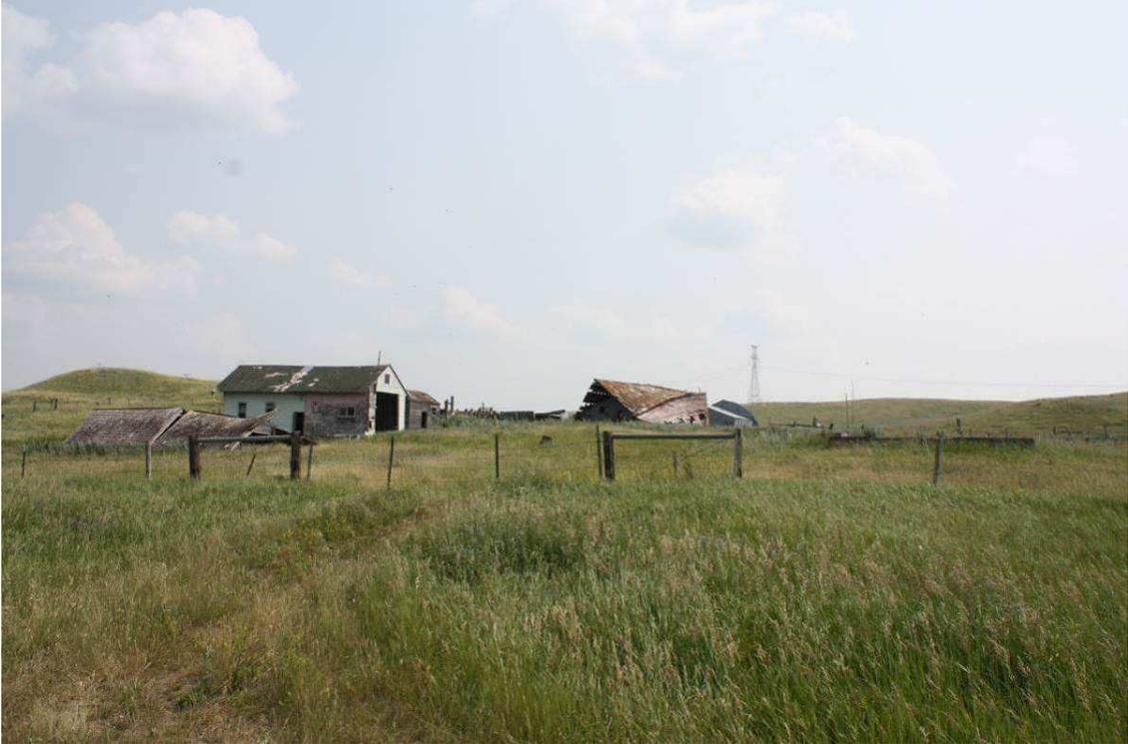
Photograph 58 -- Looking south at Tt 13. (July 9, 2014)

The property retains integrity of location, setting, and materials. However, the state of disrepair of many of the buildings diminishes the integrity of design, workmanship, and feeling. Additionally, it is not known to be associated with any historic events important to local, state or national history (Criterion A), does not have significant or unusual architecture (Criterion C), nor is it thought to have significant potential to yield historical information (Criterion D). Further research may yield information about those who lived here; at this time no association with a significant historical figure is known (Criterion B). This farmstead is recommended by Tetra Tech as not eligible for listing in the NRHP.

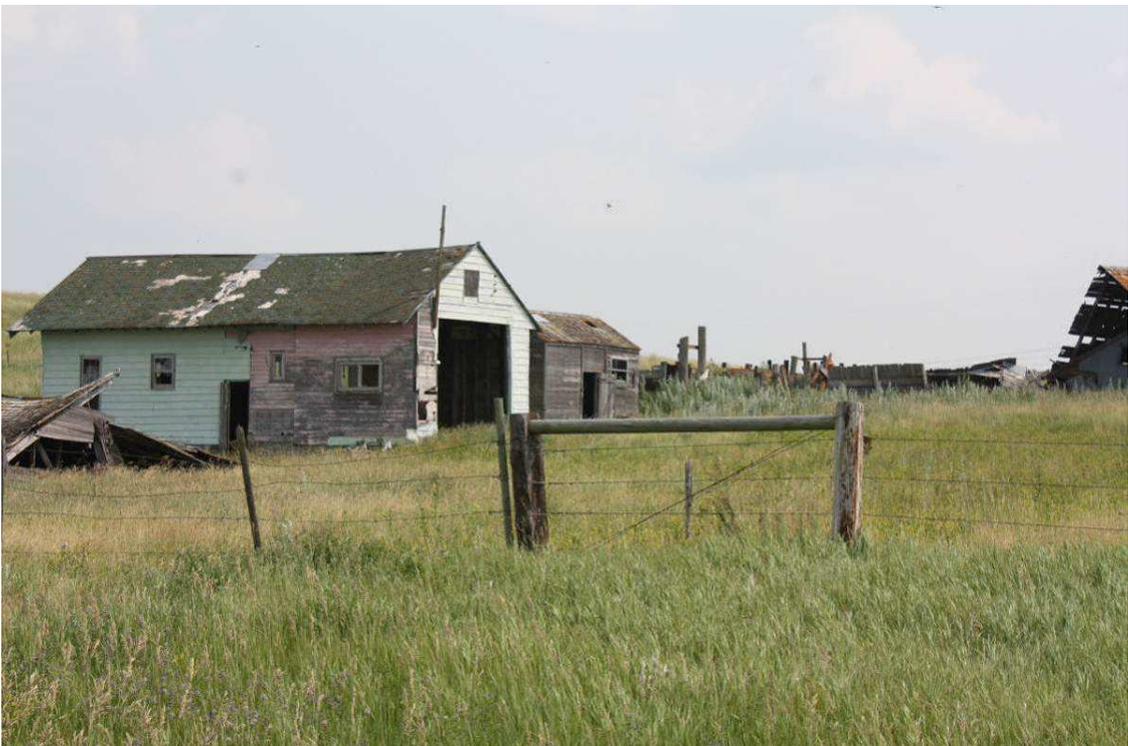
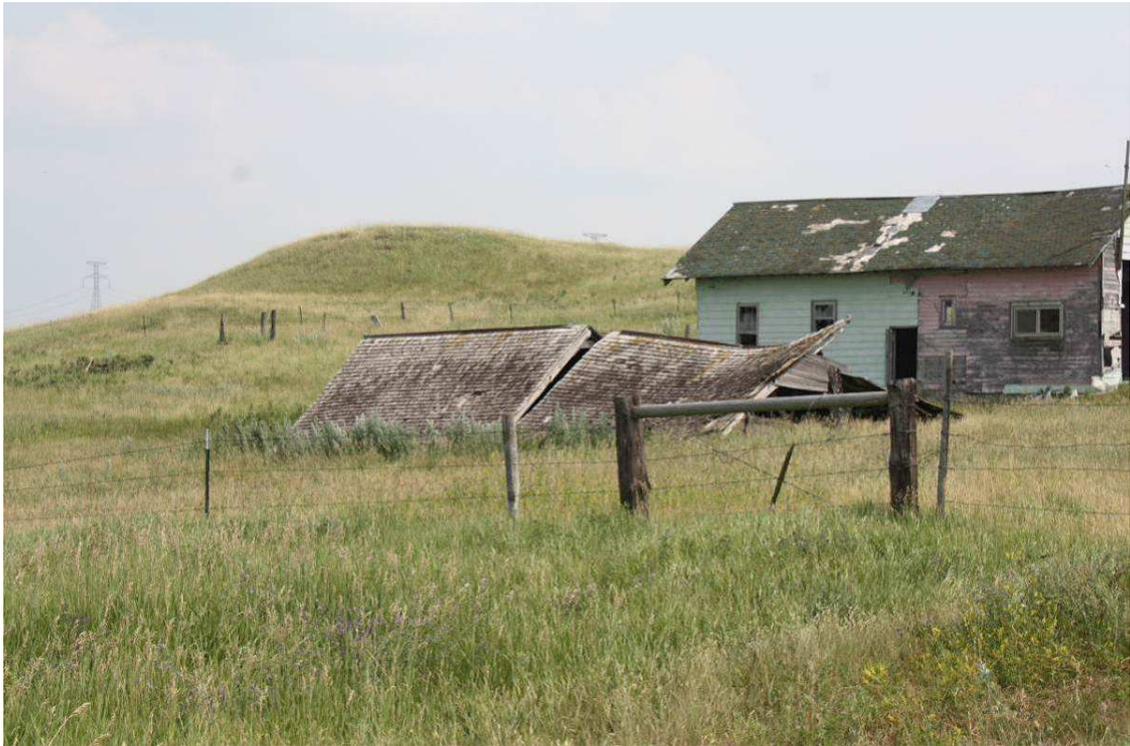
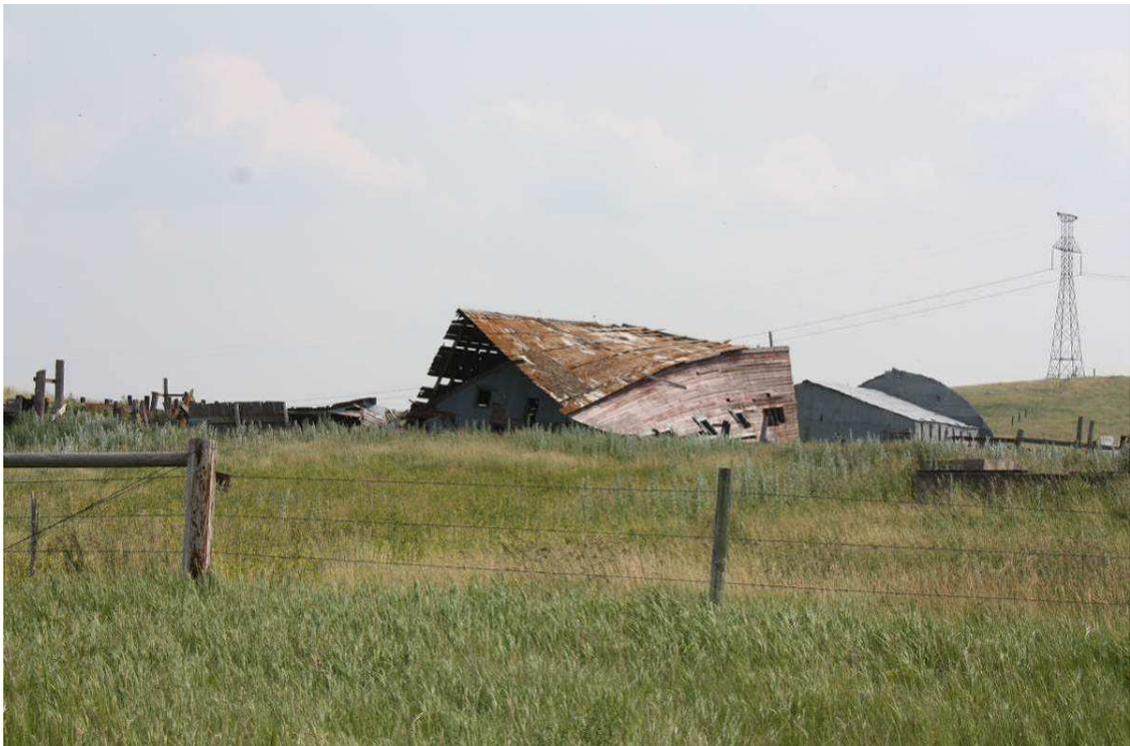
Photograph 59 -- Looking south at Tt 13. (July 9, 2014)

Photograph 60 -- Looking southeast at Tt 13. (July 9, 2014)

Photograph 61 -- Looking south at Tt 13. (July 9, 2014)

Tt 13 is a historic farmstead located in the northwest quarter of the northeast quarter of Section 3, Township 142N, Range 77W. Buildings have appeared in this location since before 1969 when the Directory Services plat map of showed "Vernon Johns" owning a residence in this location.

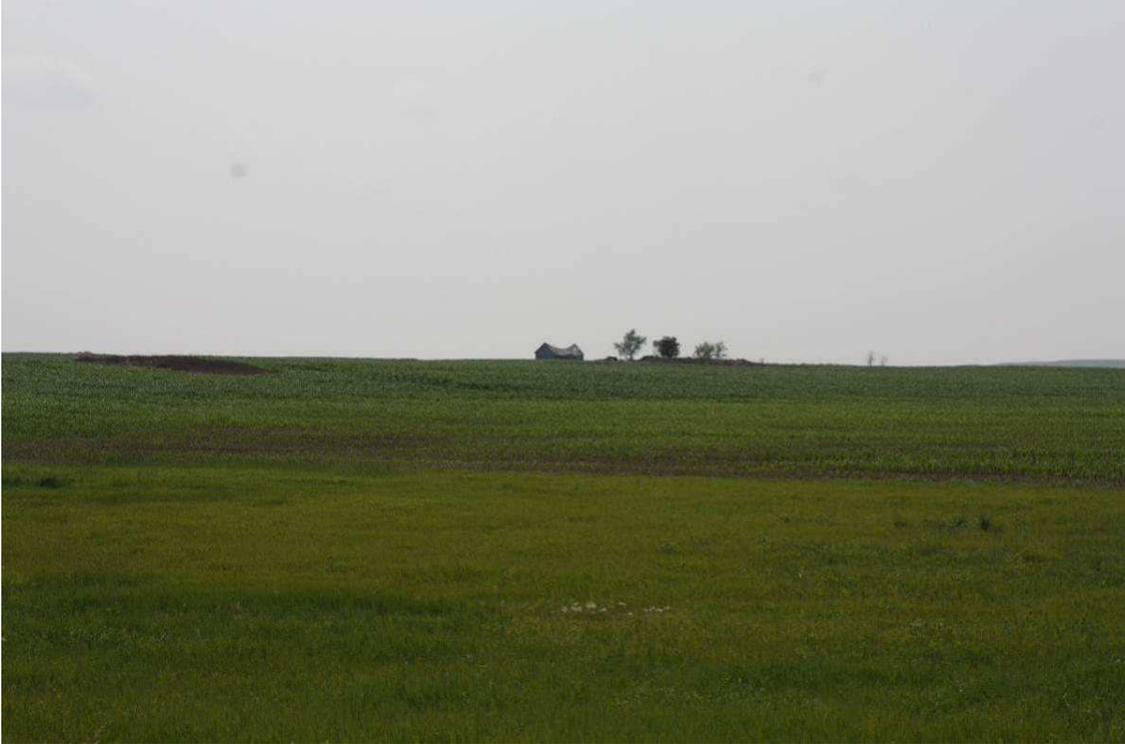
**Photograph 62 -- Looking southwest at Tt 14. (July 9, 2014)**

Tt 14 is an isolated building located in the northwest quarter of the southeast quarter of Section 14, Township 142N, Range 77W. Buildings have appeared in this location since the George Ogle plat map of 1912, which shows “Max Bilow” owning this quarter section. By 1969, the building located here is shown as an empty square, suggesting that it has been abandoned.

The property retains integrity of location, setting, and materials. However, the state of disrepair of the building diminishes the integrity of design, workmanship, and feeling. Additionally, it is not known to be associated with any historic events important to local, state or national history (Criterion A), does not have significant or unusual architecture (Criterion C), nor is it thought to have significant potential to yield historical information (Criterion D). Further research may yield information about those who lived here; at this time no association with a significant historical figure is known (Criterion B). This farmstead is recommended by Tetra Tech as not eligible for listing in to the NRHP.

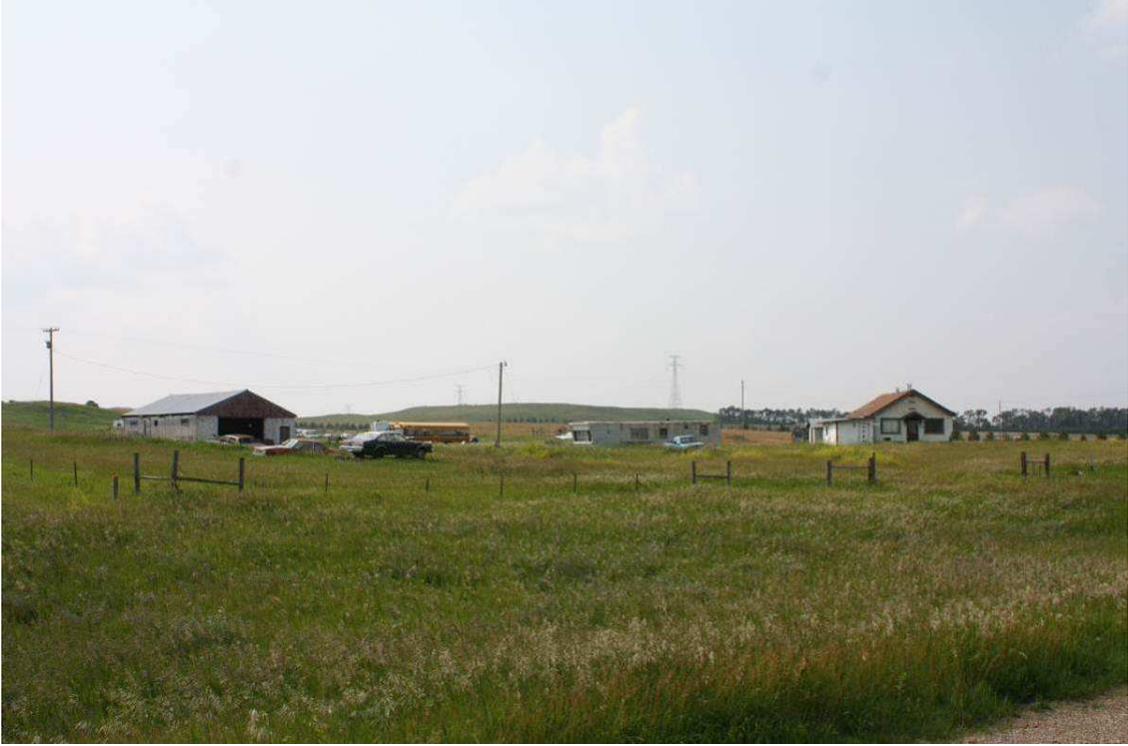
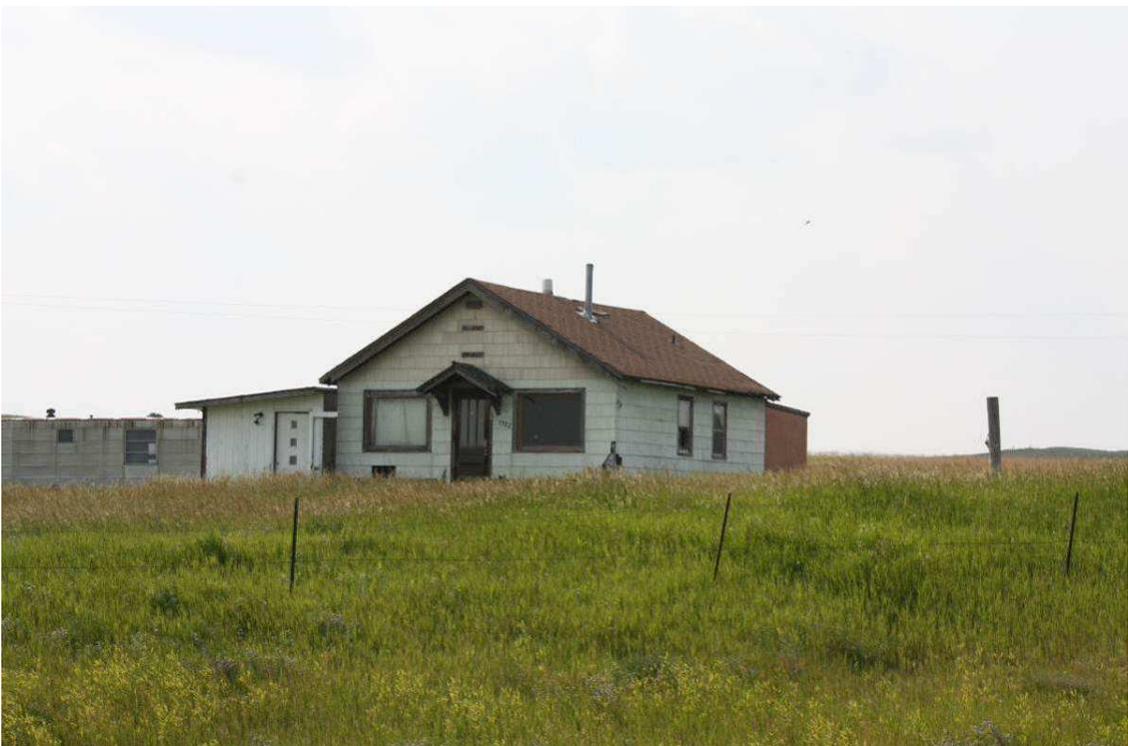
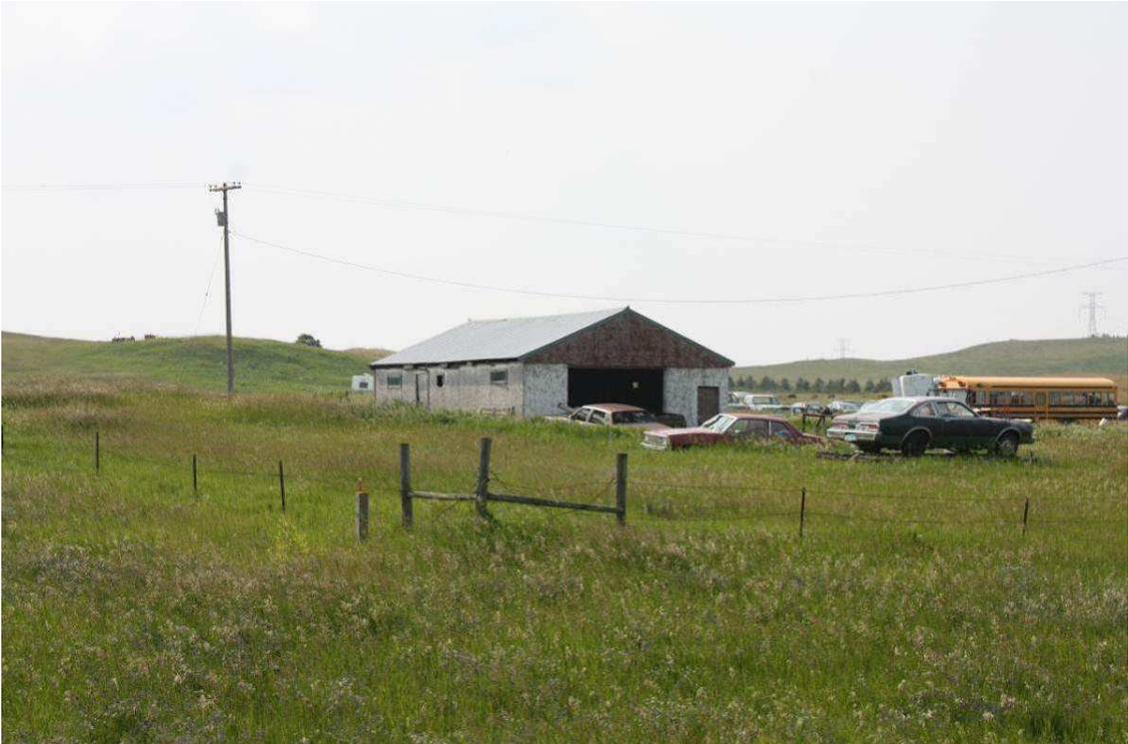
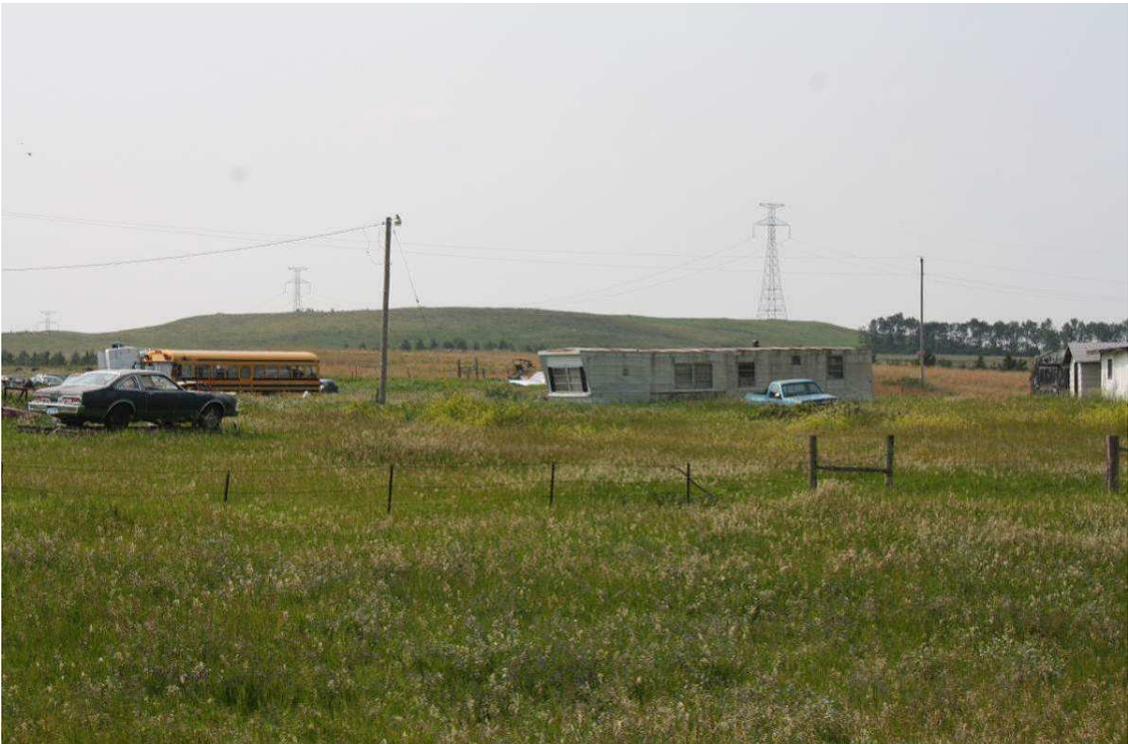
Photograph 63 -- Looking northwest at Tt 15. (July 9, 2014)

Photograph 64 -- Looking southwest at Tt 15. (July 9, 2014)

Photograph 65 -- Looking northwest at Tt 15. (July 9, 2014)

Photograph 66 -- Looking northwest at Tt 15. (July 9, 2014)

Tt 15 is a historic farmstead located in the southeast quarter of the southeast quarter of Section 2, Township 142N, Range 77W. While maps including the 1969 Directory Services plat map do not show buildings on this site, features of the house located here, such as the transite siding and 3/1 double-hung windows on the north side, suggest that it is more than 45 years old.

The property retains integrity of location, setting, and materials. However, the addition of a concrete block outbuilding and a trailer house diminishes the integrity of design, workmanship, and feeling. Additionally, it is not known to be associated with any historic events important to local, state or national history (Criterion A), does not have significant or unusual architecture (Criterion C), nor is it thought to have significant potential to yield historical information (Criterion D). Further research may yield information about those who lived here; at this time no association with a significant historical figure is known (Criterion B). This farmstead is recommended by Tetra Tech as not eligible for listing in the NRHP.
