1. Manuscript Number:
2. SHPO Reference #: 14-0606
3. Author: James Sexton, Ph. D.
4. Title: Wilton IV Wind Energy Center: A Class II Architectural Inventory In Burleigh County, North Dakota (Addendum)
5. Report Date: August 2014
6. Number of Pages: 77
7. Type: II
8. Acres: 22332 acres
9. Legal Location(s):

**Wilton IV Wind Energy Center:  
A Class II Architectural Reconnaissance Survey  
In Burleigh County, North Dakota  
(Addendum)**

**September 2014**

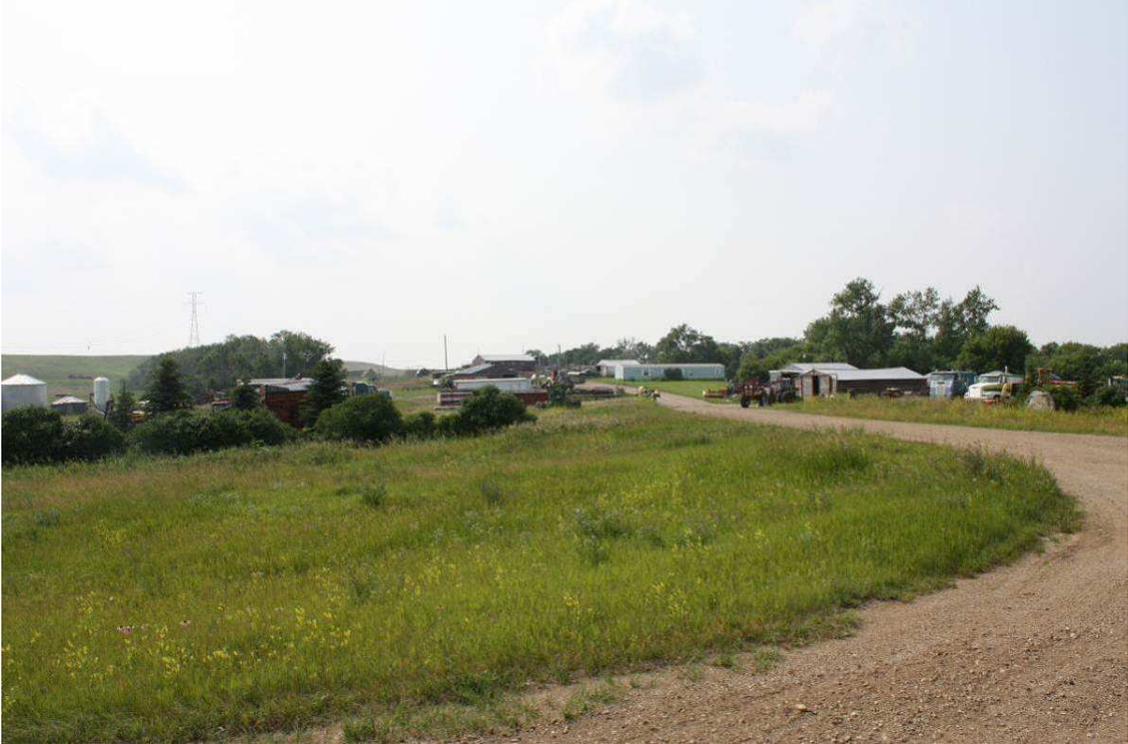
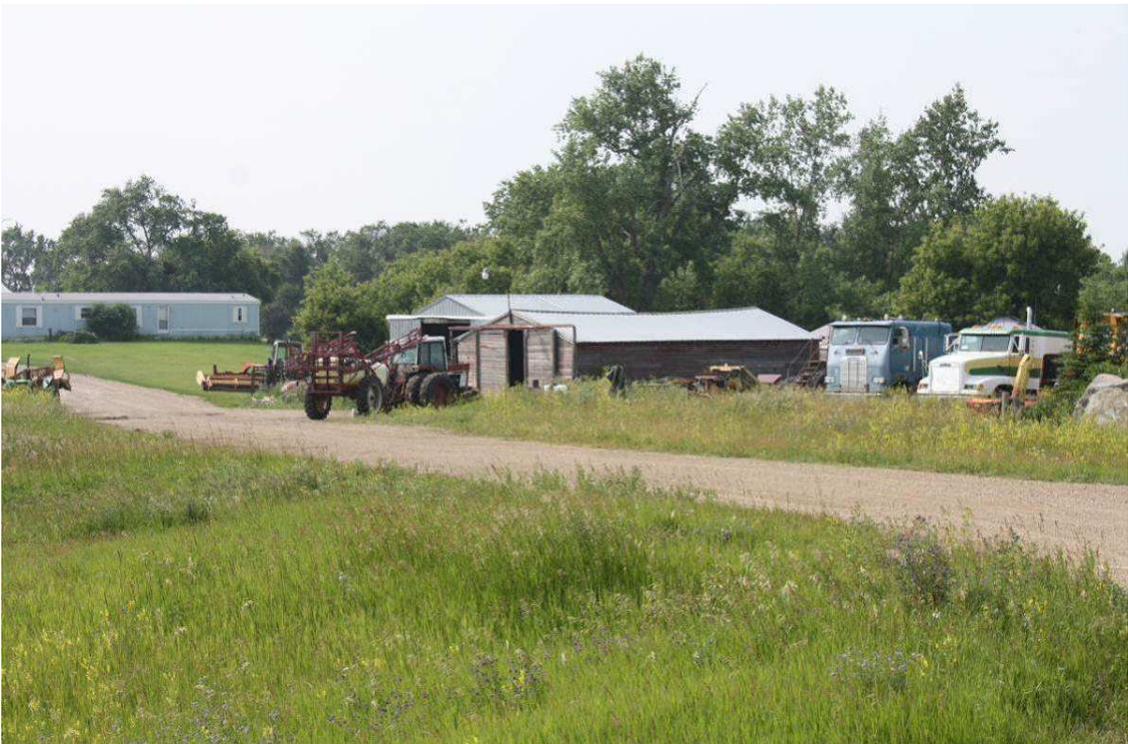
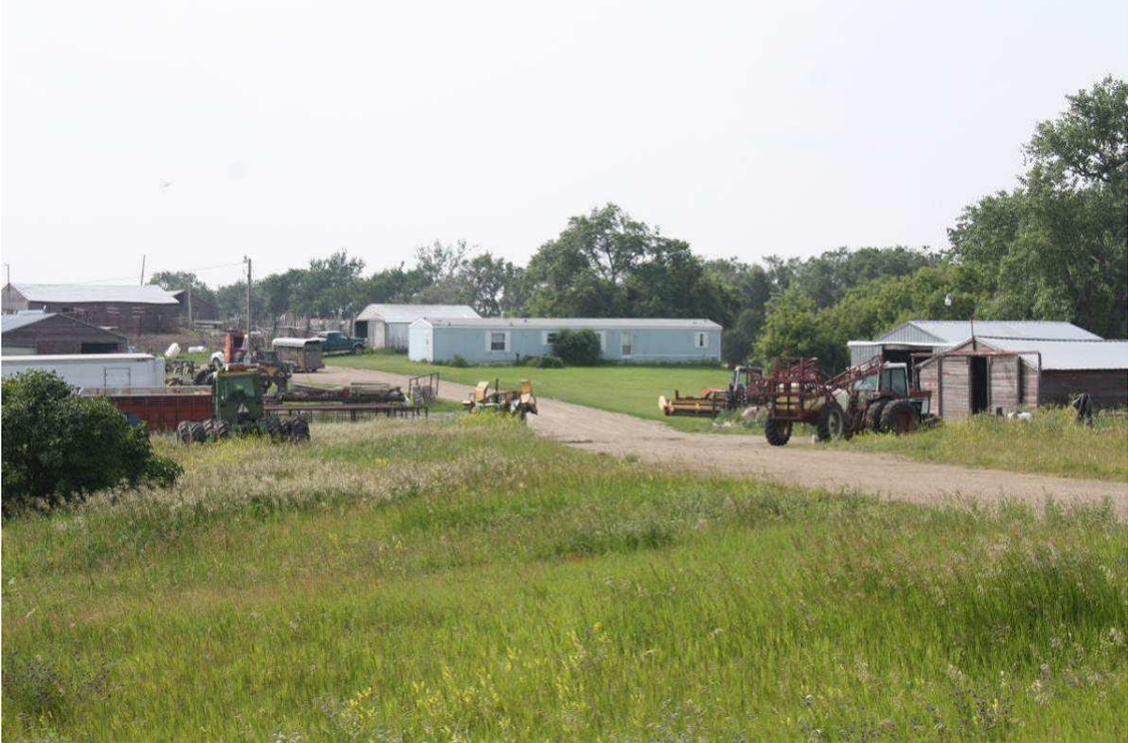
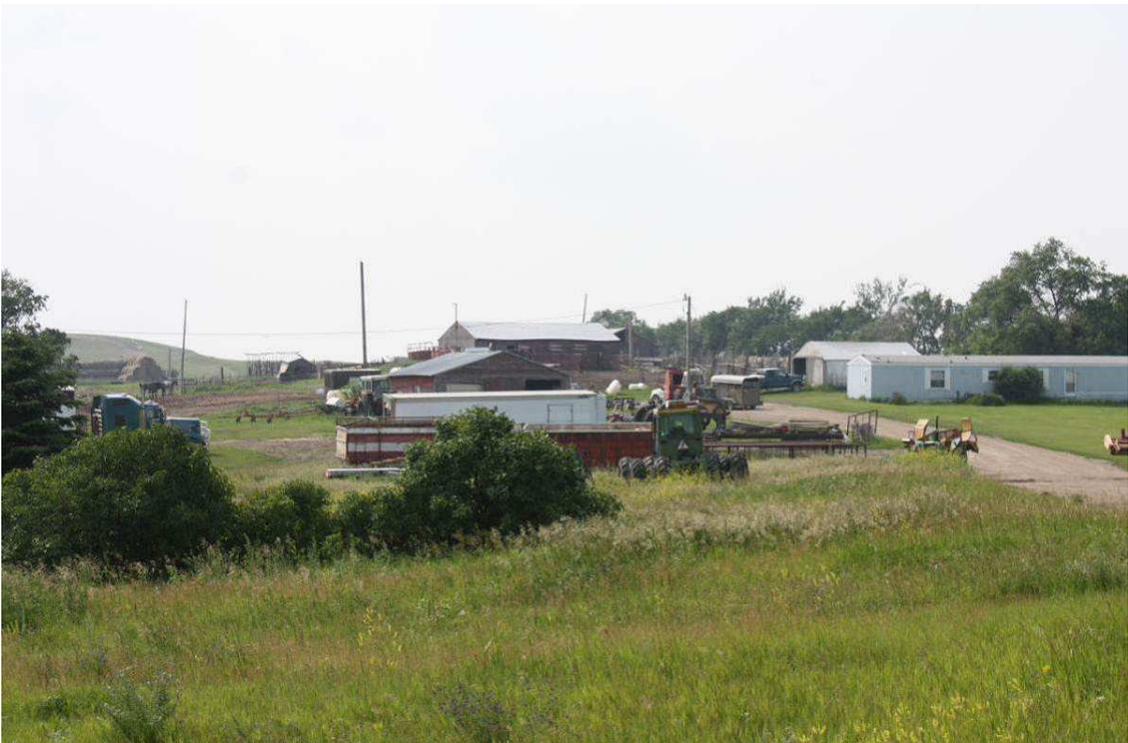
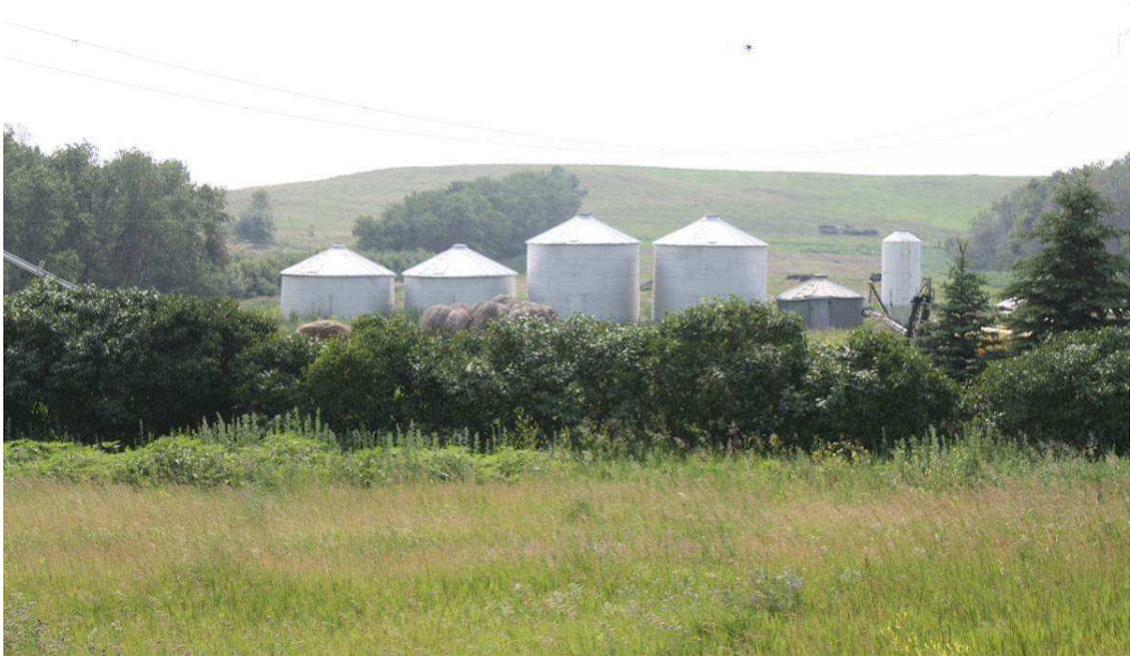
**Photograph 67 -- Looking west at Tt 16. (July 9, 2014)**

**Photograph 68 -- Looking west at Tt 16. (July 9, 2014)**

**Photograph 69 -- Looking west at Tt 16. (July 9, 2014)**

**Photograph 70 -- Looking west at Tt 16. (July 9, 2014)**

**Photograph 71 -- Looking west at Tt 16. (July 9, 2014)**

The property retains integrity of location and setting. However, the apparent removal of the main house and its replacement by a trailer house, along with the state of disrepair of many of the outbuildings, diminishes the integrity of materials, design, workmanship, and feeling. Additionally, it is not known to be associated with any historic events important to local, state or national history (Criterion A), does not have significant or unusual architecture (Criterion C), nor is it thought to have significant potential to yield historical information (Criterion D). Further research may yield information about those who lived here; at this time no association with a significant historical figure is known (Criterion B). This farmstead is recommended by Tetra Tech as not eligible for listing in the NRHP.

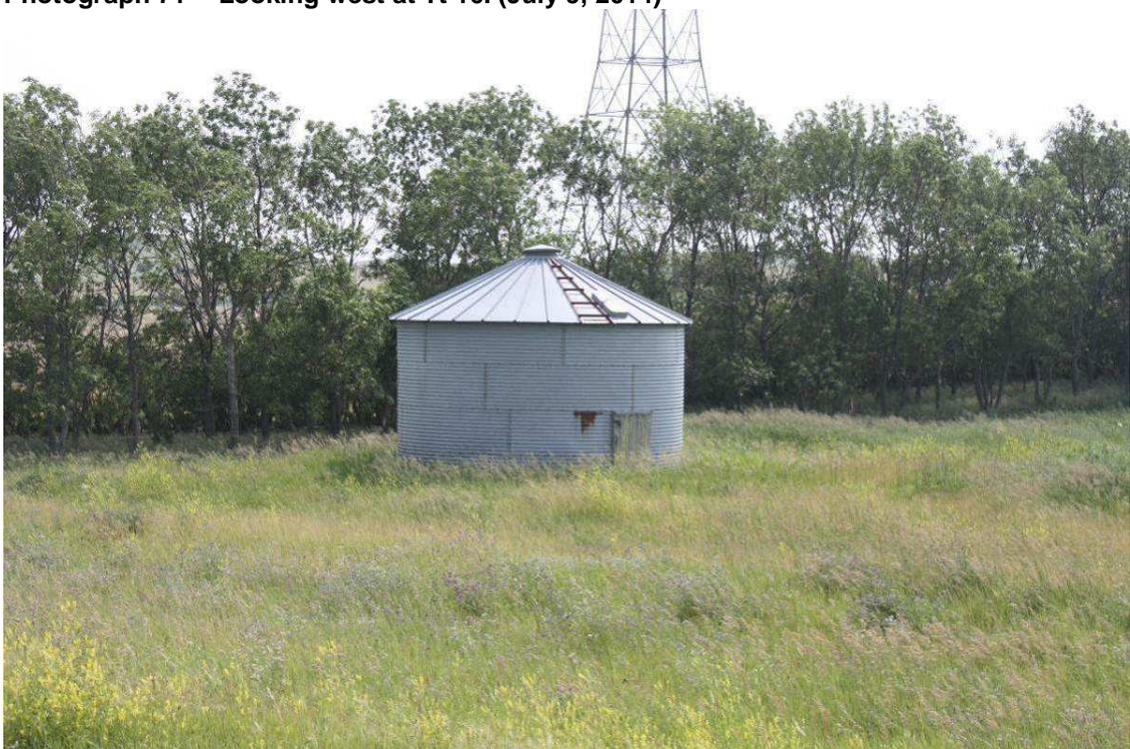
**Photograph 72 -- Looking west at Tt 16. (July 9, 2014)**

Tt 16 is a historic farmstead located in the northeast quarter of the southeast quarter of Section 2, Township 142N, Range 77W. Buildings have appeared in this location since prior to 1912, when the George Ogle plat map showed "Jane O. Mathison" owning this quarter section with a residence upon it. By 1969 the land was the residence of Fred Bittner.

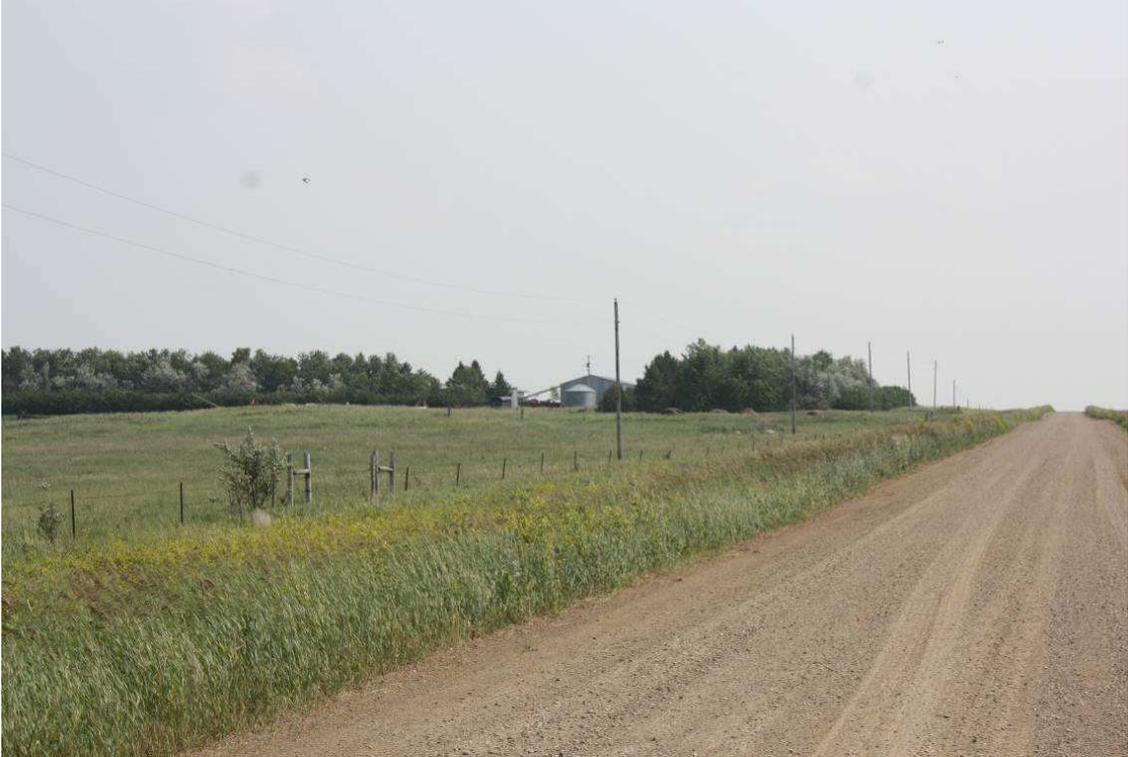
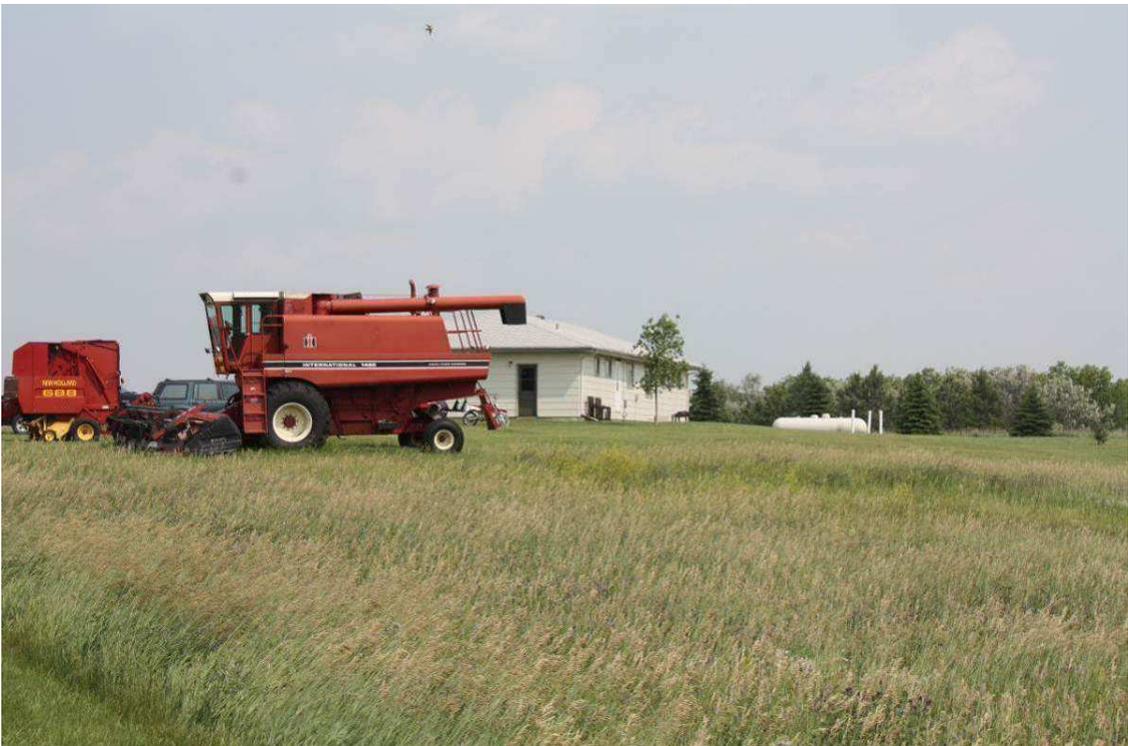
**Photograph 73 -- Looking south at Tt 17. (July 8, 2014)**

Photograph 76 -- Looking east at Tt 17. (July 9, 2014)

Tt 17 is a modern farmstead located in the southwest quarter of the northwest quarter of Section 7, Township 142, Range 76W. No buildings occur in this location in the 1969 plat map; an examination from the public right-of-way confirmed that the buildings do not appear to be 50 years old or older. The farmstead is recommended as not eligible for listing in the NRHP because all of the buildings appear to be too recent to meet the age requirement for listing in the NRHP.

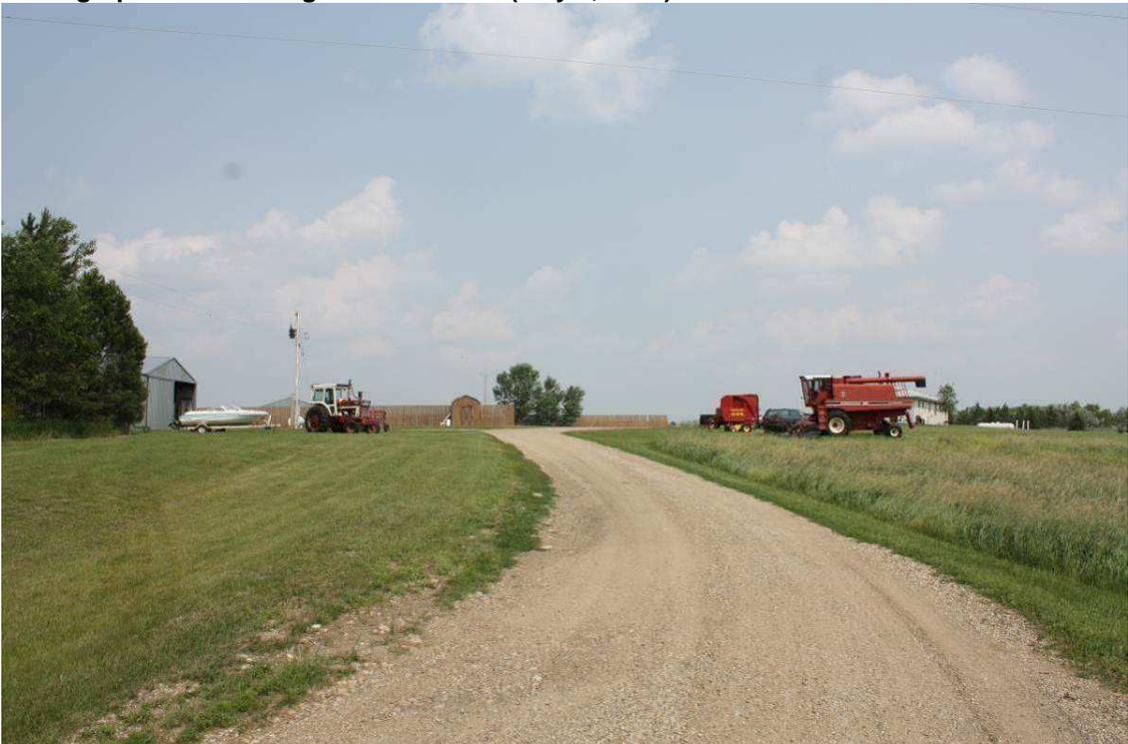
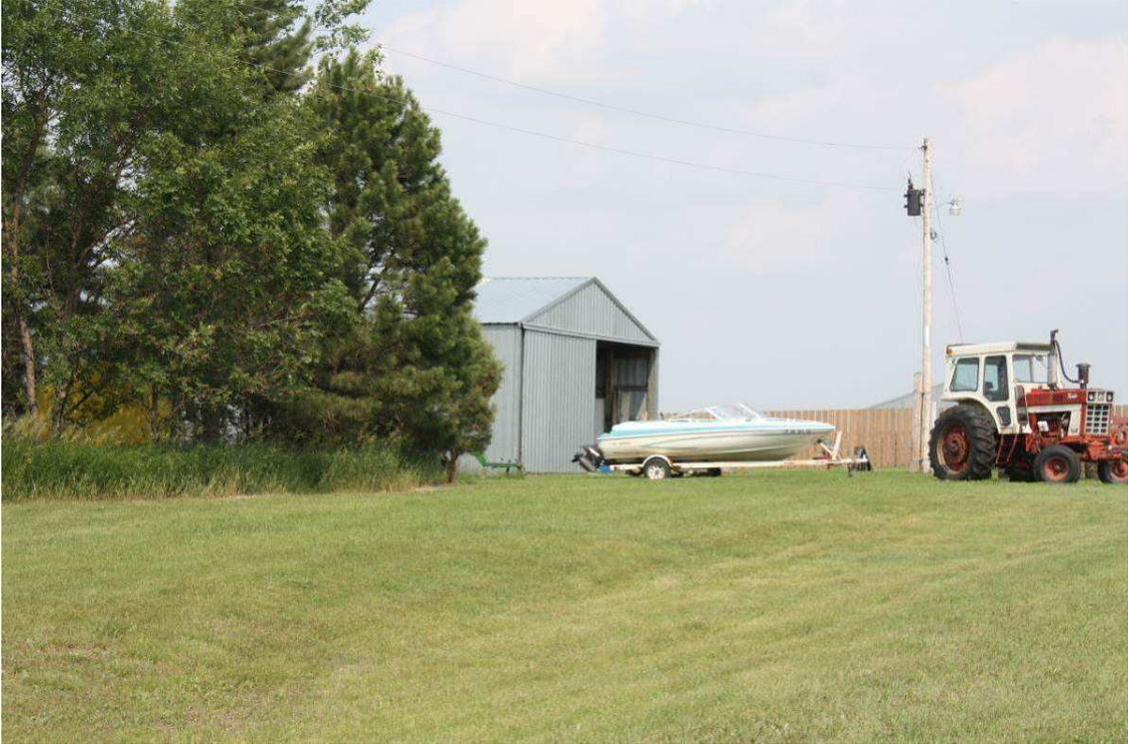
**Photograph 74 -- Looking east at Tt 17. (July 9, 2014)**

Photograph 75 -- Looking east at Tt 17. (July 9, 2014)

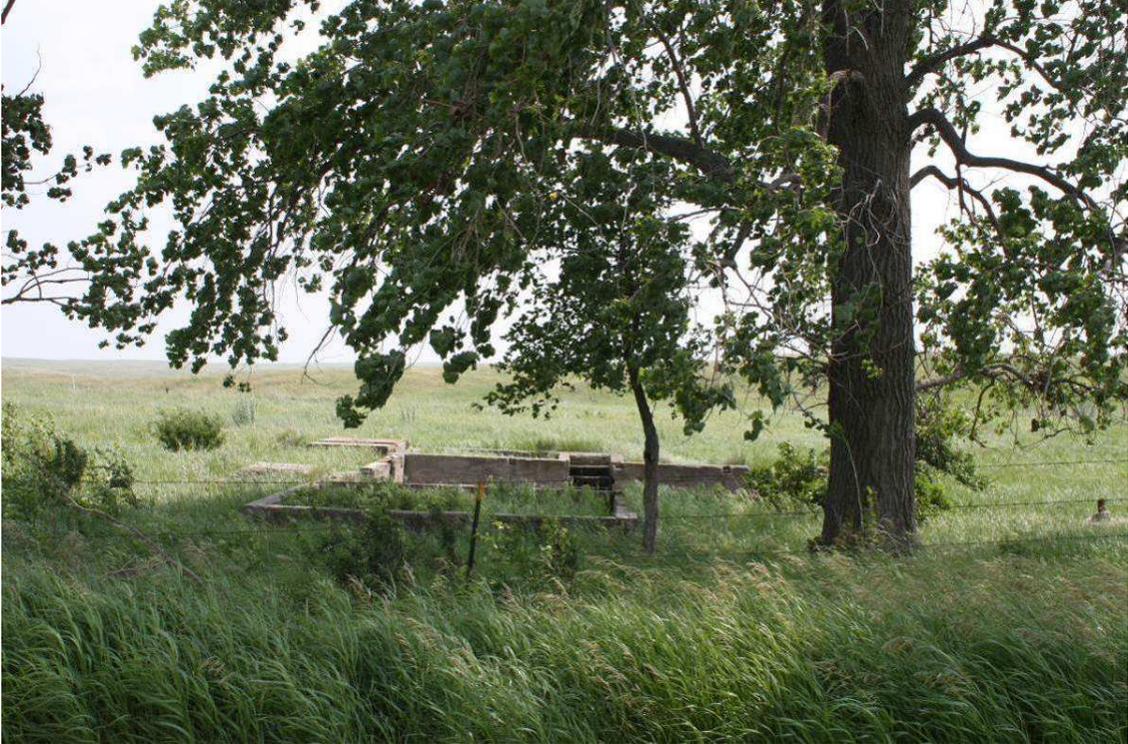
**Photograph 77 -- Looking south at Tt 18. (July 9, 2014)**

Tt 18 is a historic farmstead located in the southeast quarter of the southwest quarter of Section 24, Township 143N, Range 77W. Buildings have appeared in this location since prior to the 1969 Directory Services plat map which showed “Andrew Huff” owning a residence in this location.

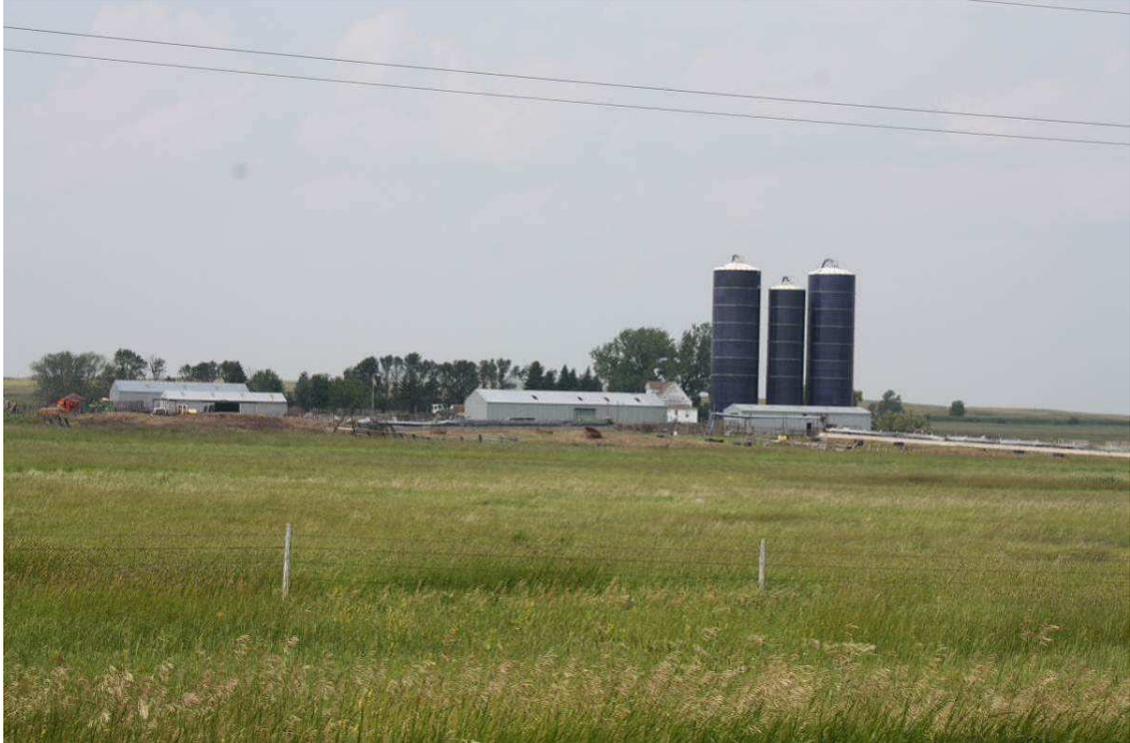
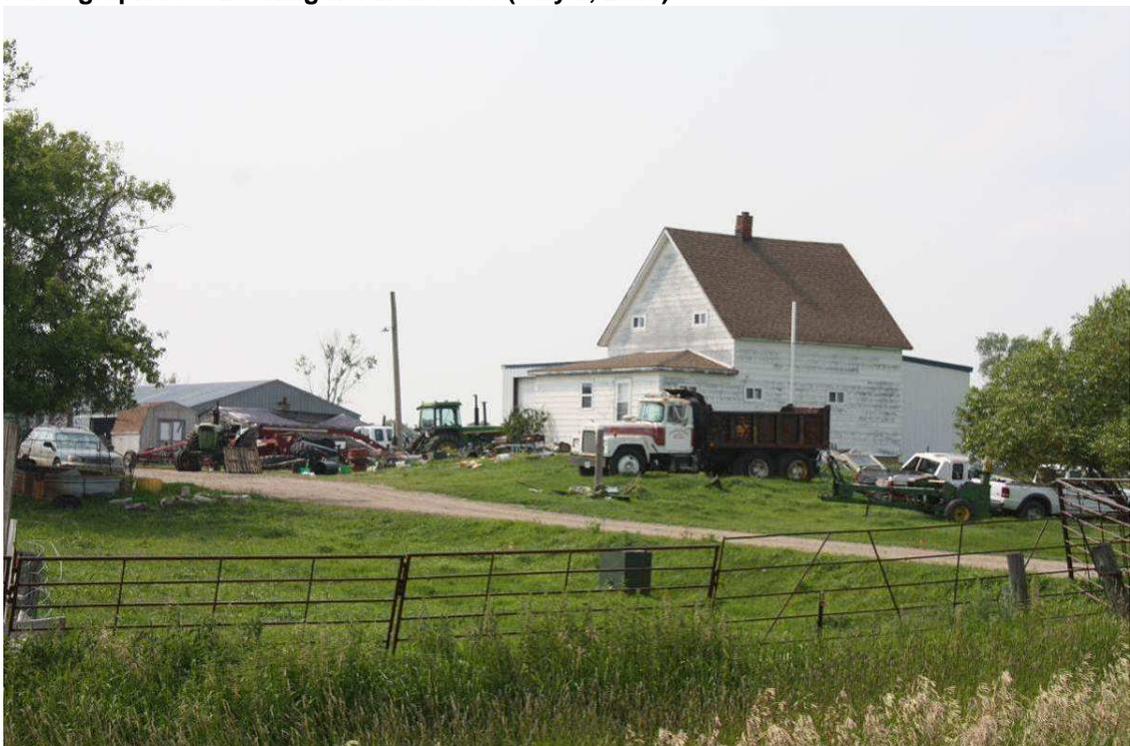
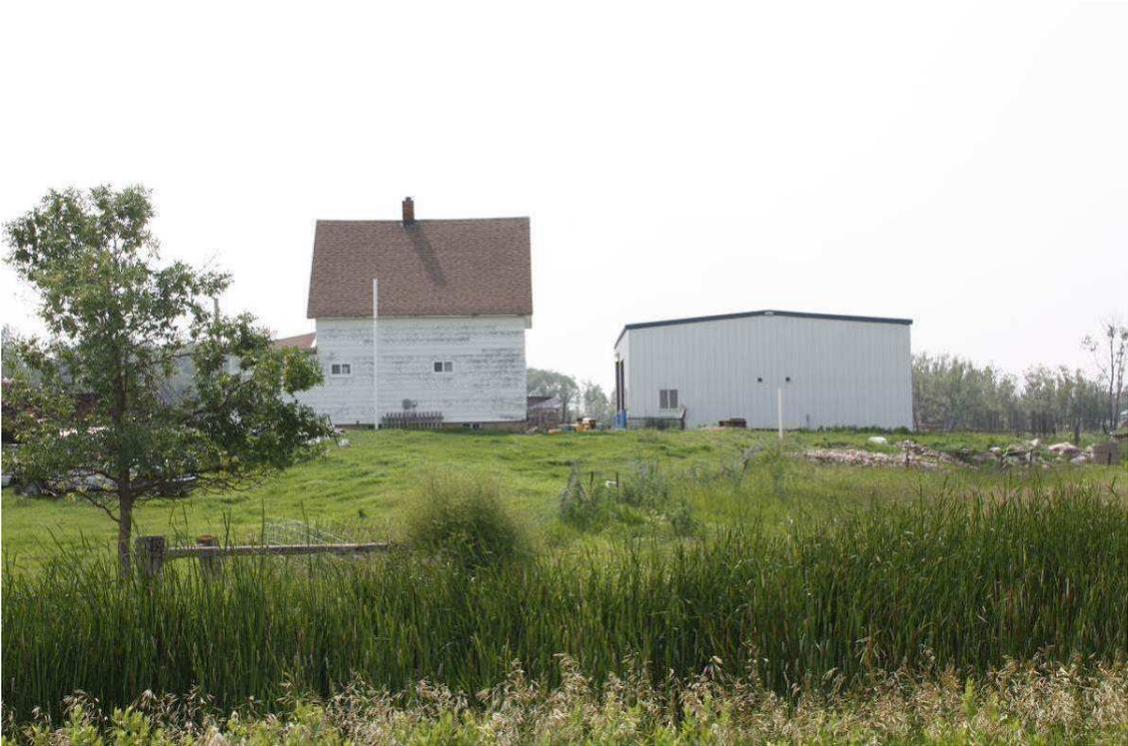
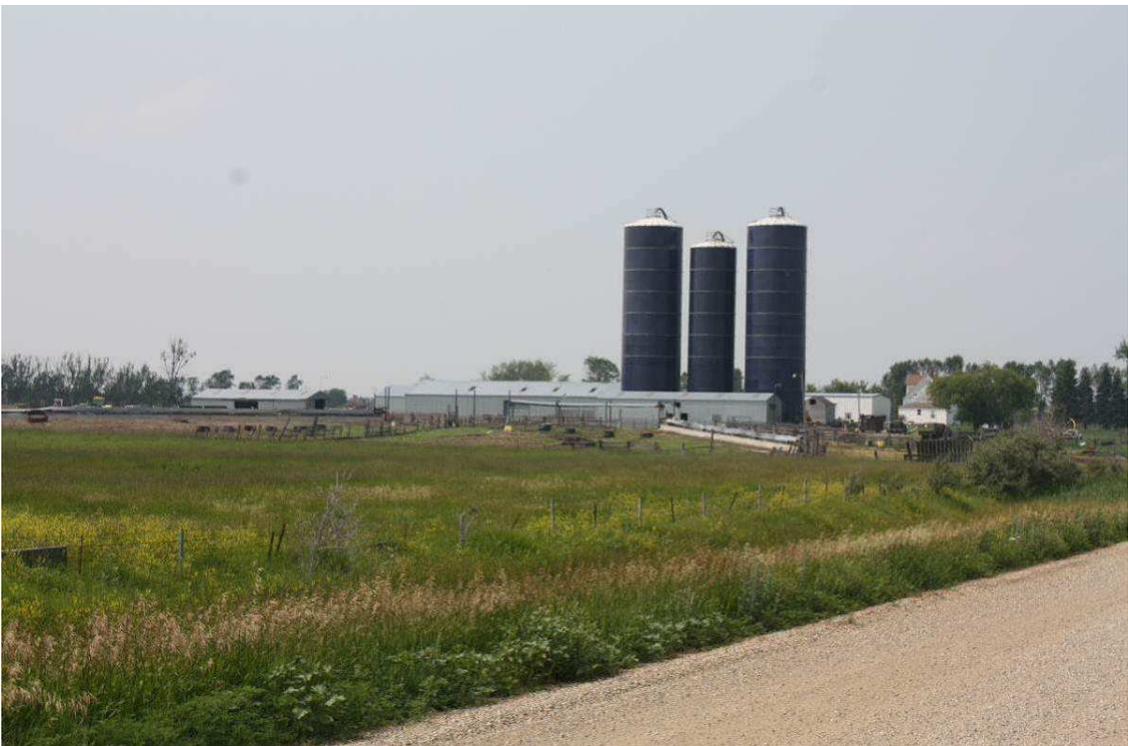
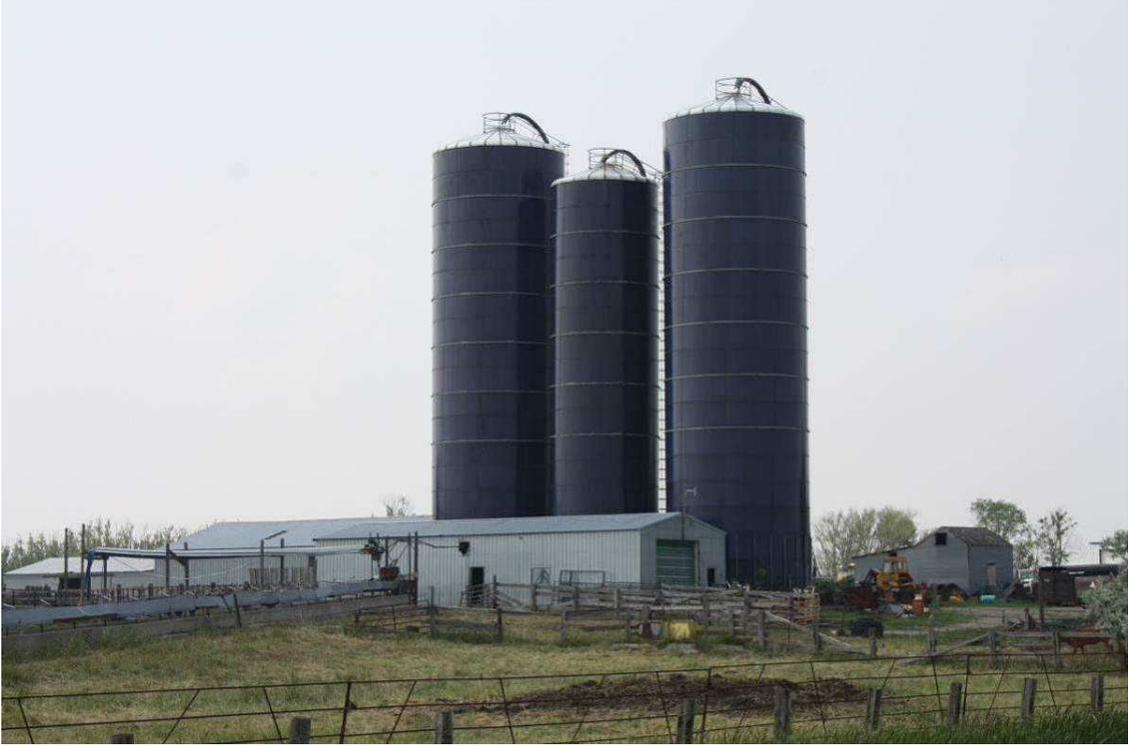
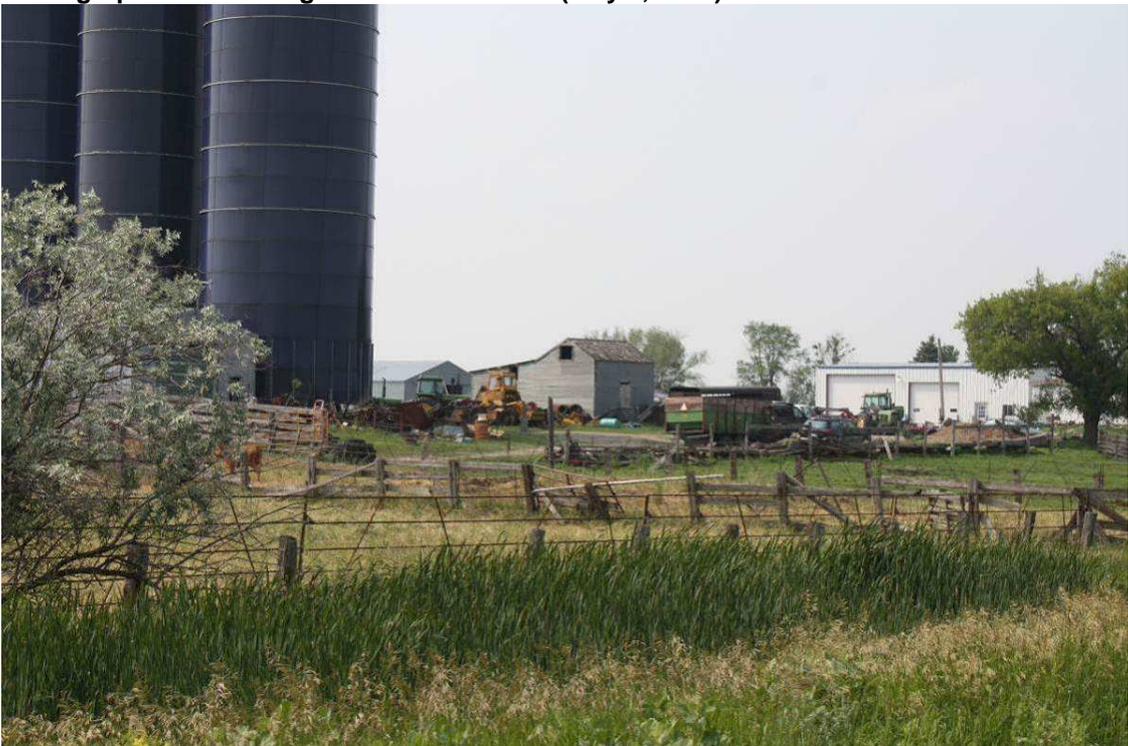
Photograph 78 -- Looking north at Tt 19. (July 8, 2014)

Photograph 79 -- Looking northwest at Tt 19. (July 8, 2014)

Photograph 80 -- Looking west at Tt 19. (July 8, 2014)

Photograph 81 -- Looking northwest at Tt 19. (July 8, 2014)

**Photograph 82 – Looking northwest at Tt 19. (July 9, 2014)**

**Photograph 83 -- Looking northwest at Tt 19. (July 9, 2014)**

Tt 19 is a historic farmstead located in the northeast quarter of the southeast quarter of Section 6, Township 142N, Range 76W. Buildings have appeared in this location since at least 1912, when the George Ogle plat map showed "A. A. Leavitts" owning a residence on this quarter section. In 1969 it was owned by Theodore Fischer.

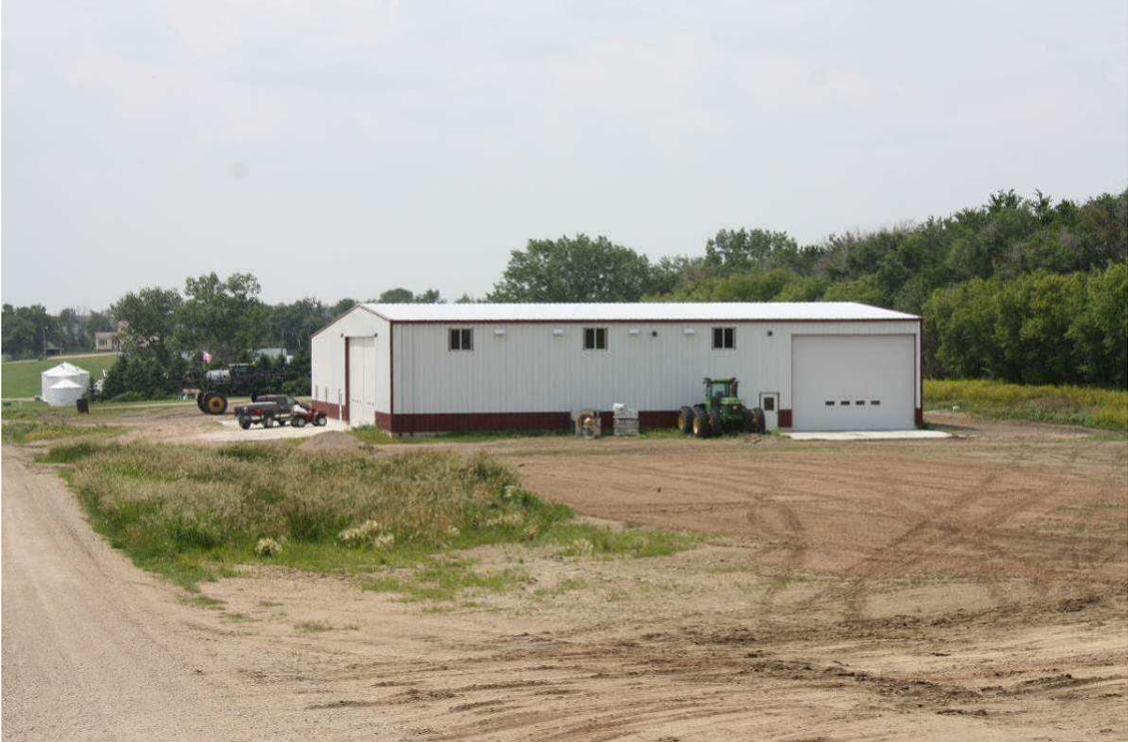
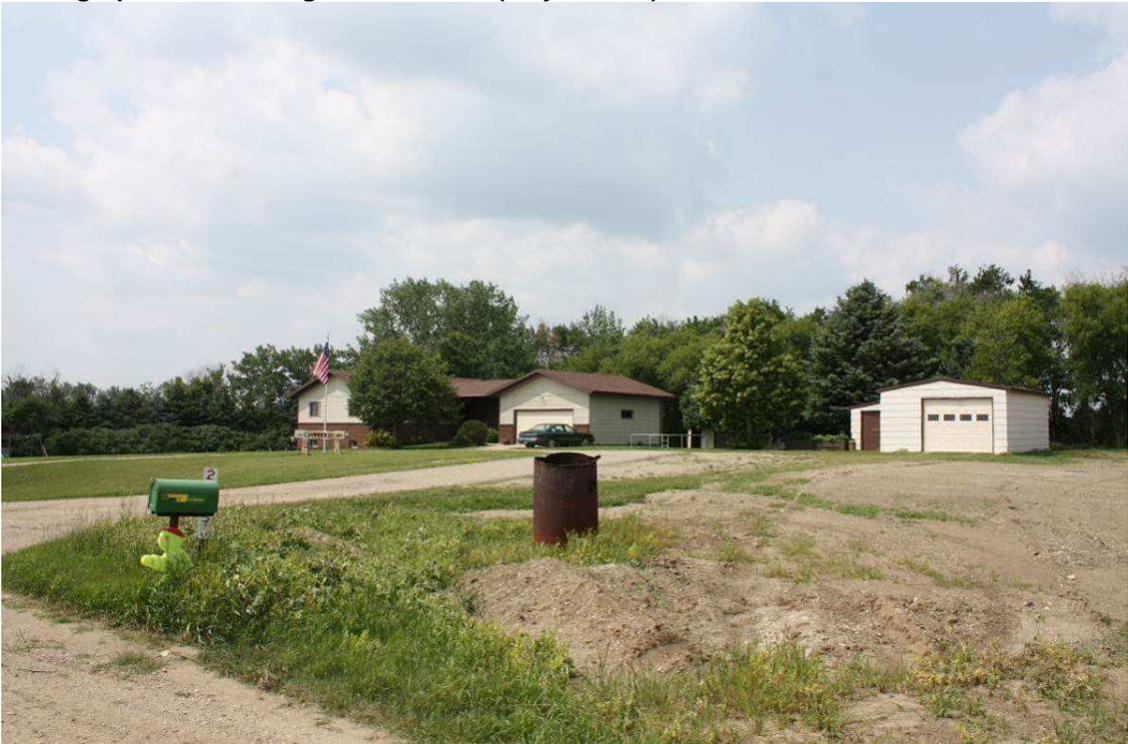
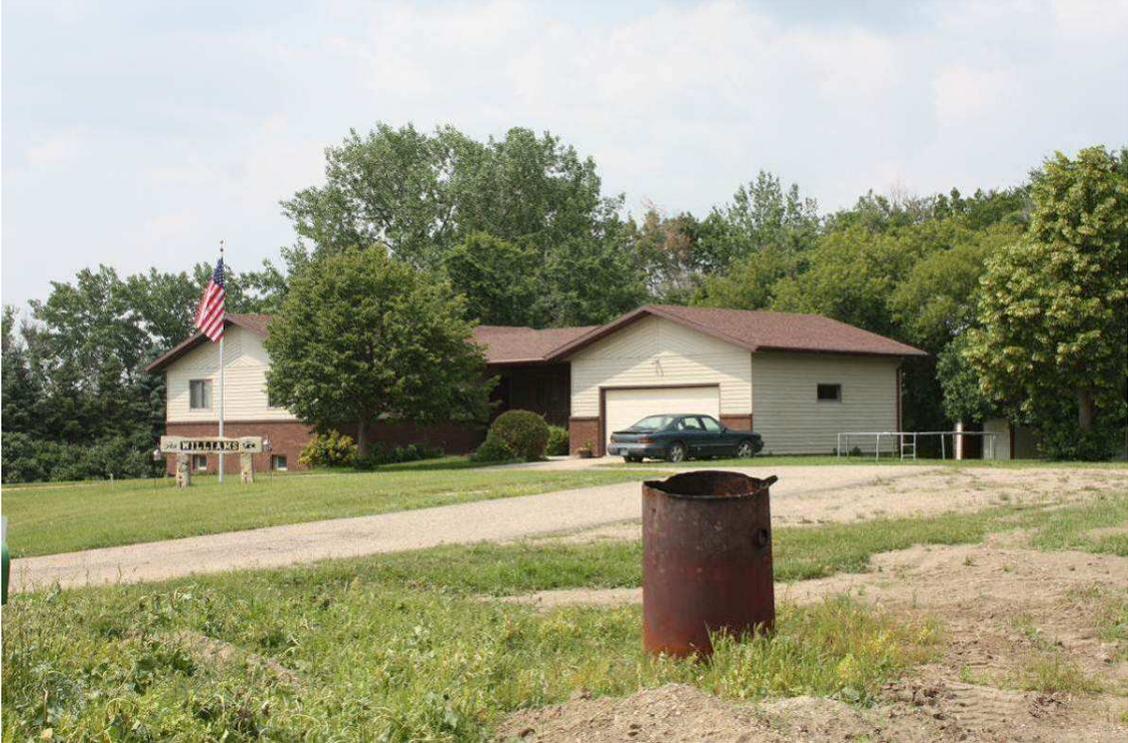
**Photograph 84 -- Looking west at Tt 20. (July 8, 2014)**

**Photograph 85 -- Looking northwest at Tt 20. (July 8, 2014)**

Photograph 86 -- Looking northwest at Tt 20. (July 8, 2014)

Tt 20 is a modern farmstead located in the southeast quarter of the southeast quarter of Section 30, Township 143, Range 76W. No buildings occur in this location in the 1969 plat map; an examination from the public right-of-way confirmed that the buildings do not appear to be 50 years old or older. The farmstead is recommended as not eligible for listing in the NRHP because all of the buildings appear to be too recent to meet the age requirement for listing in the NRHP.

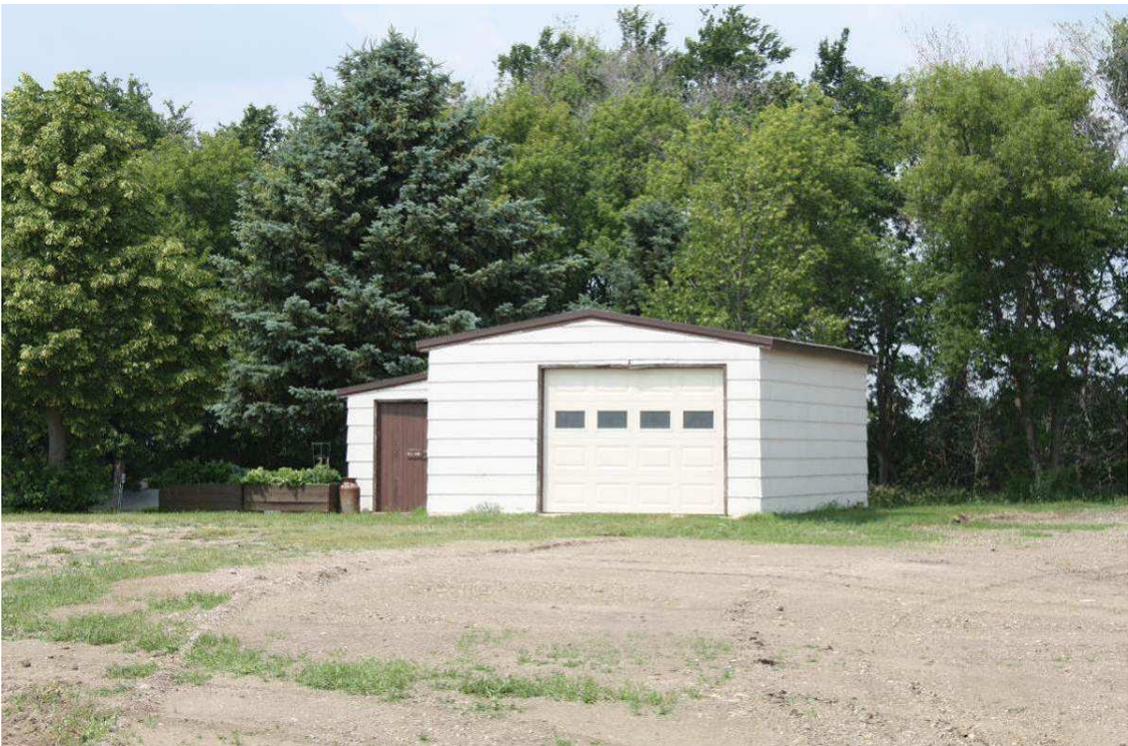
Photograph 87 -- Looking north at Tt 20. (July 8, 2014)
