1. Manuscript Number:
2. SHPO Reference #: 14-0606
3. Author: James Sexton, Ph. D.
4. Title: Wilton IV Wind Energy Center: A Class II Architectural Inventory In Burleigh County, North Dakota (Addendum)
5. Report Date: August 2014
6. Number of Pages: 77
7. Type: II
8. Acres: 22332 acres
9. Legal Location(s):

**Wilton IV Wind Energy Center:  
A Class II Architectural Reconnaissance Survey  
In Burleigh County, North Dakota  
(Addendum)**

**September 2014**

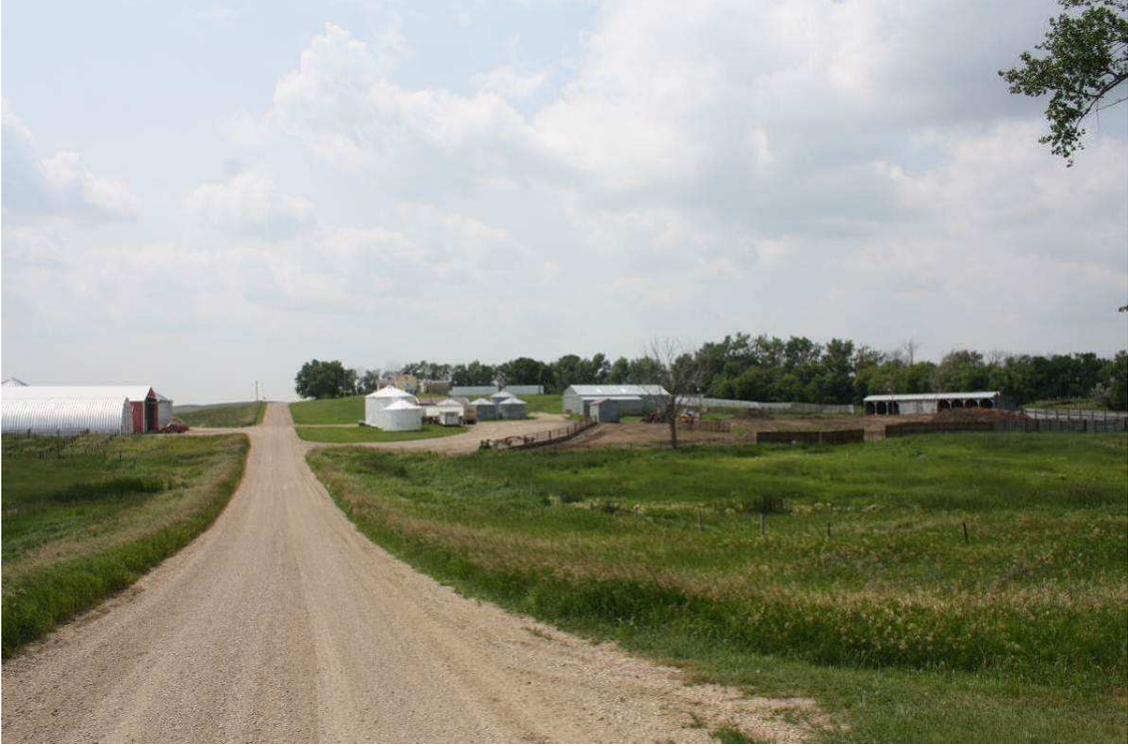
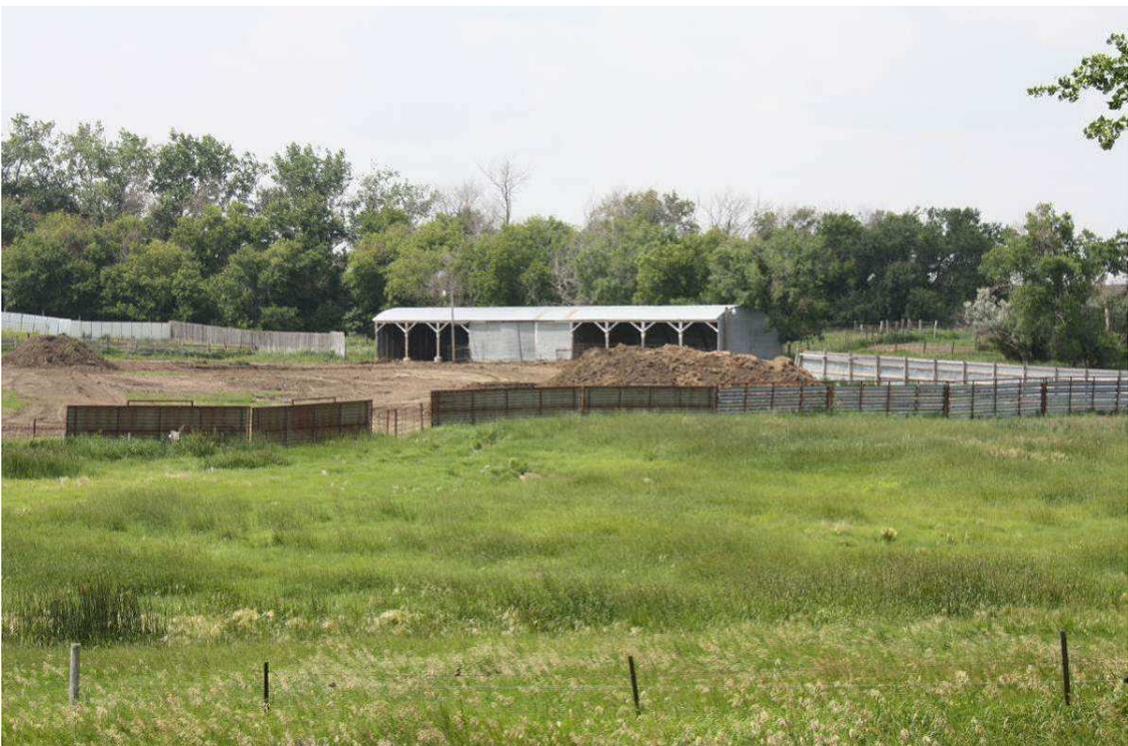
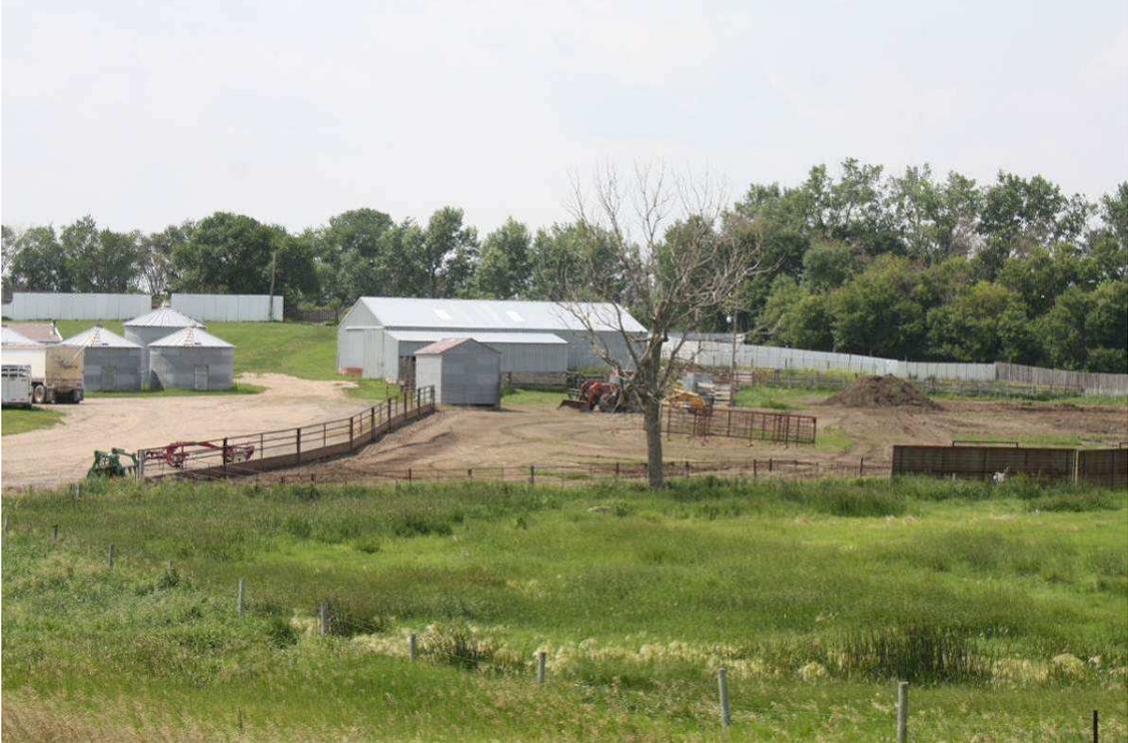
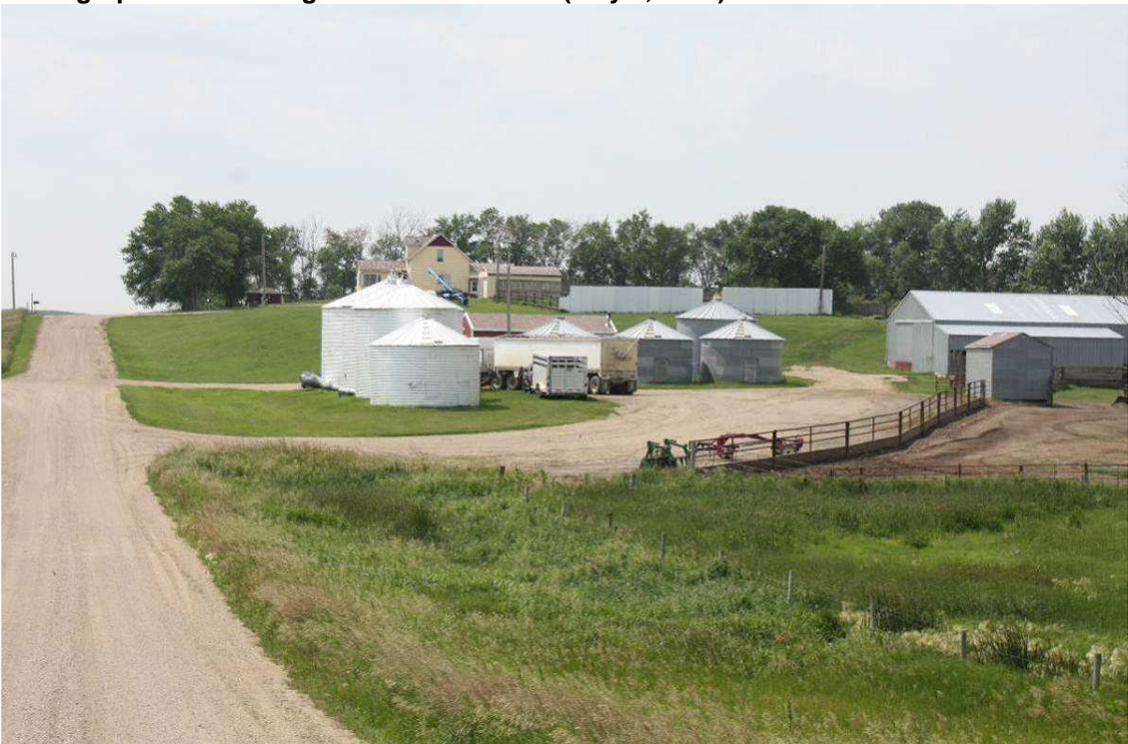
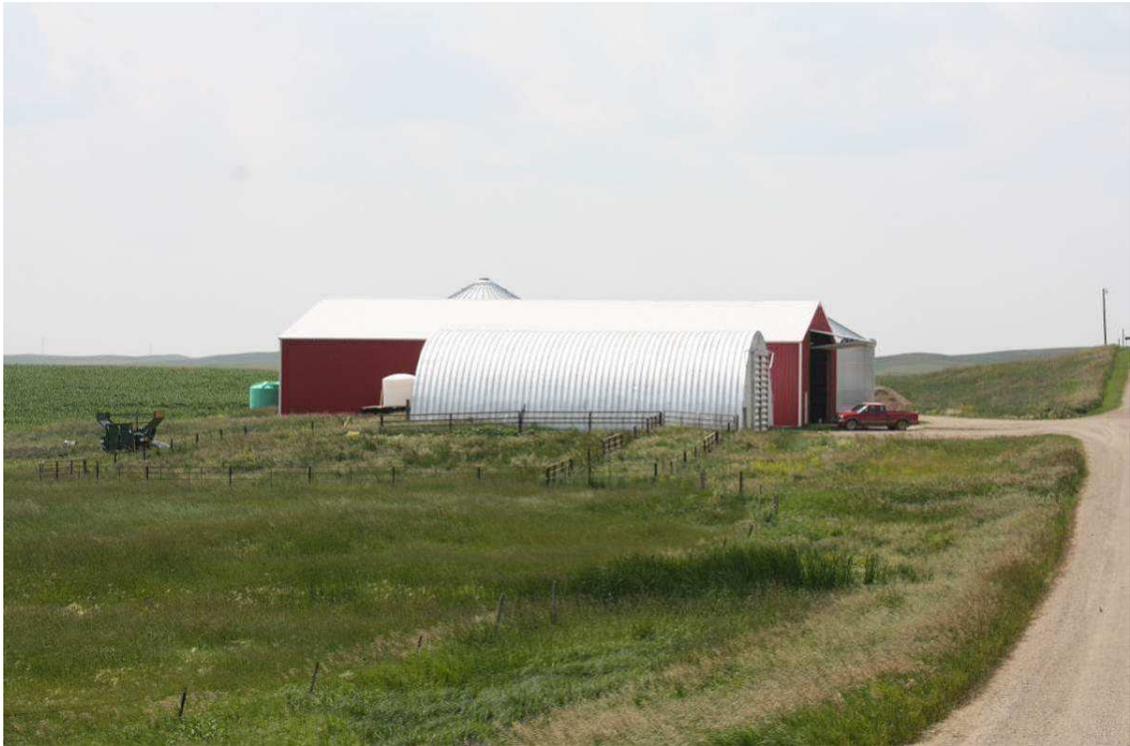
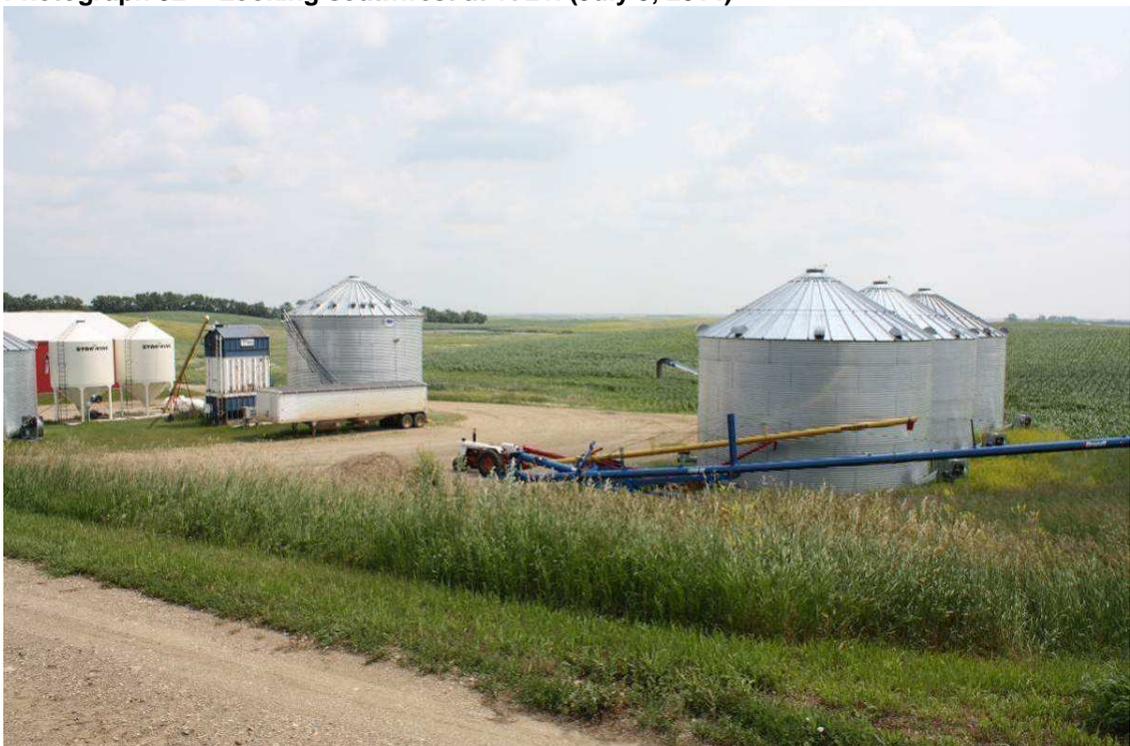
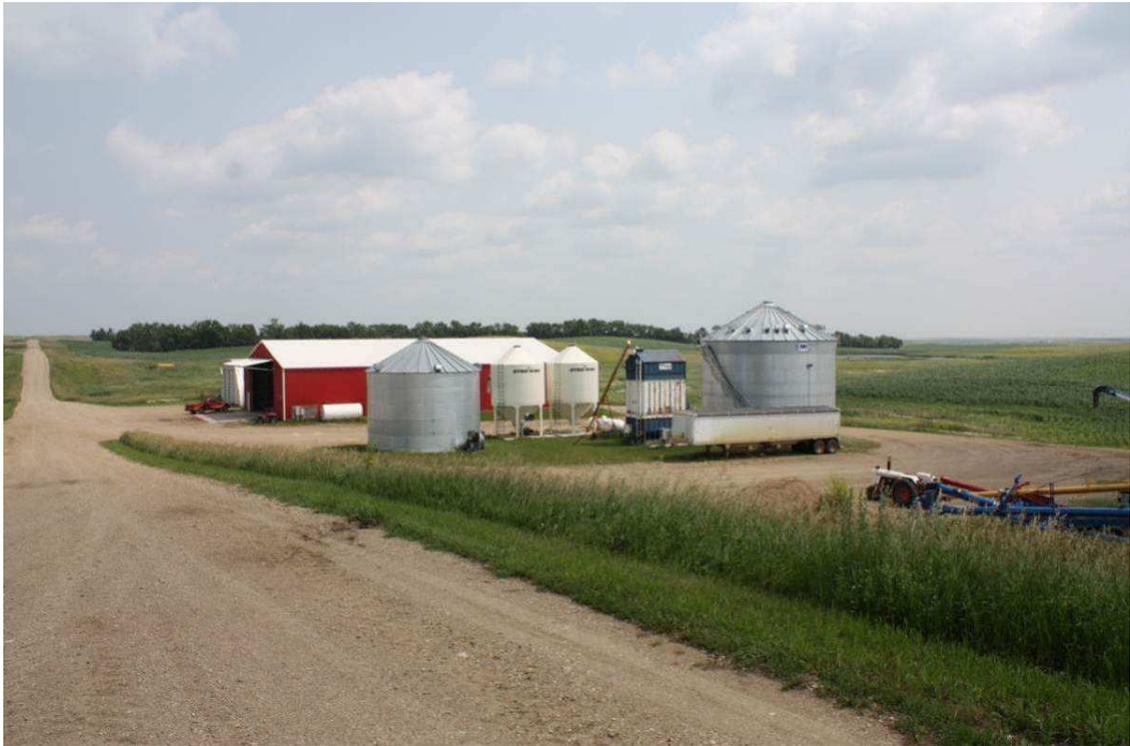
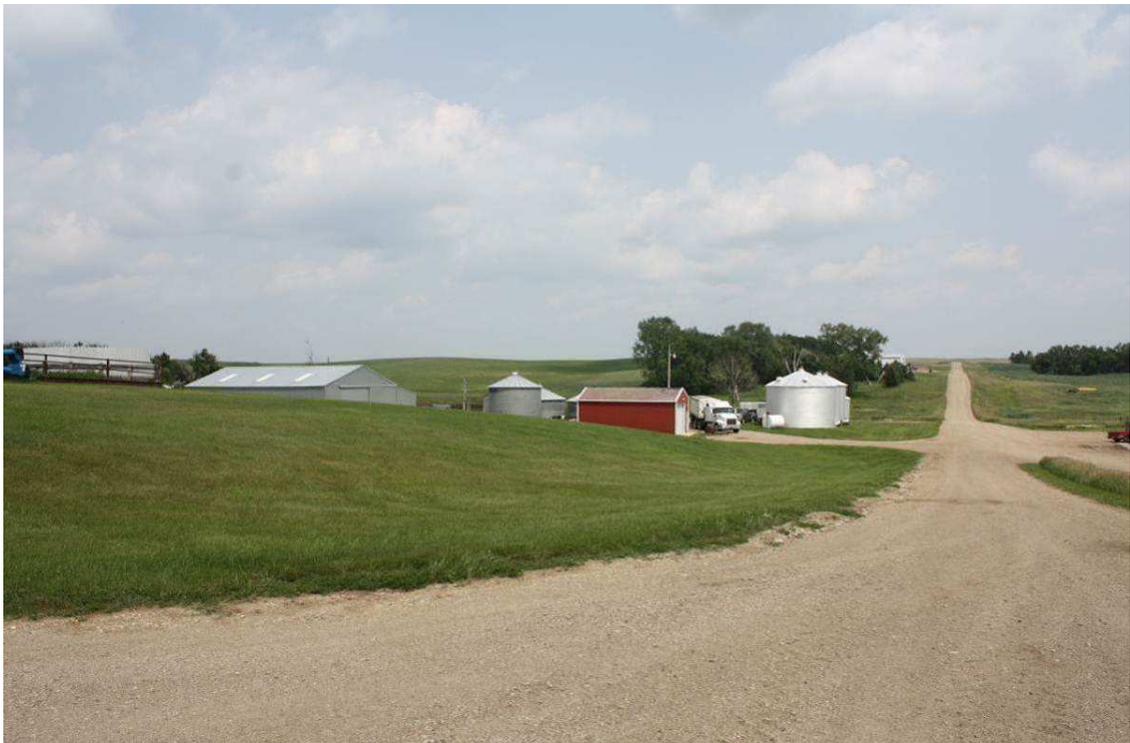
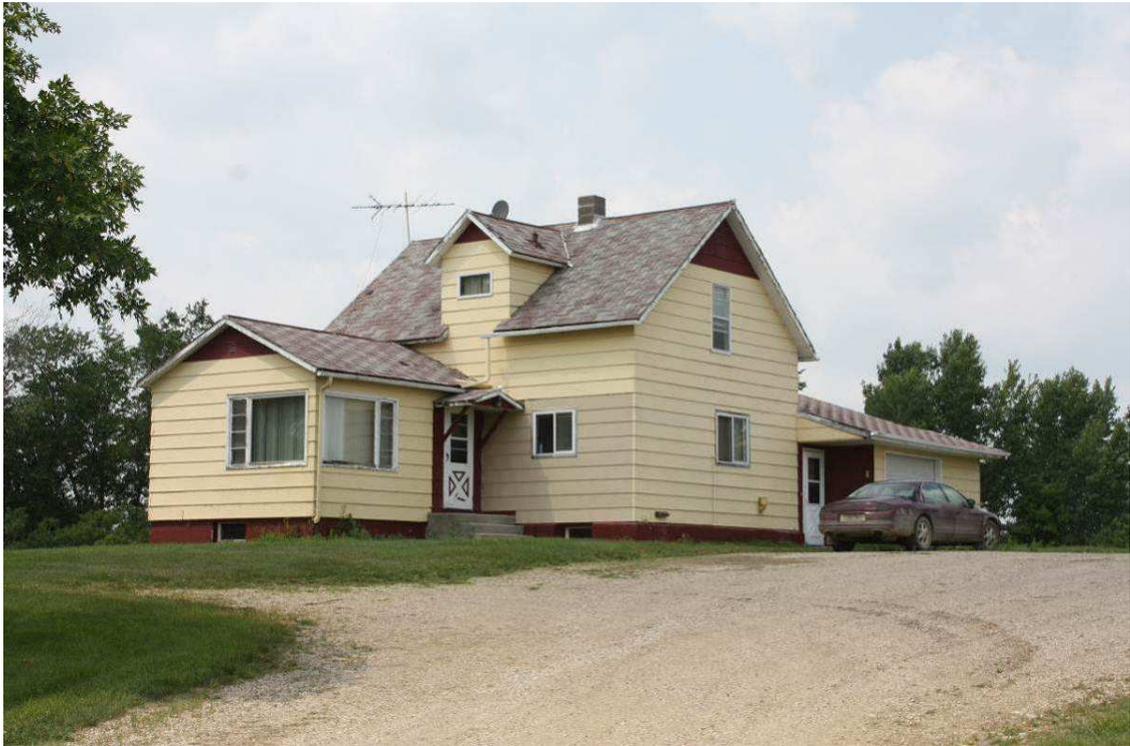
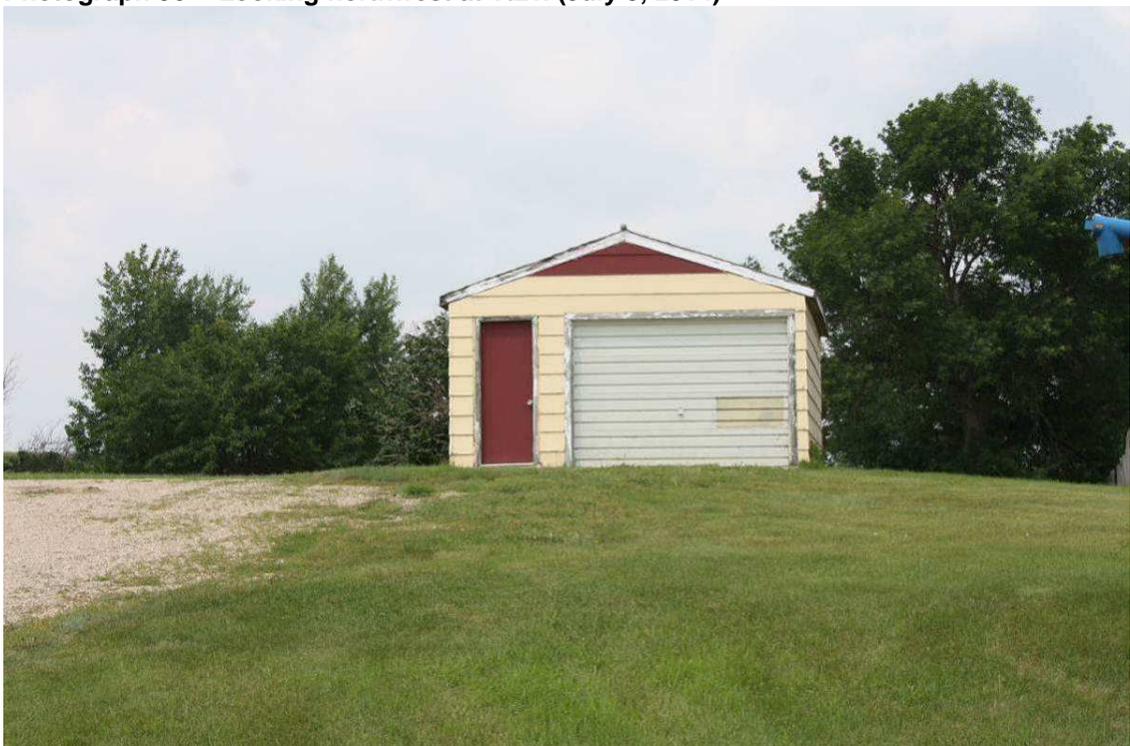
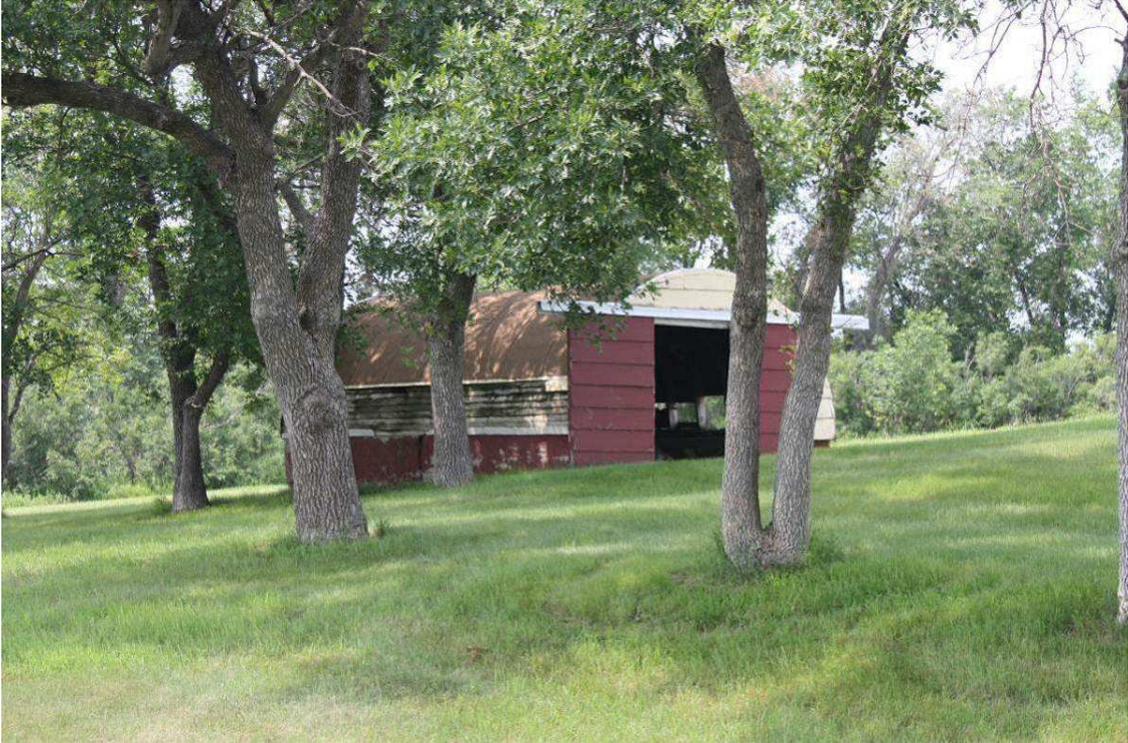
**3.1.21 Property Tt 21**

Tt 21 is a historic farmstead located in the southwest quarter of the southeast quarter of Section 30, Township 143N, Range 30W. Buildings have appeared in this location since prior to the Directory Services plat map of 1969, which shows "Harold Williams" owning a residence in this quarter section.

The property retains integrity of location and setting. However, the introduction of a large number of modern outbuildings diminishes the integrity of design, workmanship, materials, and feeling. Additionally, it is not known to be associated with any historic events important to local, state or national history (Criterion A), does not have significant or unusual architecture (Criterion C), nor is it thought to have significant potential to yield historical information (Criterion D). Further research may yield information about those who lived here; at this time no association with a significant historical figure is known (Criterion B). This farmstead is recommended by Tetra Tech as not eligible for listing in the NRHP.

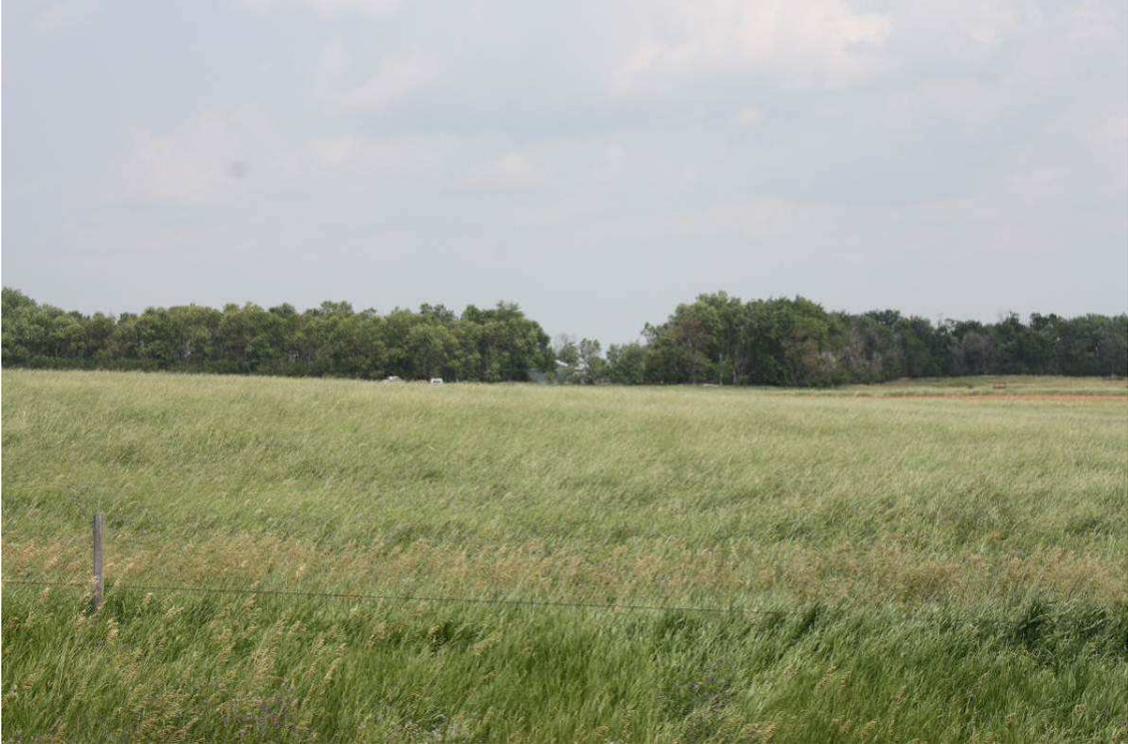
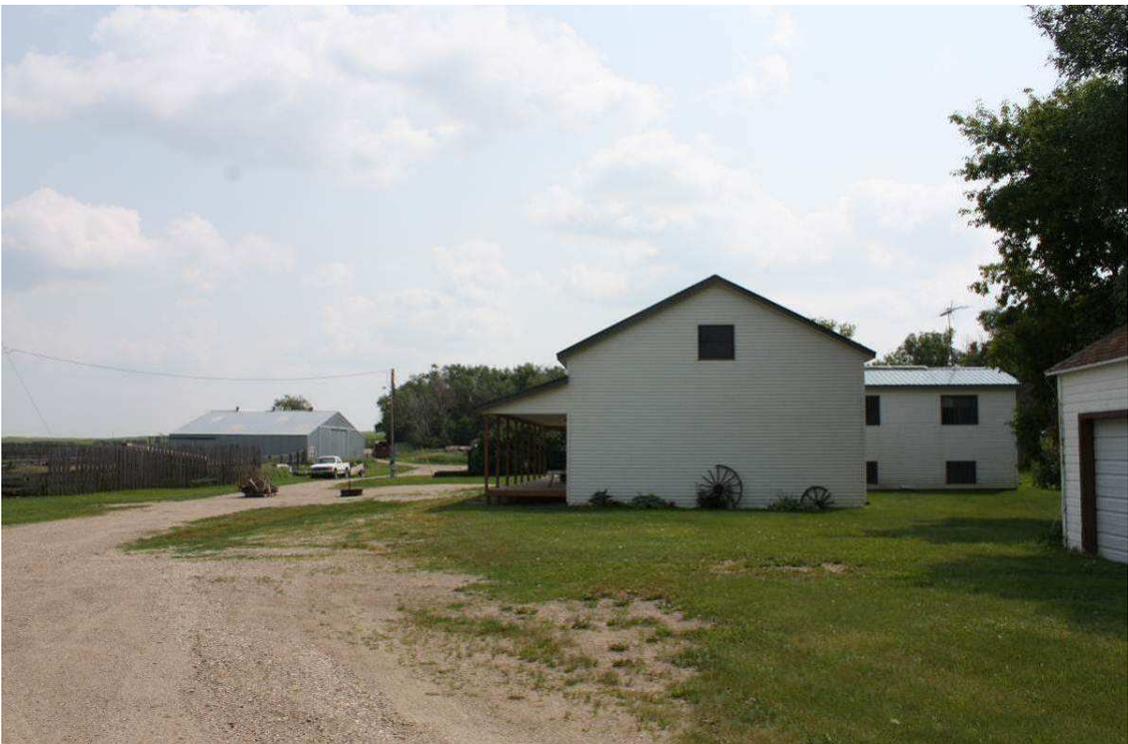
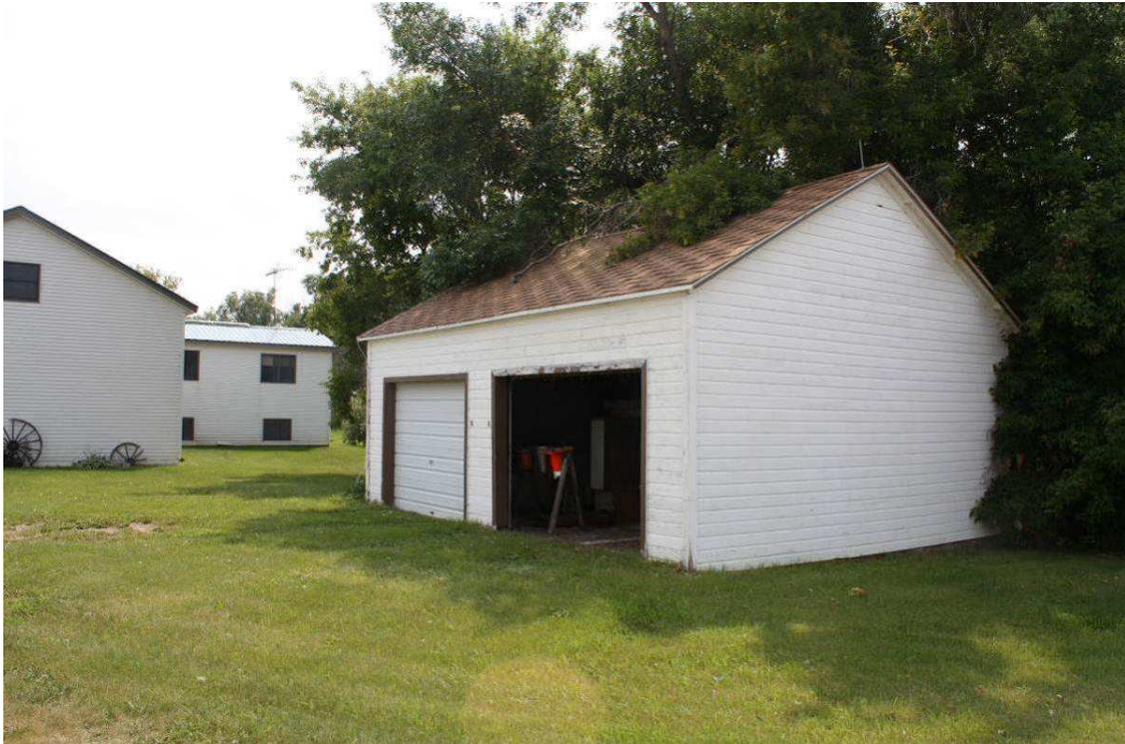
**3.1.22 Property Tt 22**

Tt 22 is a historic farmstead located in the northeast quarter of the northwest quarter of Section 20, Township 143N, Range 76W. Buildings have appeared in this location since prior to the George Ogle plat map of 1912, which shows “C.J. Rhoads” owning a residence in this location. On the 1969 Directory Services plat map, the property is owned by Henry Hein.

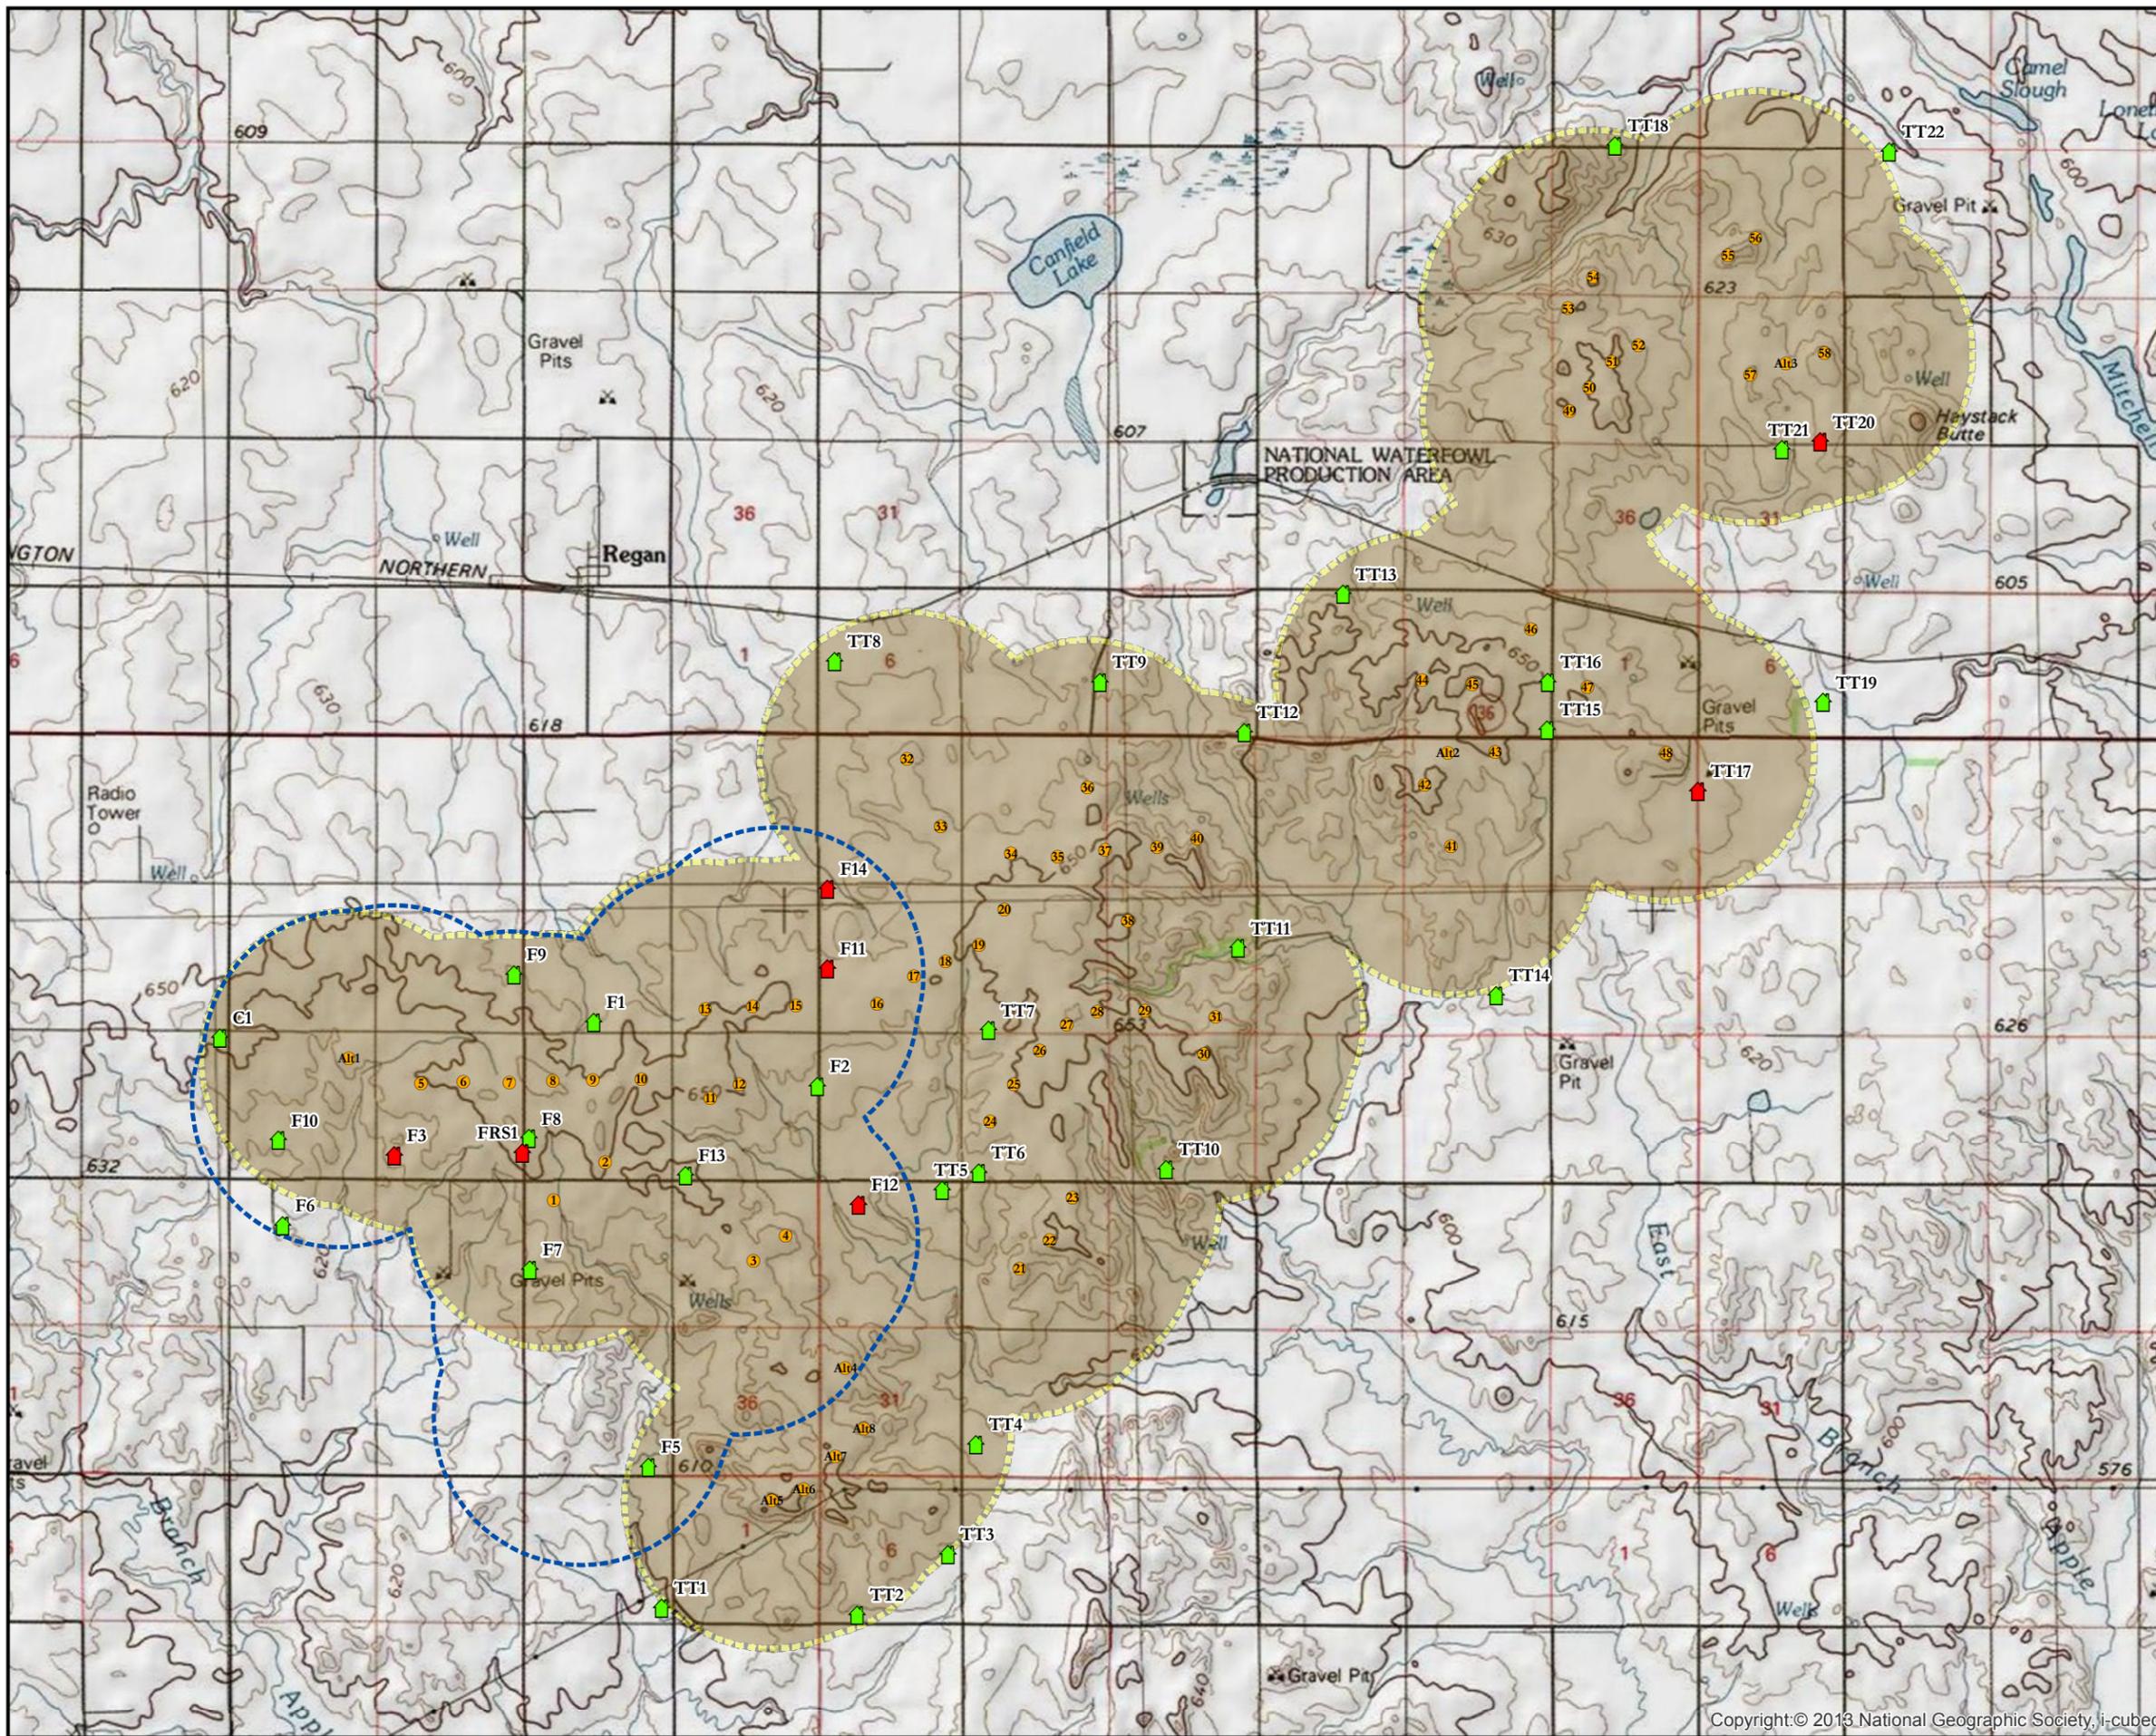
Figure 2  
 Historic Properties within  
 the APE for Historic Architecture  
 Wilton IV Wind Energy Center  
 Burleigh County, North Dakota

Twenty-two previously-unrecorded historic and recent properties within the APE were observed. The locations of these properties are shown on Figure 2. Through documentary research using historic plat books, 20 of the 22 previously unrecorded historic and recent properties were identified as potentially being 45 years old or older. Properties Tt 17 and Tt 20 were found to be without buildings on the 1969 plat map. They were therefore considered not to meet the criterion for documentation of being 45 years old or older. All previously unrecorded properties were evaluated to determine if they retained integrity in seven aspects defined by the National Park Service (NPS, 1997). These aspects of integrity are the following:
