**WETLAND EVALUATION REPORT
FOR THE WILTON IV WIND ENERGY CENTER
BURLEIGH COUNTY, NORTH DAKOTA**

**NextEra Energy Resources, LLC
700 Universe Boulevard
Juno Beach, Florida 33408**

**Tetra Tech
December 2012**

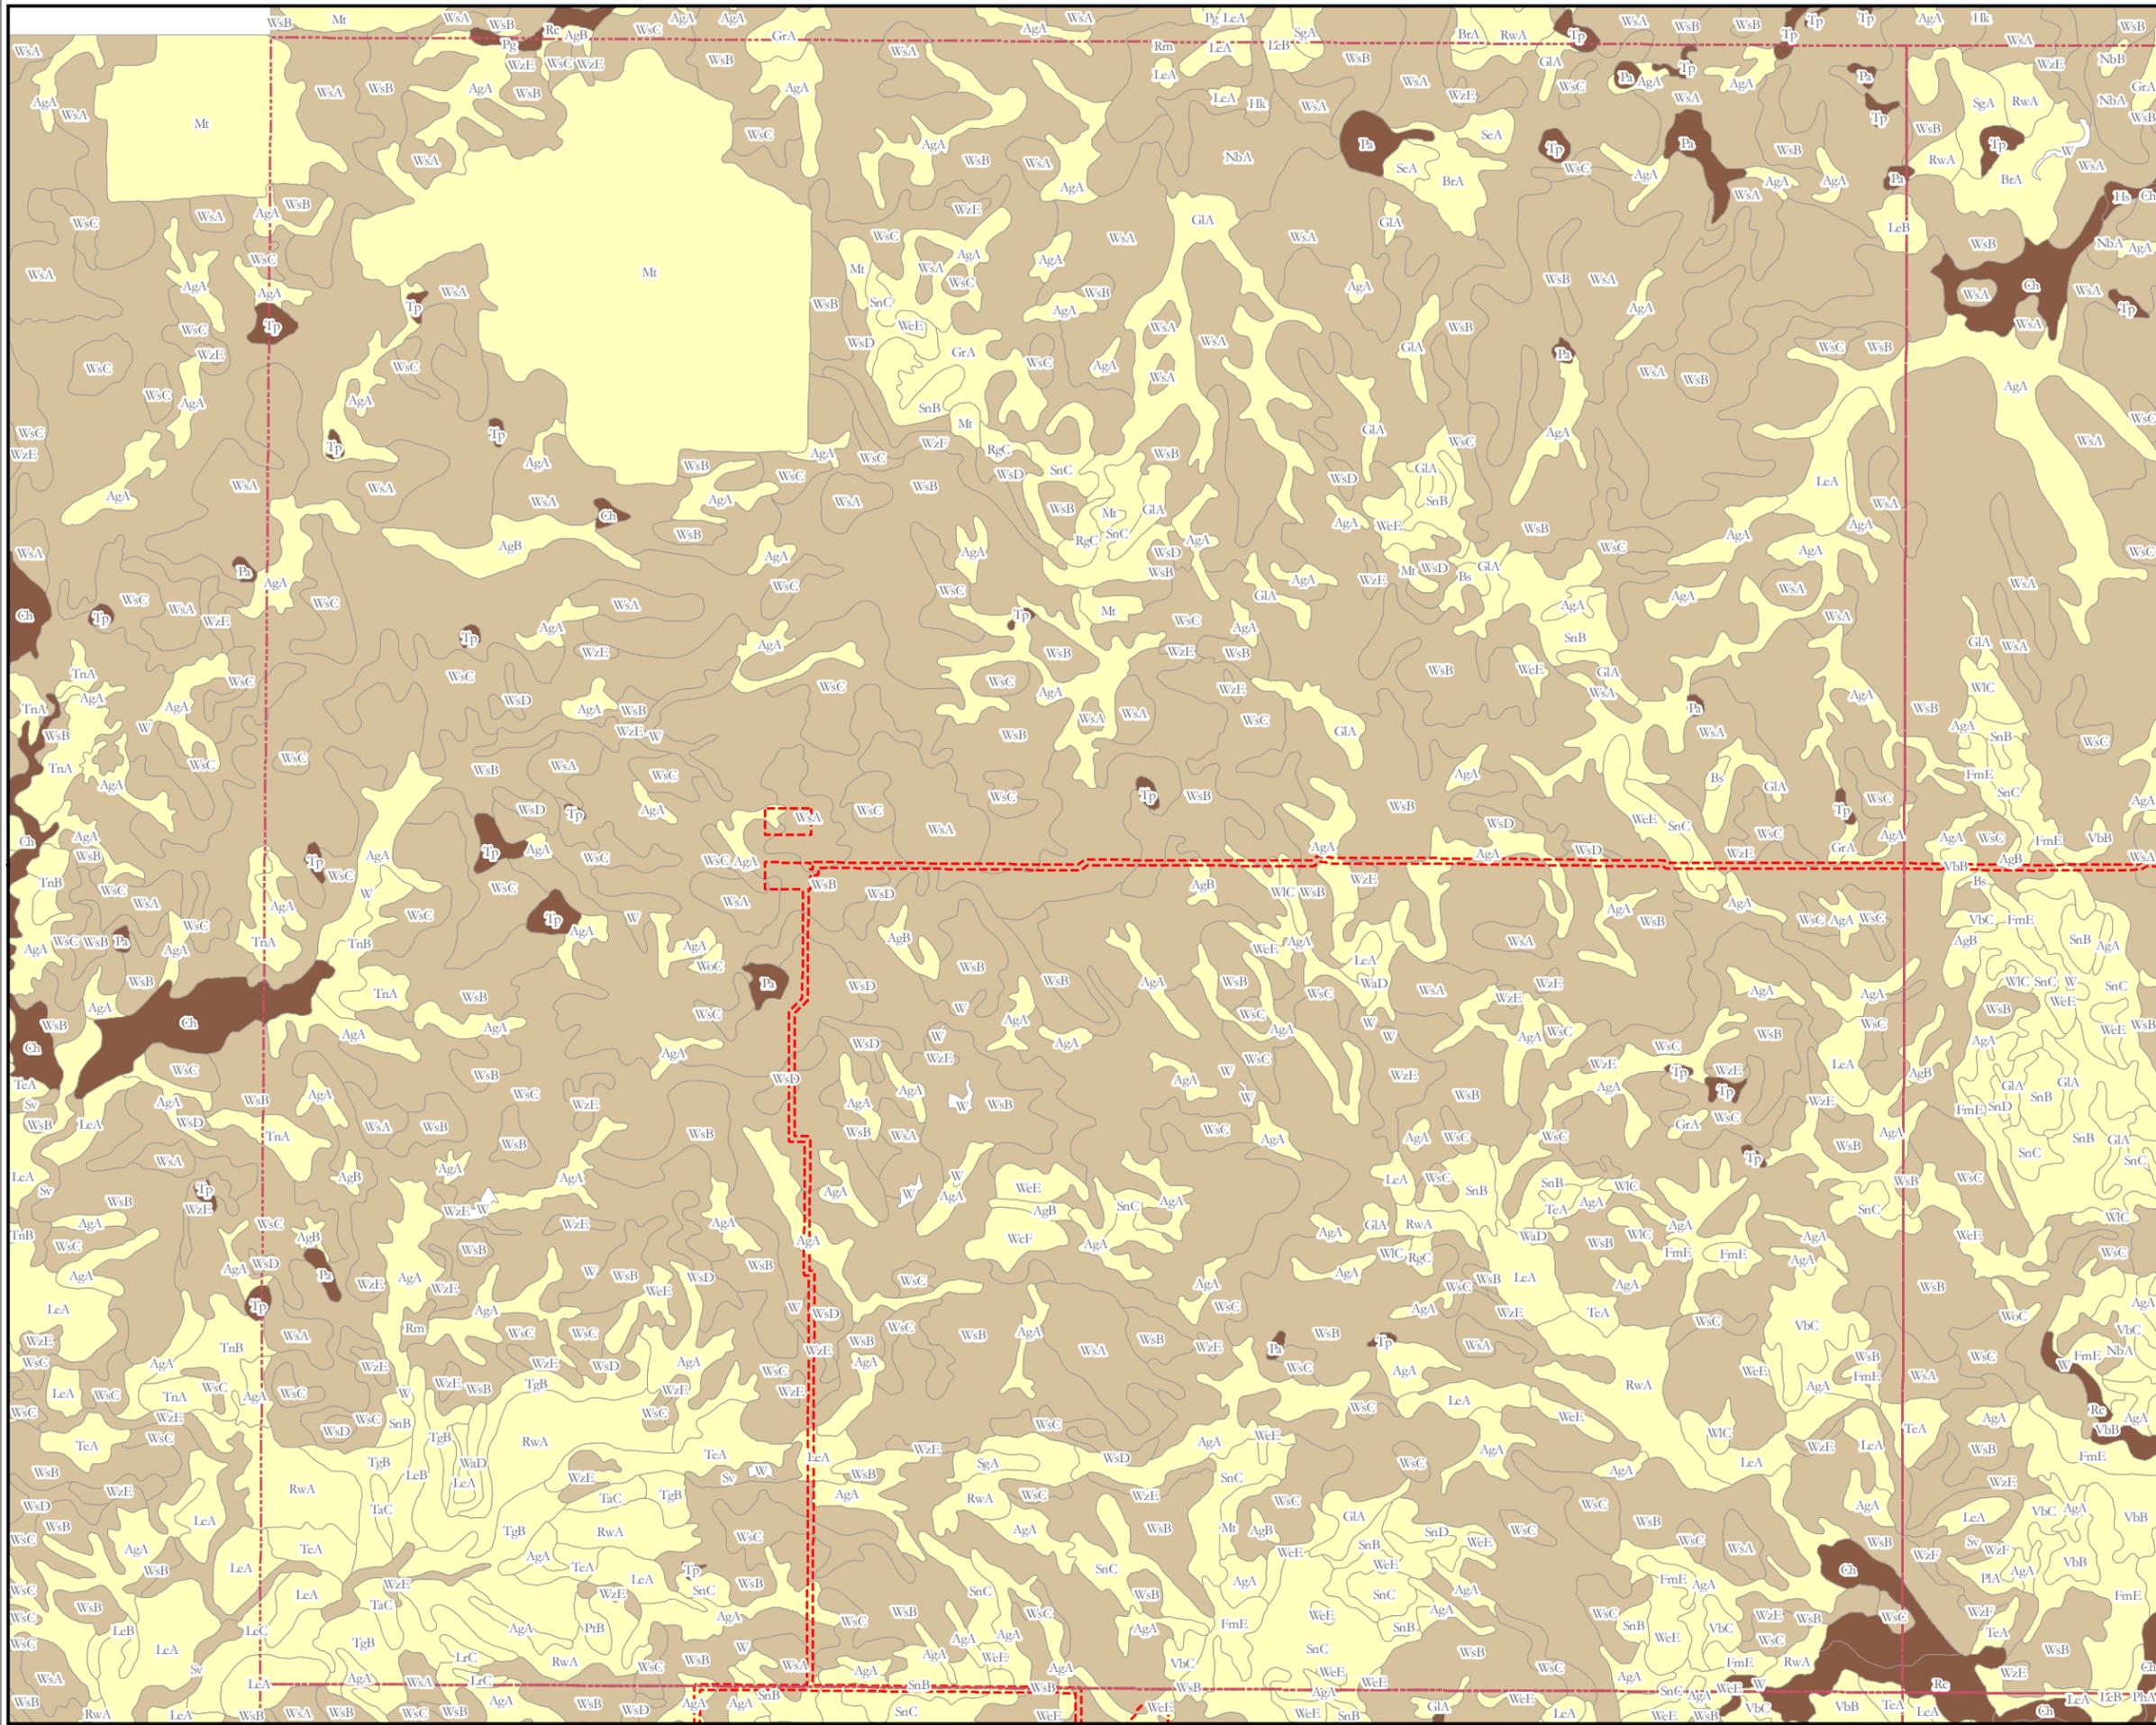
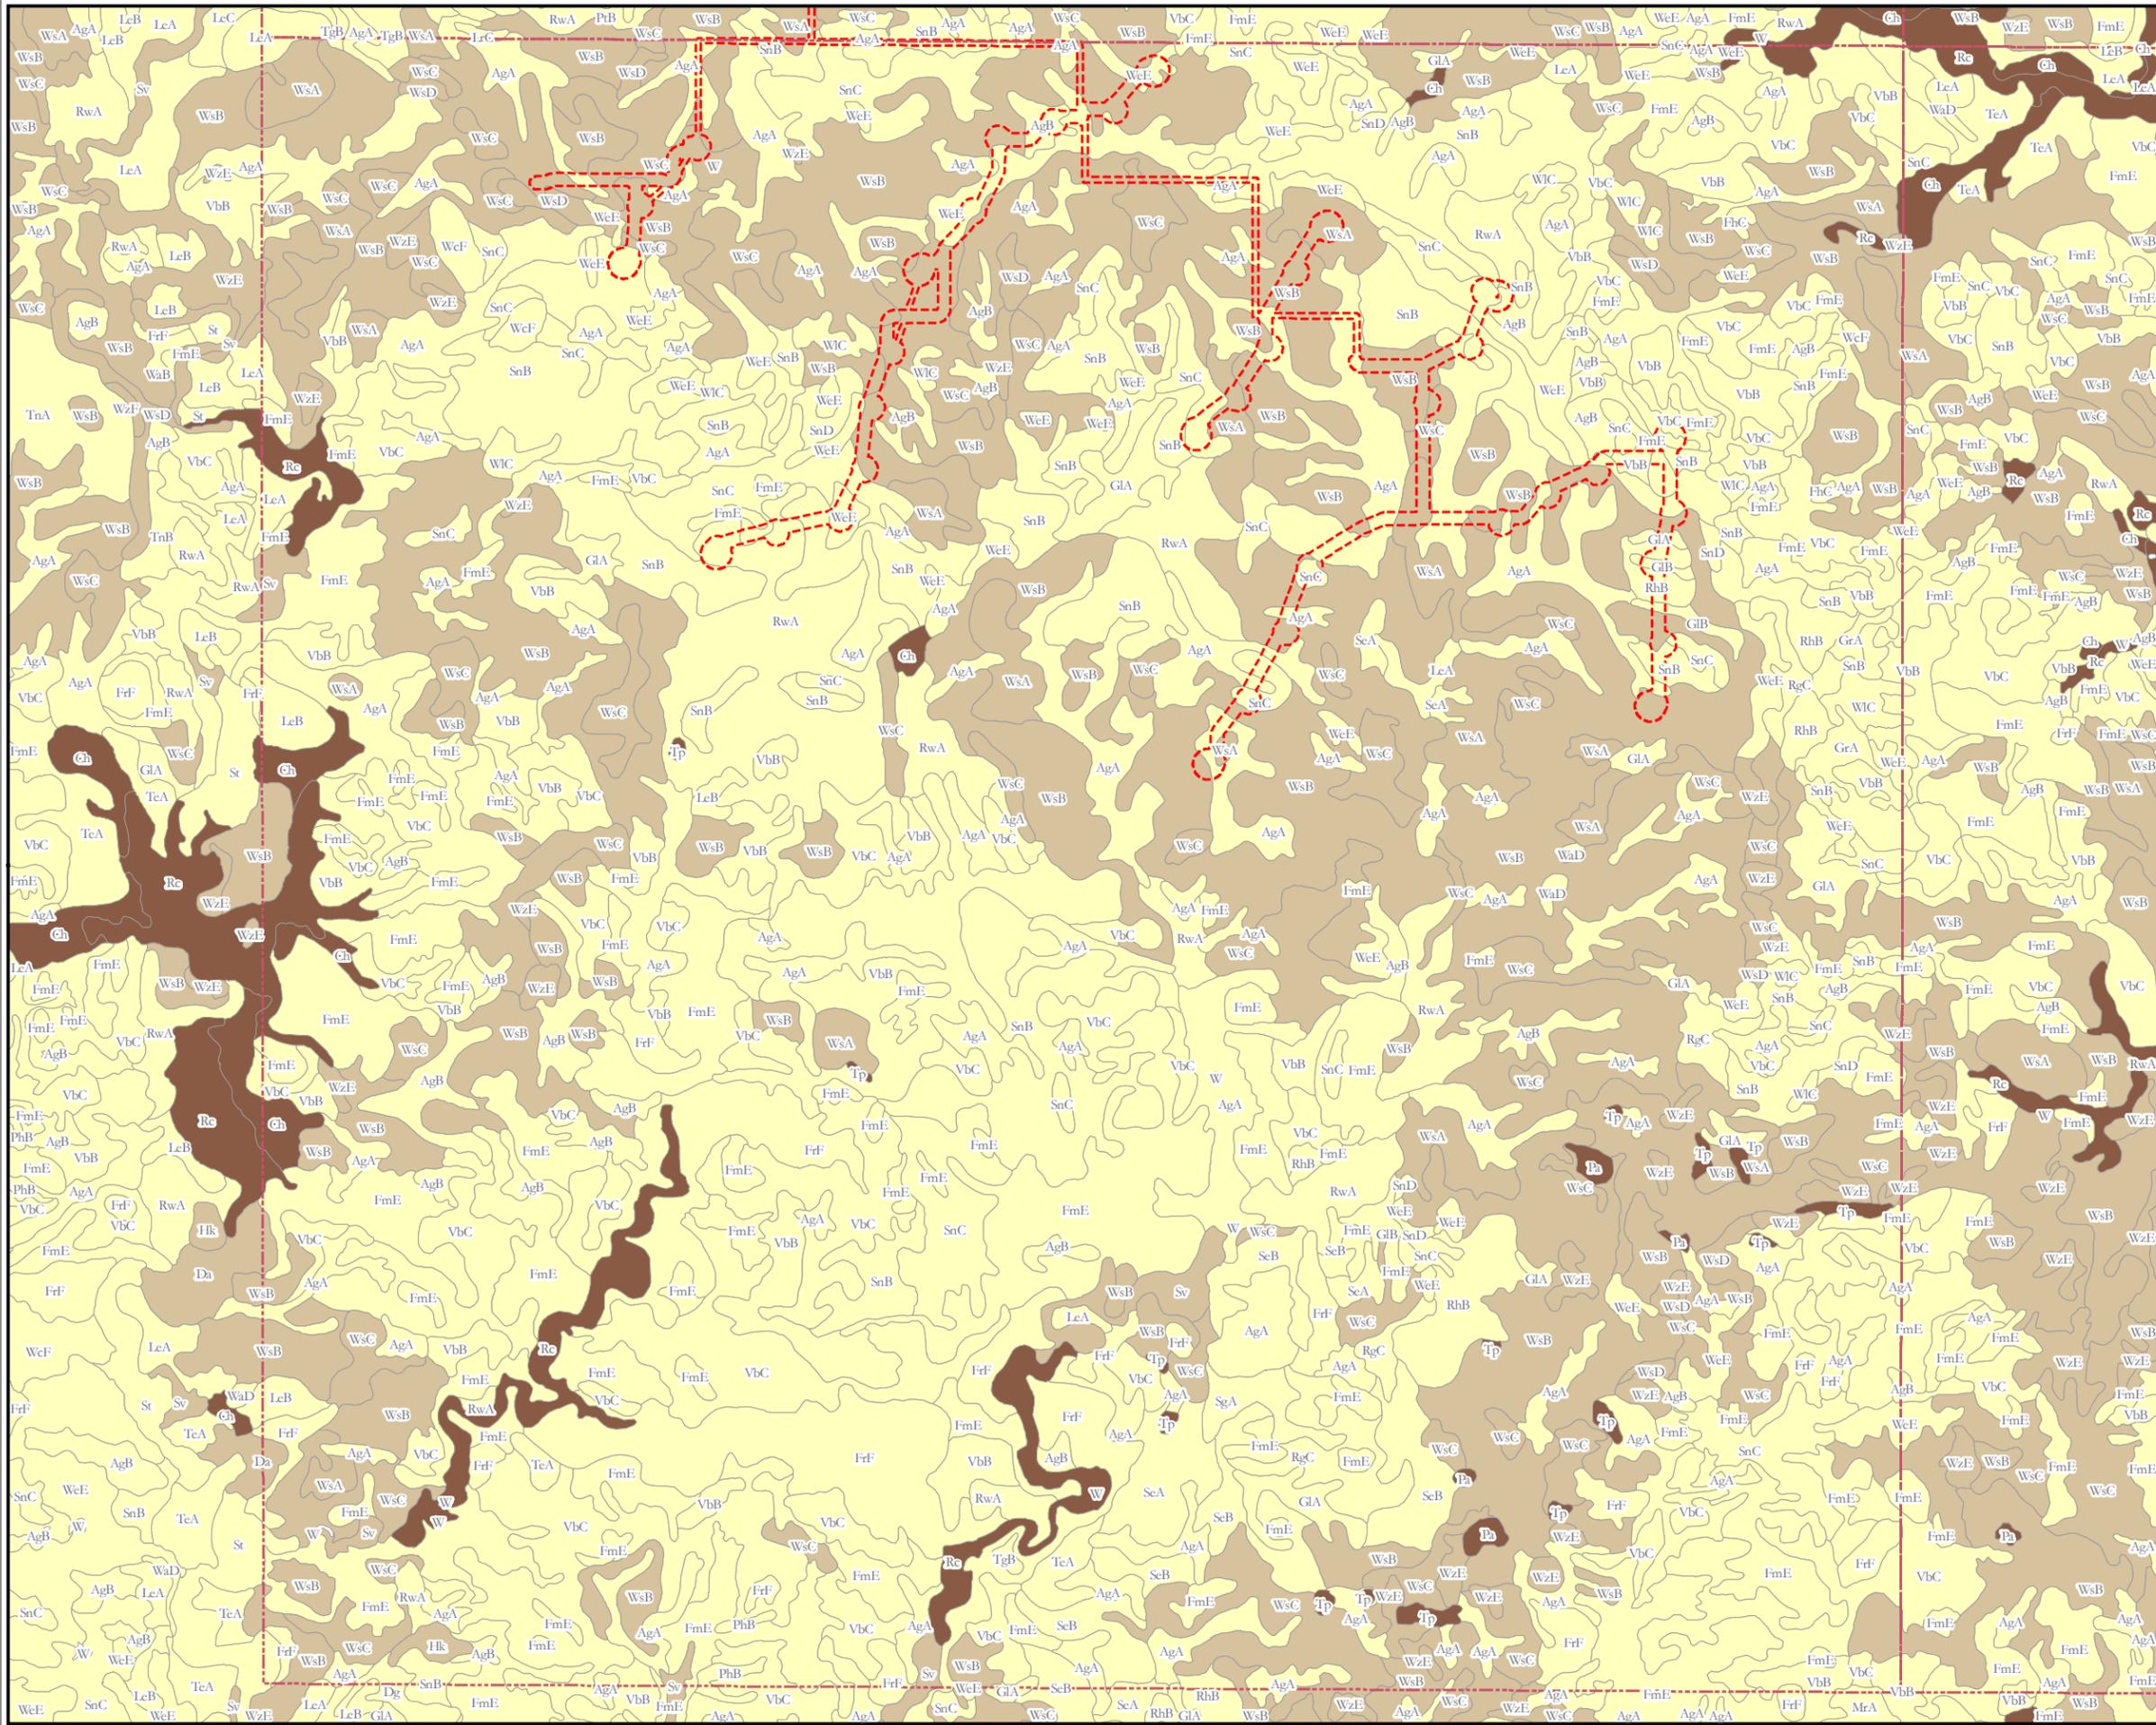
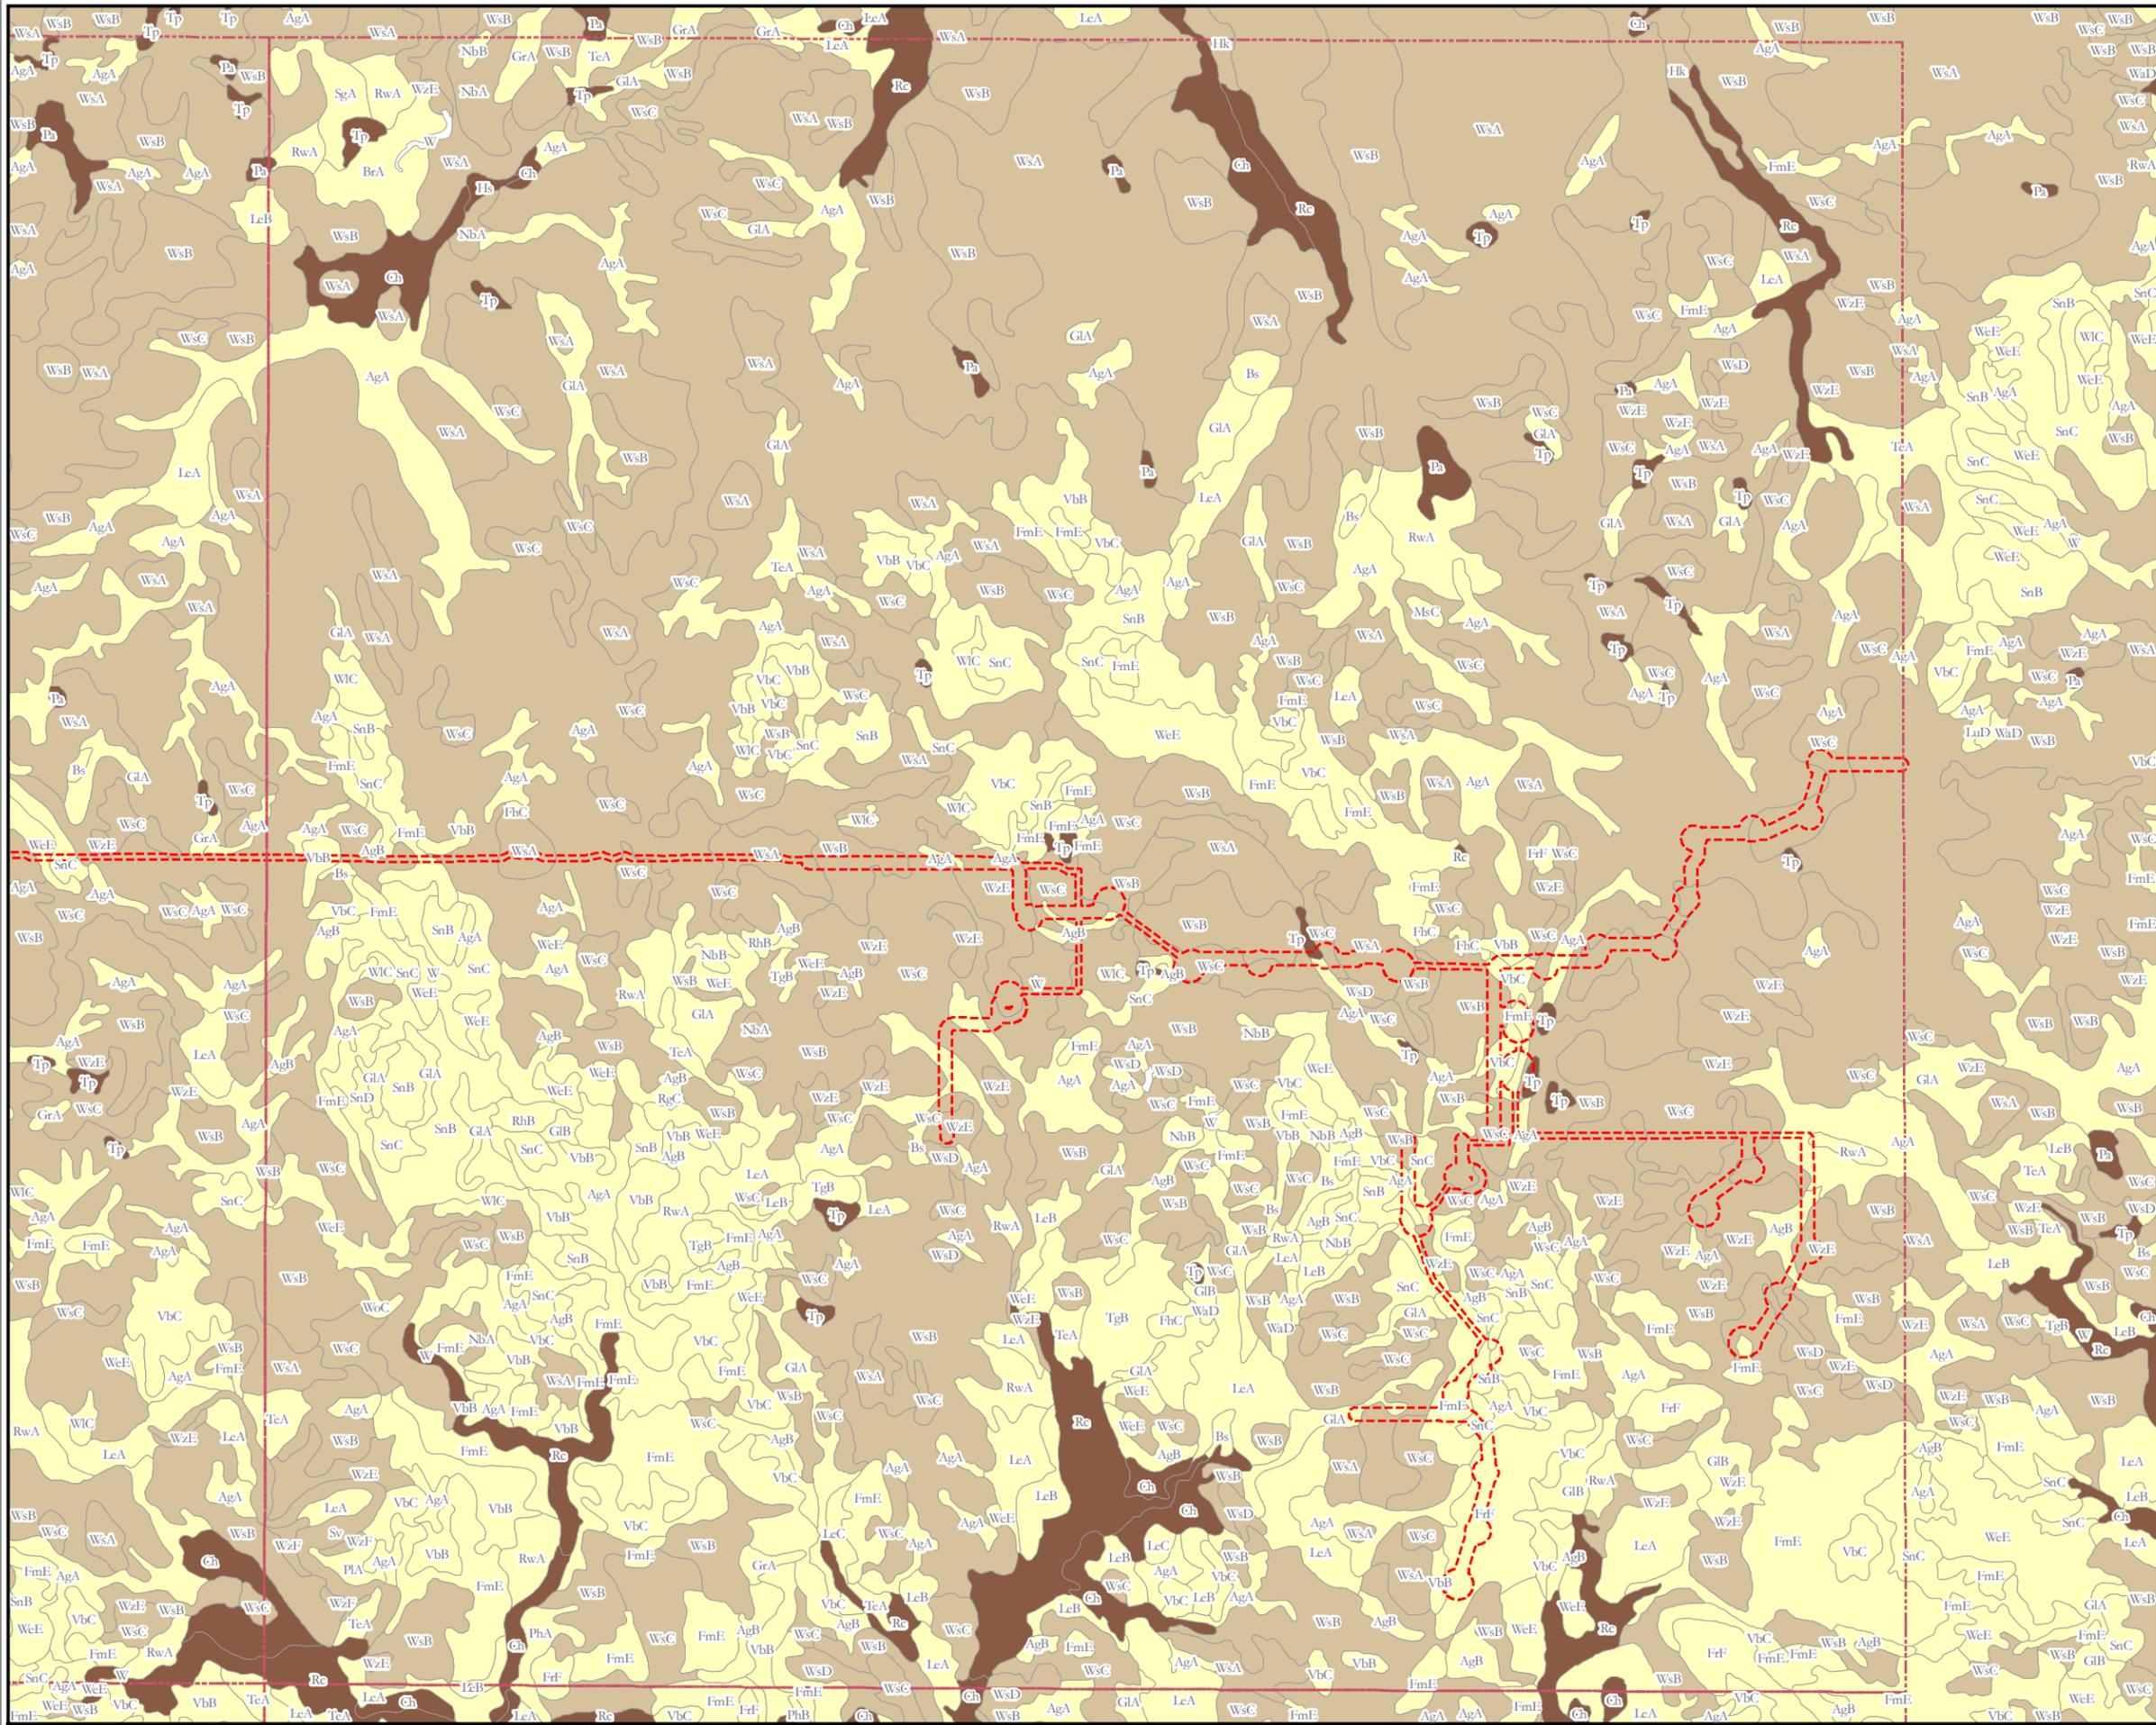
The most common hydric soil indicators observed at soil test plot locations included the following indicators: depleted below dark surface, loamy mucky mineral, and redox depressions. A complete description of the hydric soil types identified and the hydric soil indicators observed at delineation plots are presented on the wetland determination data forms in **Appendix B**. **Figure 3** depicts hydric soil classifications in the Project vicinity based on SSURGO.

- SSURGO Soils - Hydric Classification
- All hydric
 - Partially hydric
 - Not hydric
 - Survey Corridor
 - Township

within the Project Area. According to reviewed data, there are 33 soil series represented within the survey corridor. Soil, as it relates to wetland delineations, must be classified as a hydric soil for the area to qualify as a wetland in accordance with the 1987 Manual (Environmental Laboratory 1987) and the Regional Supplement (USACE 2010). Hydric soils are defined as soils that are formed under conditions of saturation, flooding, or ponding that occurs long enough during the growing season to develop anaerobic conditions. In the SSURGO dataset, soils may be classified as not hydric (all series components rated as not hydric), partially hydric (at least one component rated as hydric and at least one component rated as not hydric) or all hydric (all series components rated as hydric). In the survey corridor, approximately 61 percent of soils are classified as not hydric, 39 percent are classified as partially hydric and less than 1 percent are classified as all hydric. The following table summarizes the type and extent of soils found in the survey corridor and the distribution of hydric soils within the Project area is depicted on **Figure 3**.
